Rock Island Dam

RICHARD W. GALSTER
Consulting Engineering Geologist

PROJECT DESCRIPTION

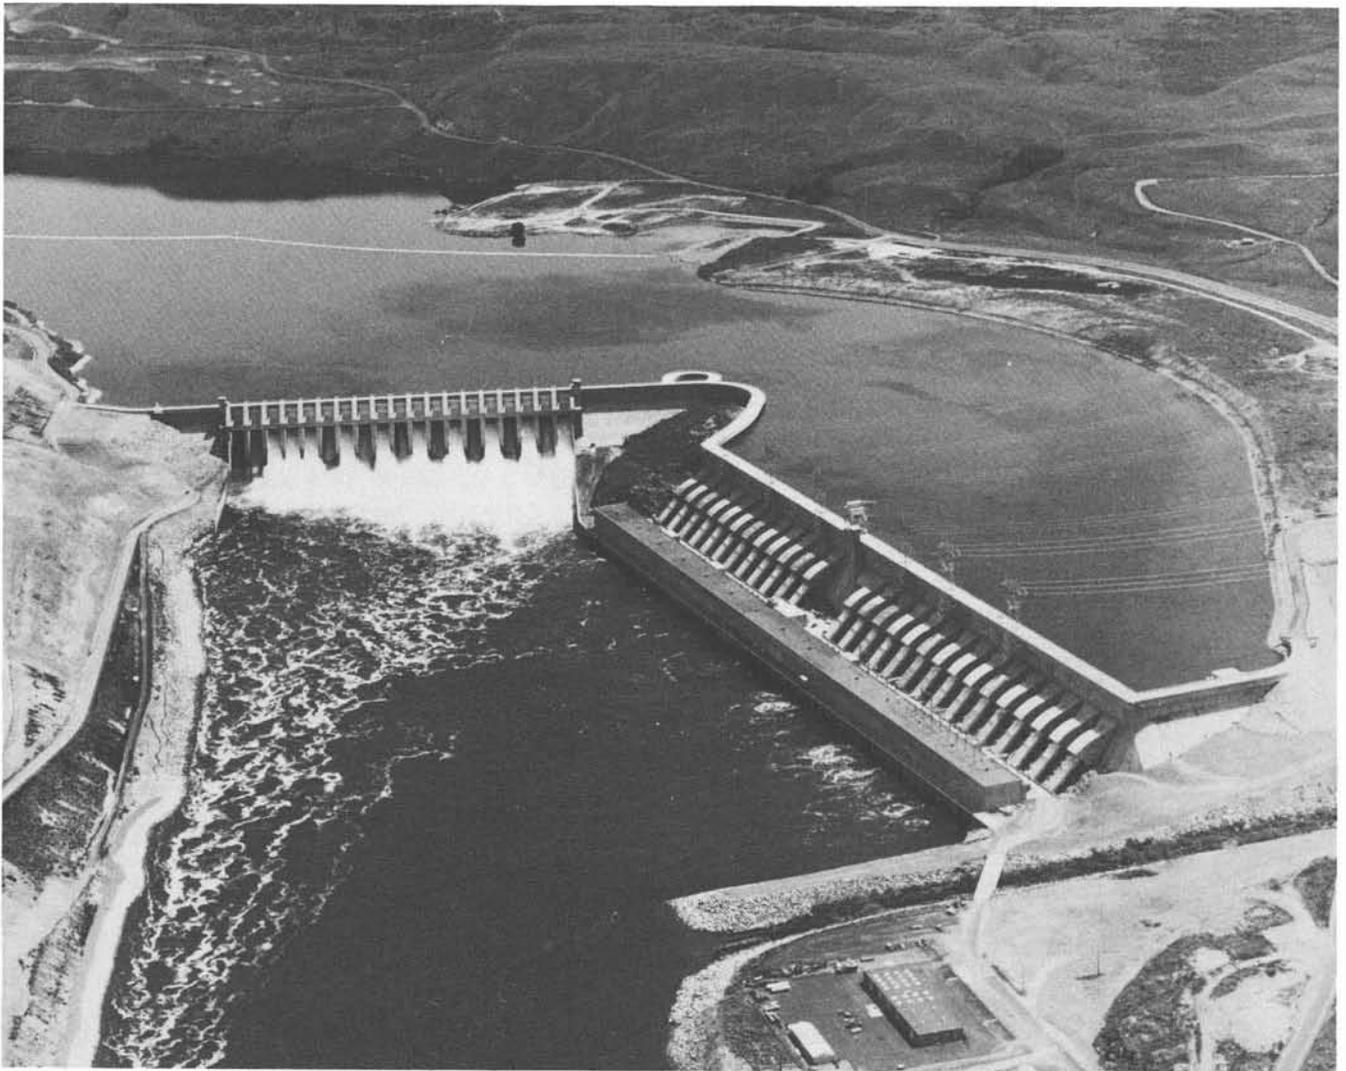
Figure 1. Chief Joseph Dam. View upstream showing the spillway dam abutting a glacial terrace (left) and the intake structure/powerhouse (right) connected by the gravity arch "bottonhook" section (center). Foster Creek enters the Columbia River in an artificial channel at the lower right. Pearl Hill Road (Douglas County Road 321) ascends across the Bridgeport slide beyond the forebay. Photo courtesy U.S. Army Corps of Engineers, May 1981.

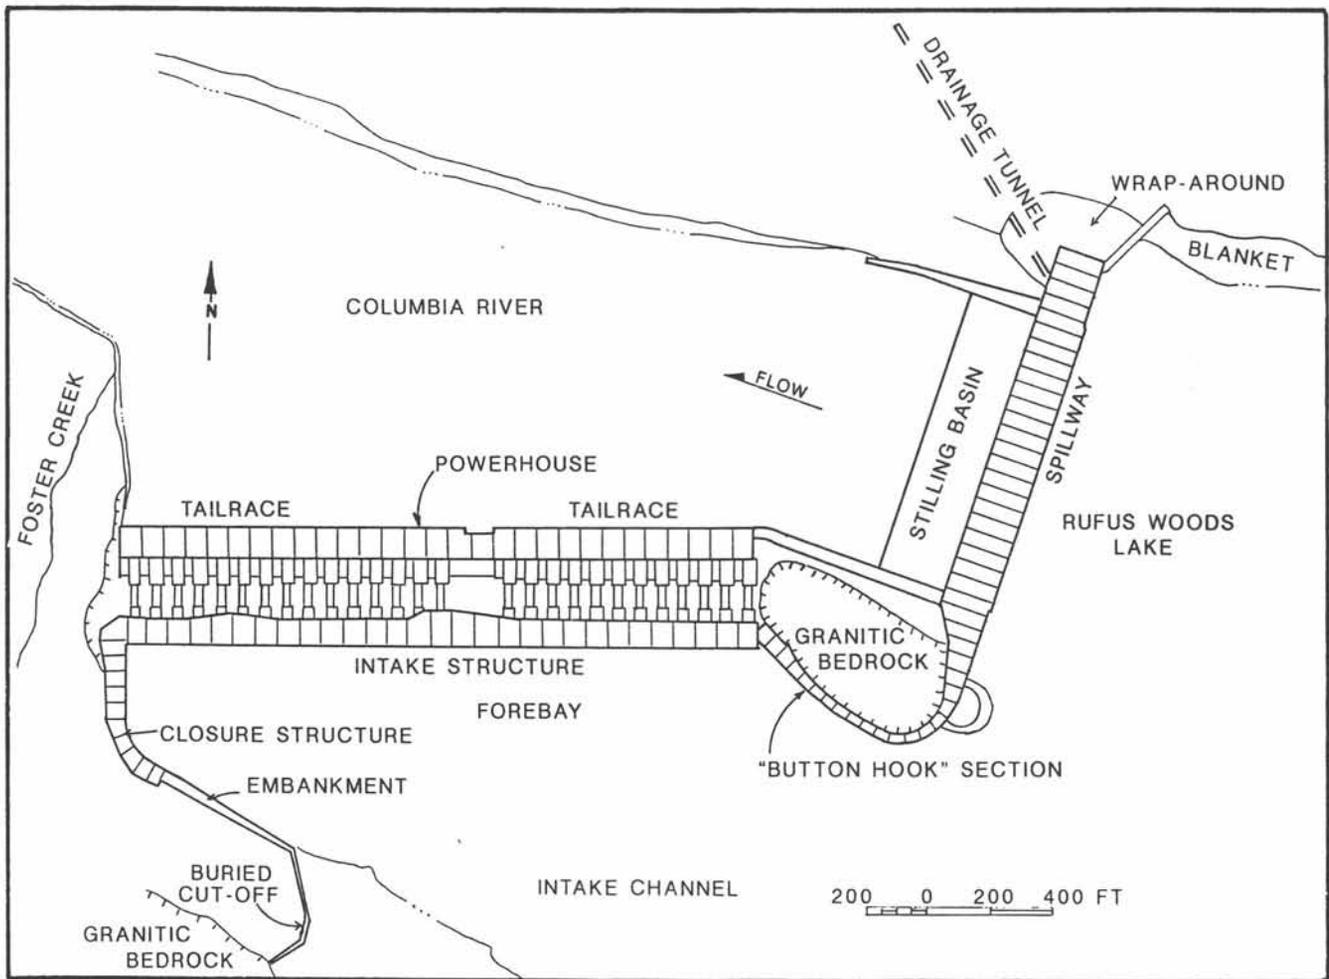
Figure 2. General project layout of Chief Joseph Dam.

cial sequence in the right bank. The sequence consists of an extensive deposit of torrentially cross-bedded, largely openwork gravel and cobbles that is 10 to 100 ft thick and directly overlies bedrock. This obviously highly pervious unit is overlain by a varied thickness of "dump moraine" and more than 100 ft of till. The dump moraine consists of large boulders and blocks of basalt and Latah sediments (siltstone and sandstone) in a varied matrix of locally bedded sand, gravel, silt, and clay. The till is a silt-rich, sandy, gravelly lodgement-attrition till. The design and construction of the right bank leakage control feature was, for the time, unique. It consisted of a 2,000-ft-long upstream blanket and a 1,000-ft-long relief tunnel (adit) located just downstream from the dam (Figure 2).

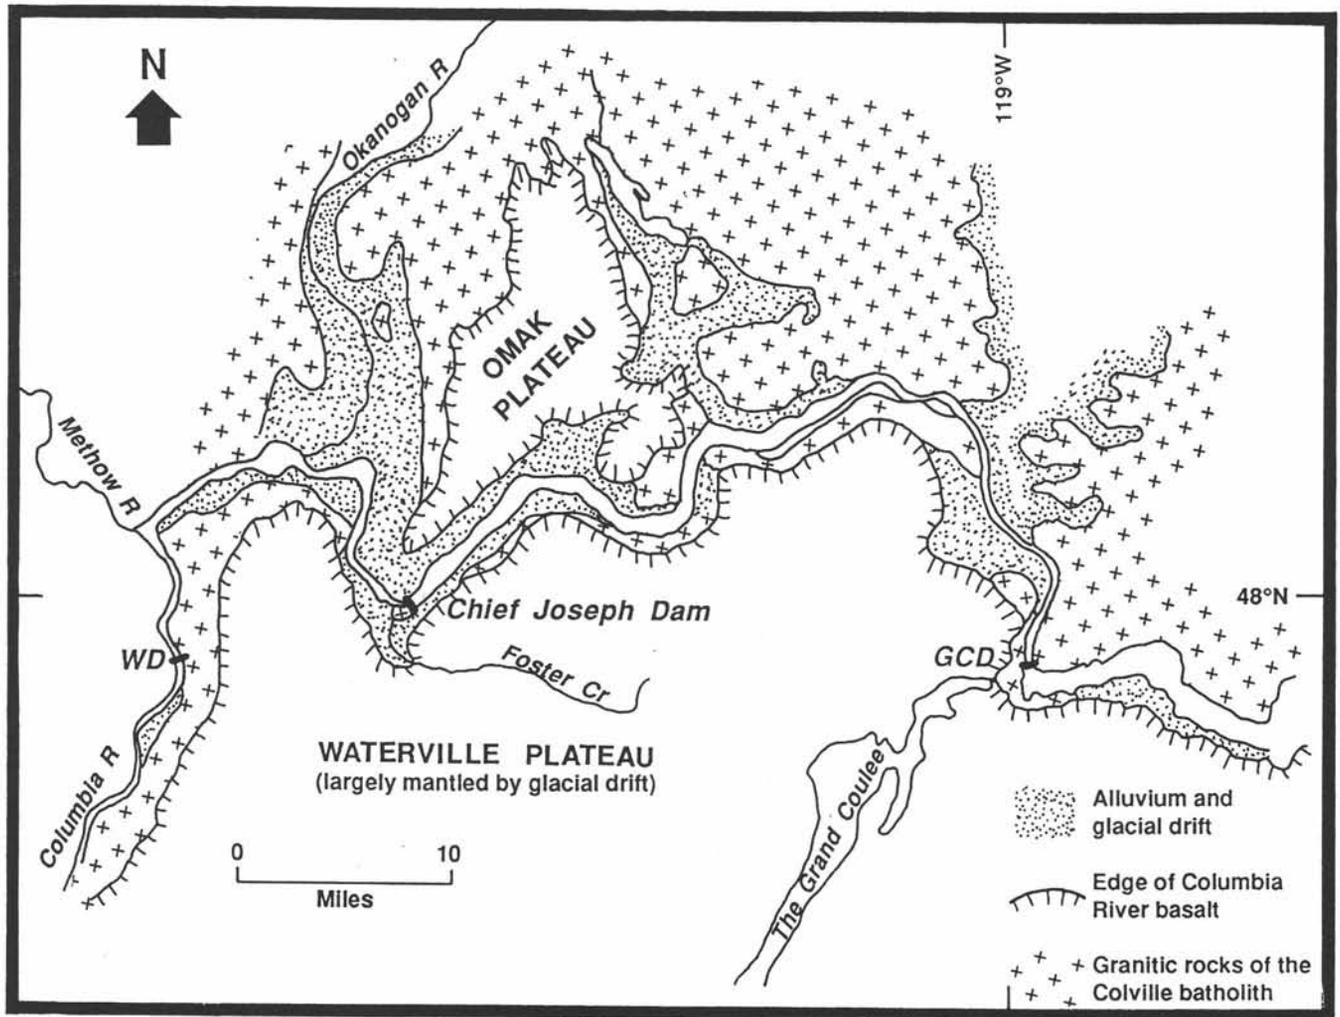
Figure 3. Regional geologic setting of Chief Joseph Dam. GCD, Grand Coulee Dam; WD, Wells Dam.

downstream end of this remote segment of the valley where it enters the south end of the broad, glaciated Okanogan River valley (Okanogan Trench) (Figures 3 and 4). Sound granite was exposed on the left (south) bank and appeared to be at shallow depths beneath the river channel. Moreover, there was space for construction of extensive powerhouse facilities with a minimum of excavation. The 250-ft-high bluff rising to a broad glacial terrace on the right bank of the river was known to be composed of a heterogeneous mix of glacial drift, but it was believed to contain sufficient clay to prevent serious abutment leakage (U.S. Congress, 1934).

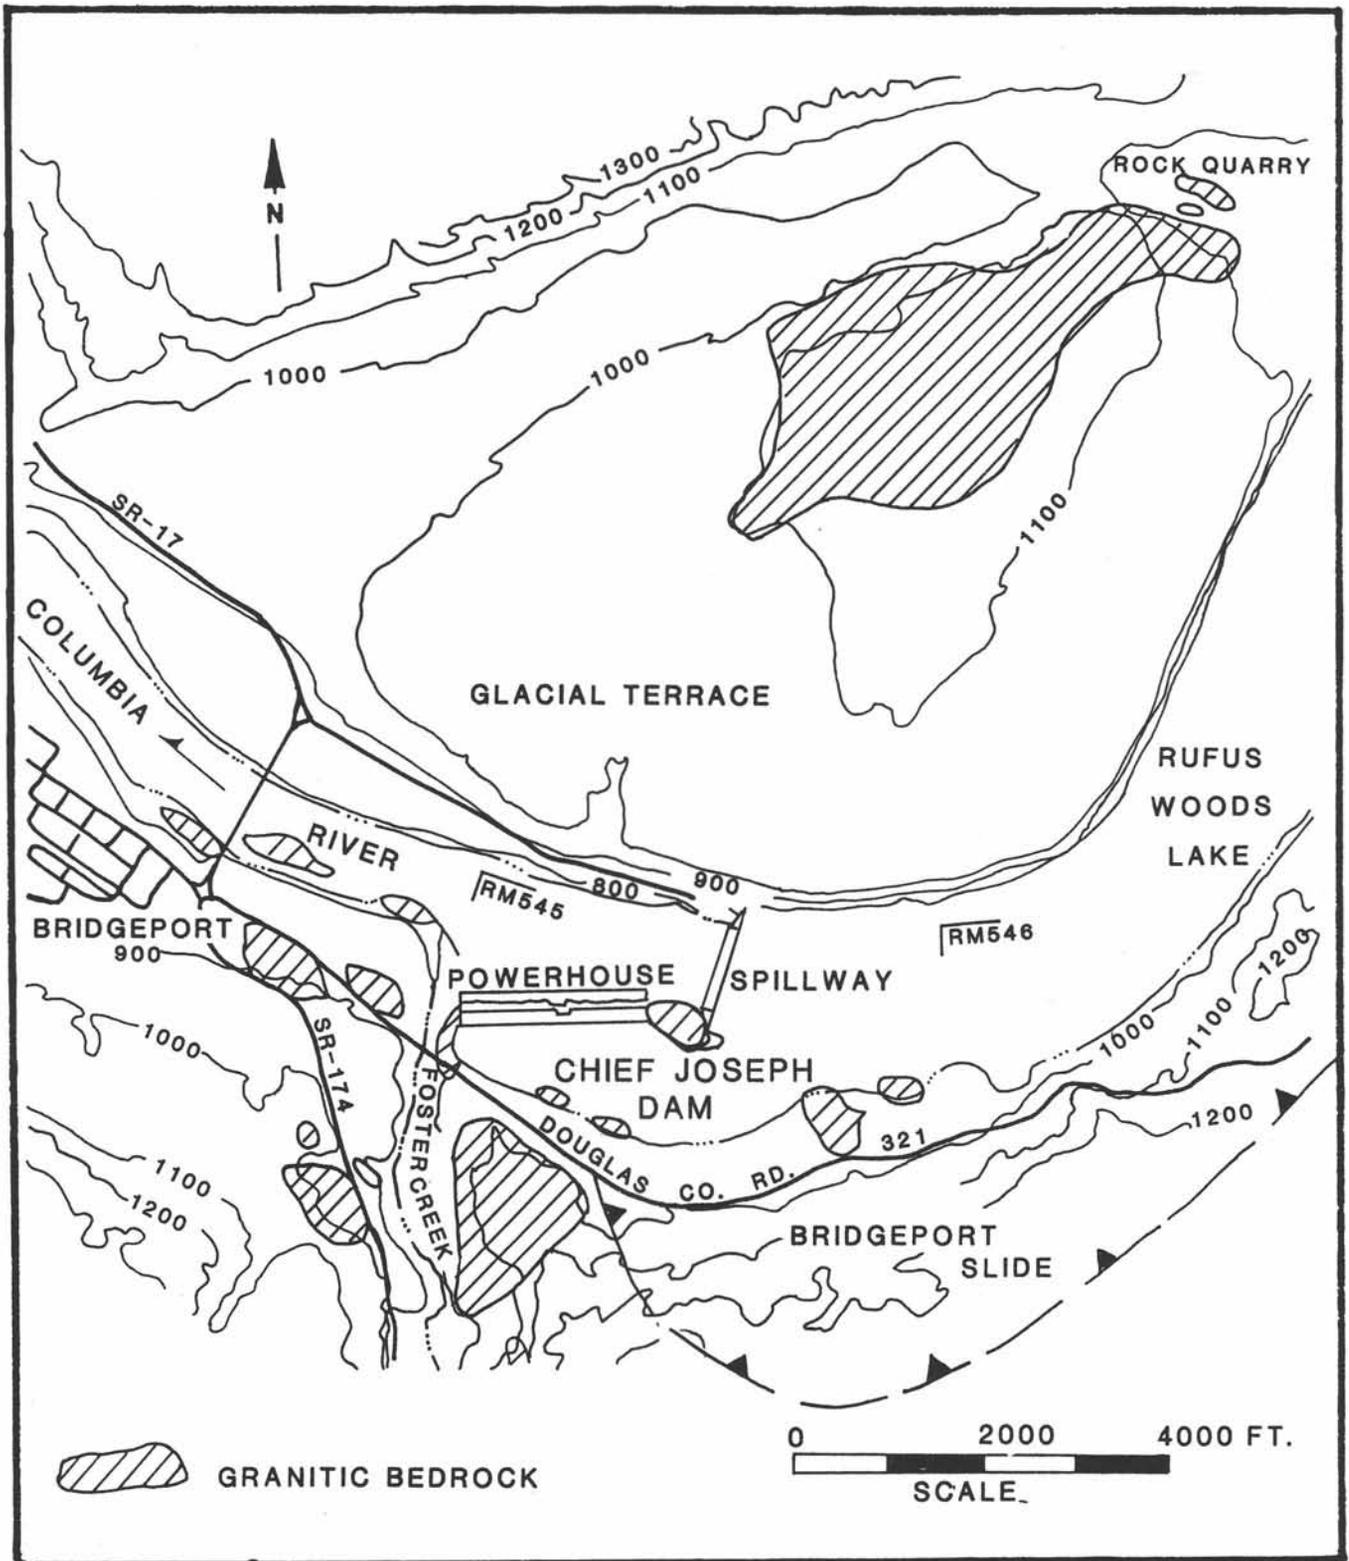
Figure 4. Generalized geology at the Chief Joseph Dam site.

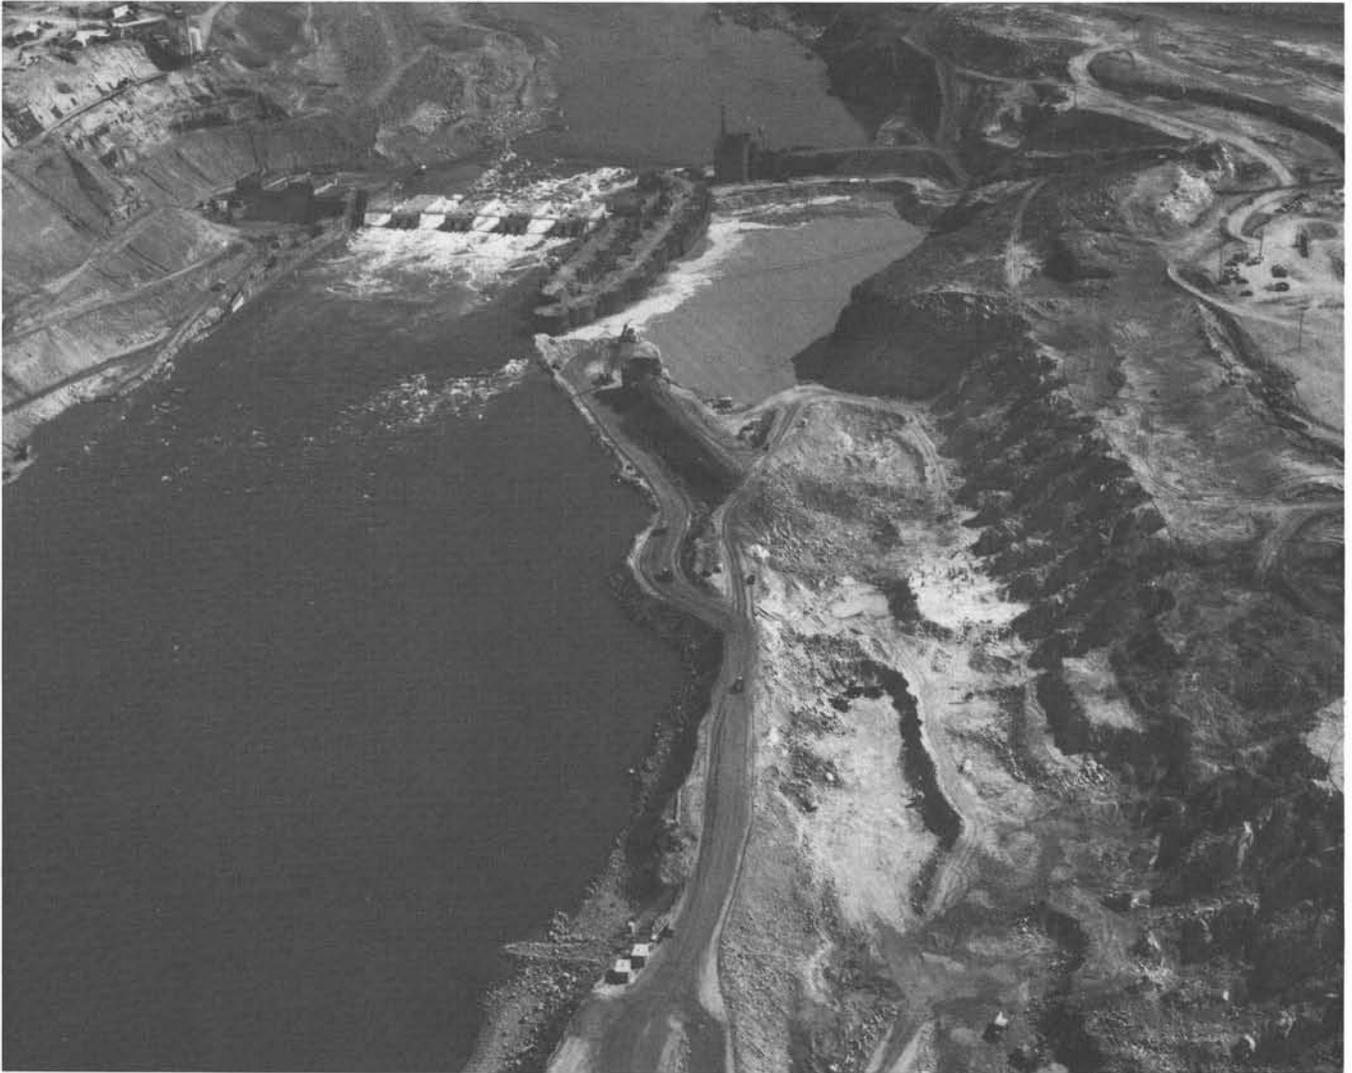
Figure 5. Chief Joseph Dam. View upstream during construction (March 1952) at the beginning of stage 2 diversion. Monoliths for the north half of the spillway are partly constructed (left), and the river is being diverted through the low blocks. Preparation of the right abutment is under way (left), and construction of the right bank blanket can be seen behind dikes upstream from the partly completed spillway. Dewatering for stage 2 construction of the spillway is incomplete. Excavation for the powerhouse and intake structures is at the right. Rock ribs between penstock slots were removed prior to actual construction of the intake structure. Photo courtesy of U.S. Army Corps of Engineers.

spillway was constructed behind cellular and earthen cofferdams. The right bank blanket and the powerhouse excavation proceeded simultaneously with spillway construction behind earthen cofferdams (Figure 5). Intake channel excavation and foundation preparation for the intake structure, closure structure, and buttonhook section were all above river flood levels and proceeded simultaneously with activities requiring diversion.

necessitated considerable rock excavation. A bedrock low in the center section of the intake structure required the foundation to be as low as elevation 813 ft. Locally, till was present in depressions in the bedrock surface, and its removal commonly required blasting. Mass rock excavation methods were used in this excavation as well as in development of the penstock slots below the intake structure. The resulting rock ribs between the penstock slots (Figure 5) were judged to be unstable, however, and were removed prior to powerhouse construction.

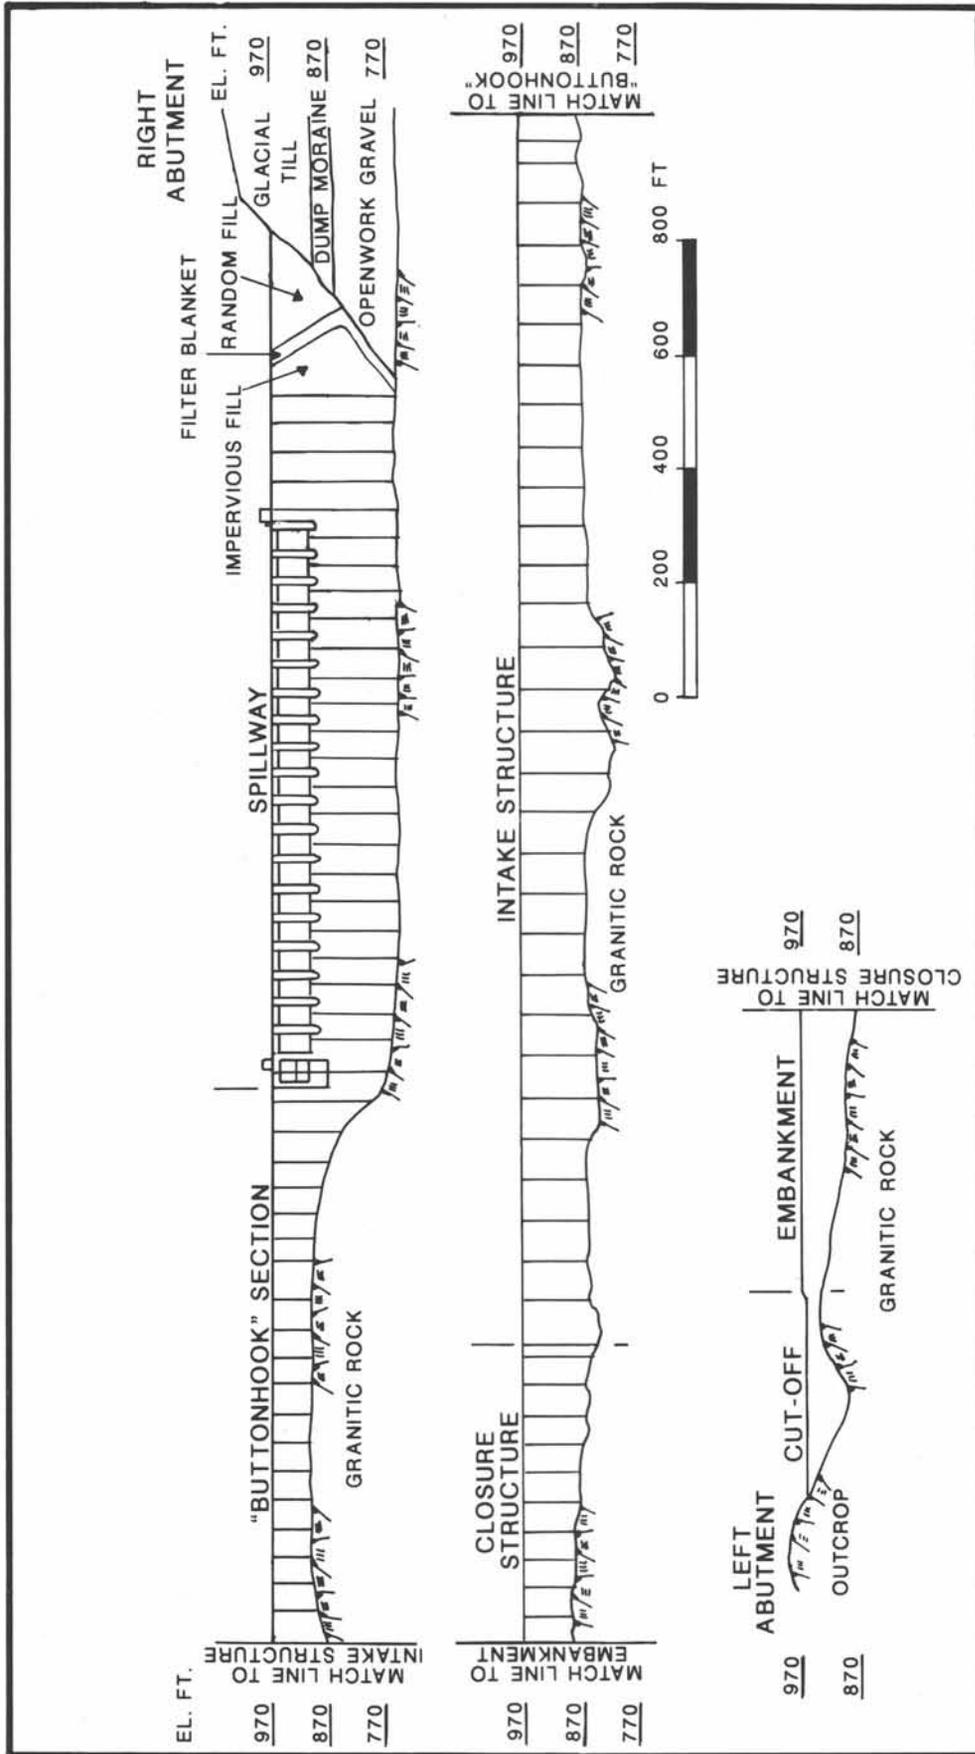
Figure 6. Geologic profile along the axis of Chief Joseph Dam; view downstream.

The bedrock surface beneath the river channel was found to be at a general elevation of 750 ft. The surface was smooth and waterworn and had relief of about 5 ft (Figure 6). Locally, river-bed erosion extended to depths of 20 ft along fault zones (U.S. Army Corps of Engineers, 1957). The river gravels varied in thickness by as much as 20 ft, and basalt lag blocks as much as

A keyway was developed at the right abutment, sloped about 1.5H to 1V in the cobbles and gravel and about 0.5H to 1V in the overlying till and dump moraine (Figure 6). The till required blasting and was excavated in 24-ft-high lifts. The embankment section, which was constructed at the dam abutment, consisted of an impervious fill (composed of recompacted till) wrapped around the base of the three northernmost concrete monoliths of the spillway dam and tied to the upstream blanket. The impervious fill is separated from random fill in the keyway by a filter blanket (Figure 6). The impervious blanket extending 2,000 ft upstream was placed behind puddle dikes after the gravelly slope to the bedrock surface had been excavated (Figure 5). The bedrock surface was waterworn and had about 10 ft of relief. The blanket, composed of recompacted till from adjacent sources, was placed in the dry. Some moisture was added to attain the 10 percent optimum moisture content. Drainage of the gravelly slope was required prior to and during blanket placement. The top of the 10-ft-thick blanket was brought to elevations between 870 and 950 ft, depending on local geologic conditions (U.S. Army Corps of Engineers, 1957).

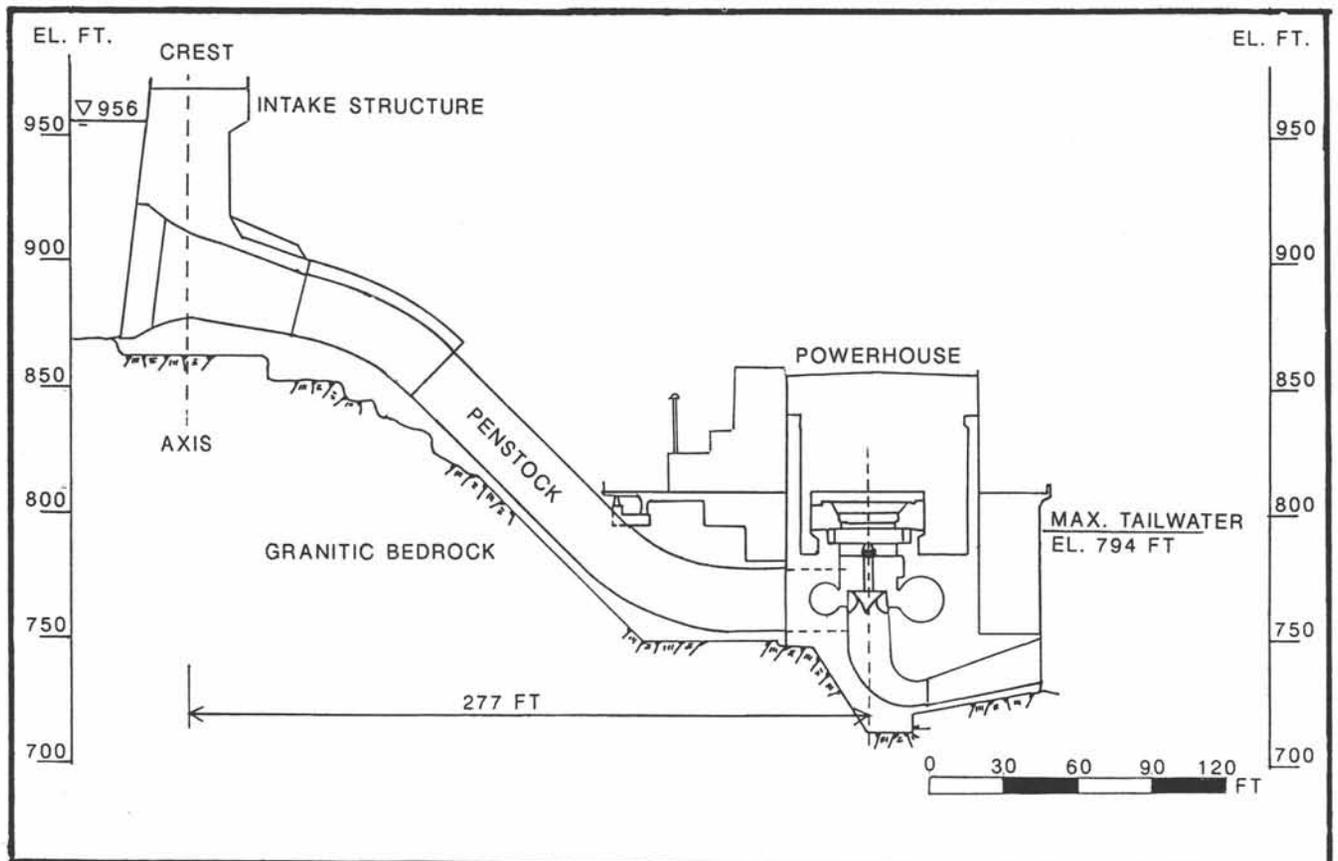
Figure 7. Typical geologic section through the intake structure and powerhouse at Chief Joseph Dam.

The powerhouse configuration required considerable rock excavation down to about elevation 720 ft (Figure 7). The mass rock method of excavation resulted in overbreak and locally caused opening of joints in the rock mass necessitating removal of additional rock. Although some controlled blasting methods (for that time) were tried, results were not effective. Several faults in the powerhouse foundation were treated by overexcavation and concrete backfill.

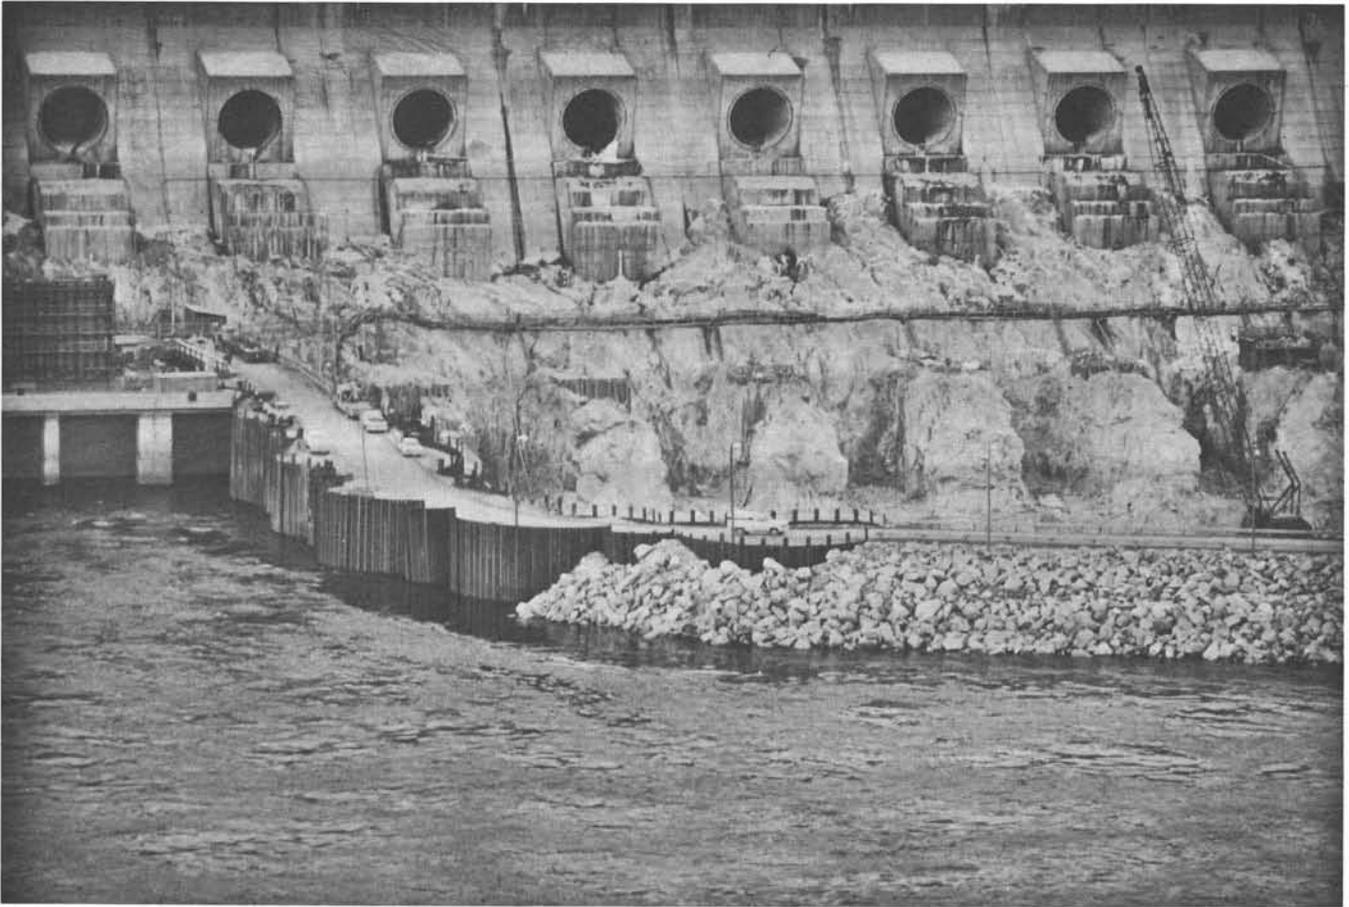
Figure 8. The powerhouse extension at Chief Joseph Dam; view across the cofferdam to the penstock slot excavation and intake structure showing penstock blanks provided during original construction. Completion of powerhouse skeleton bays is in progress (far left). Controlled blasting techniques allowed rock ribs to remain between penstock slots in which penstocks were later placed and encapsulated in concrete. Photo taken in December 1975; courtesy U.S. Army Corps of Engineers.

Powerhouse units 21 to 27 required excavation in the dry. This was done behind a combination cellular and embankment cofferdam between the original powerhouse and the right bank of Foster Creek (Figure 8). Foundation excavation for the 60-ft-diameter cellular cofferdam units was by dragline. Large boulders required blasting. The pile cut-off wall in the embankment cofferdam section did not extend to the rock surface. Thus, an extensive dewatering system and monitoring of phreatic levels within the cofferdam were required throughout the construction period. In December 1975 during a high spillway discharge, a leak occurred through the northwest corner of the embankment cofferdam section. Pre-dam topography indicated that an old channel of Foster Creek, about 50 ft east of the leak area, was apparently filled during original powerhouse construction. A seepage interceptor system was built to insure continued stability of the cofferdam.

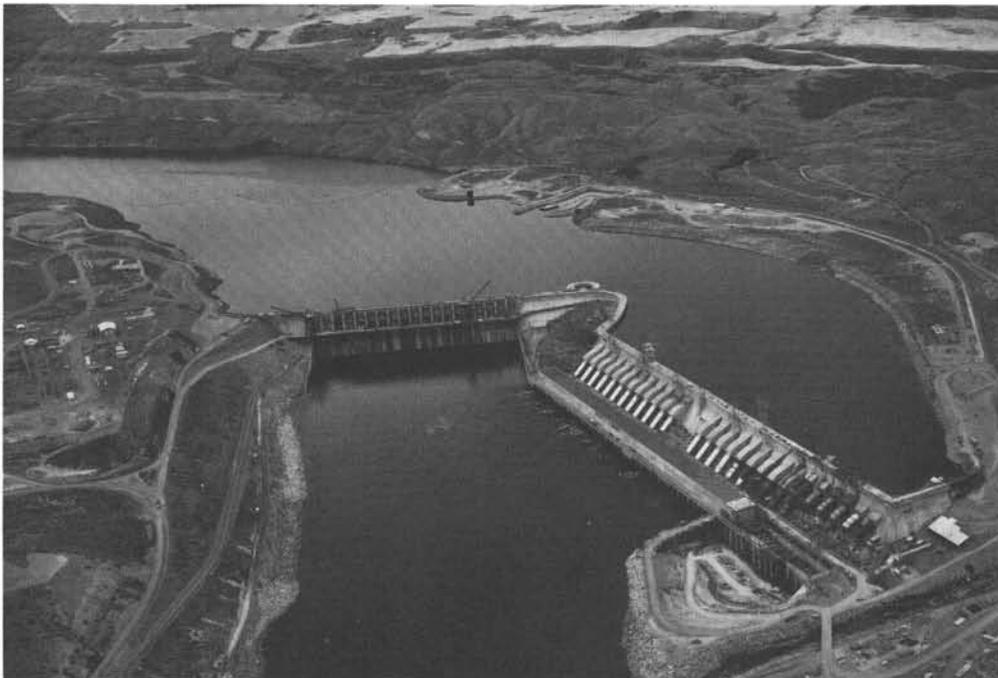
Chief Joseph Dam, July 25, 1977, during modification and powerhouse addition activities. A steel trestle has been constructed across the face of the spillway dam, and the process of partial removal of spillway gate piers has begun (left center) behind a floating cofferdam. A second floating cofferdam is being prepared on the far shore behind the dam. Work on the powerhouse extension can be seen within a combination embankment and cellular cofferdam (lower right). Photograph by Seattle District, U.S. Army Corps of Engineers.

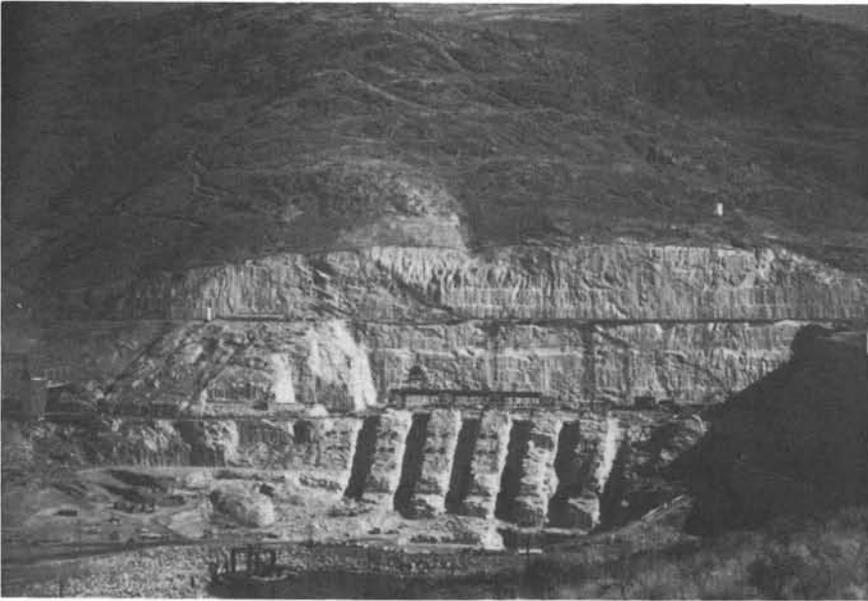
Grand Coulee Dam, right forebay and Third Powerplant excavation showing the slots cut into granite for future penstocks. Photograph by R. W. Galster, October 1970.

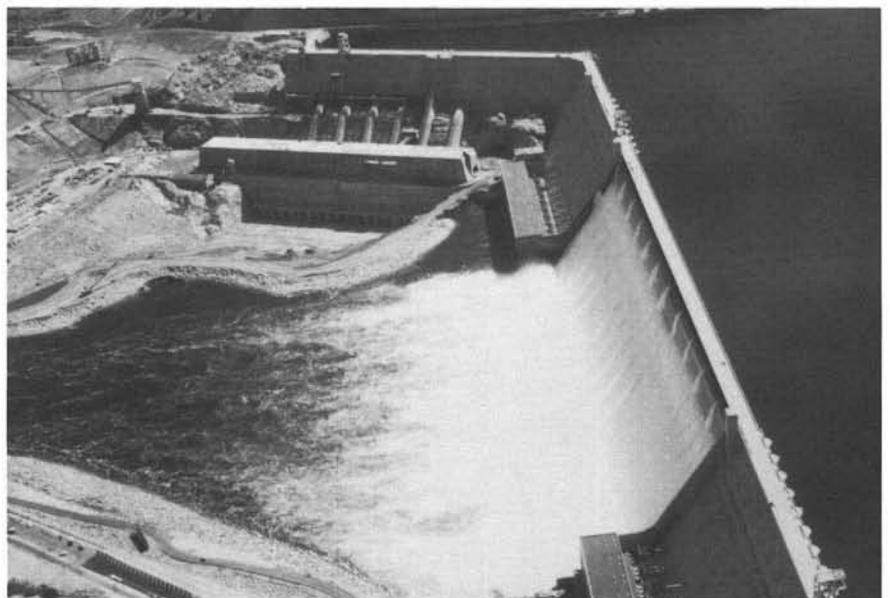
Aerial view of Grand Coulee Dam showing the completed Third Powerplant behind the downstream cofferdam. Photograph by R. W. Galster, August 6, 1974.

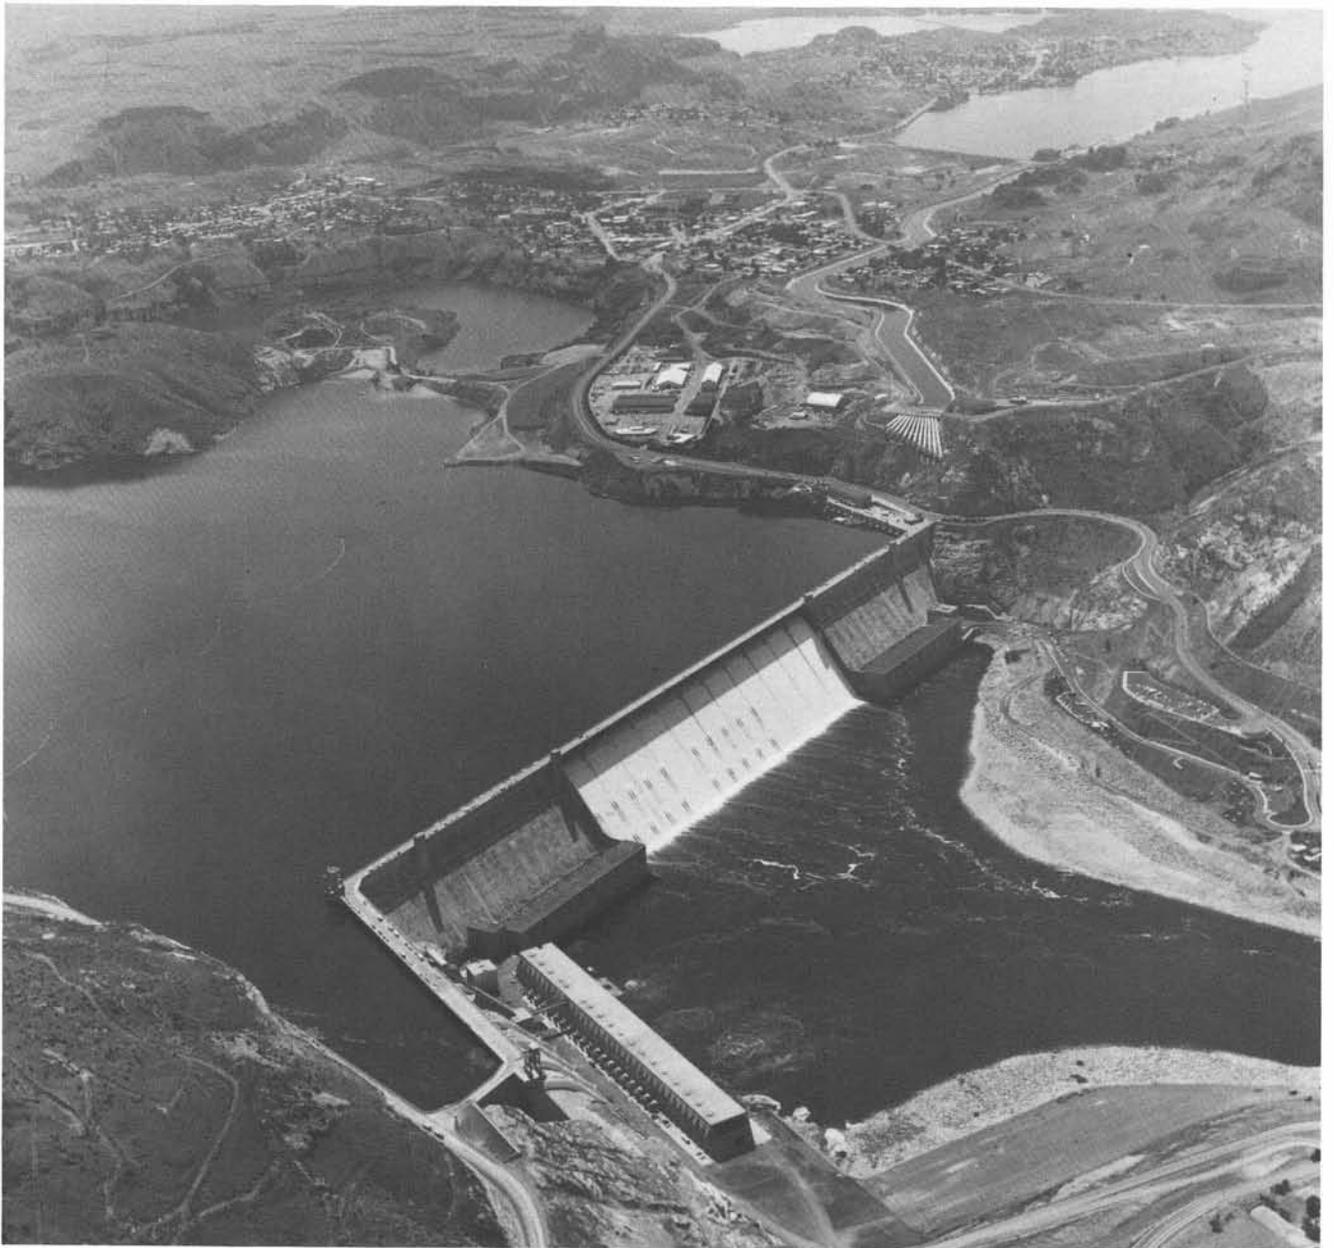
Figure 1. Grand Coulee Dam complex; view southwest, July 21, 1983. Franklin D. Roosevelt Lake is at nearly full pool elevation (1,290 ft). The Third Powerplant is in the center foreground, with the Forebay Dam to the left. The pumping plant is upstream of the far end of the dam, and the Feeder Canal and North Dam of the equalizing reservoir (Banks Lake) are in the right background. Columbia River basalt overlies Colville granitic rock at the upper left. The amphitheater-shaped valley downstream from the far side of the main dam is an area that was excavated to prevent landsliding into the foundation excavation. U.S. Bureau of Reclamation photograph by Hubert Holmes.

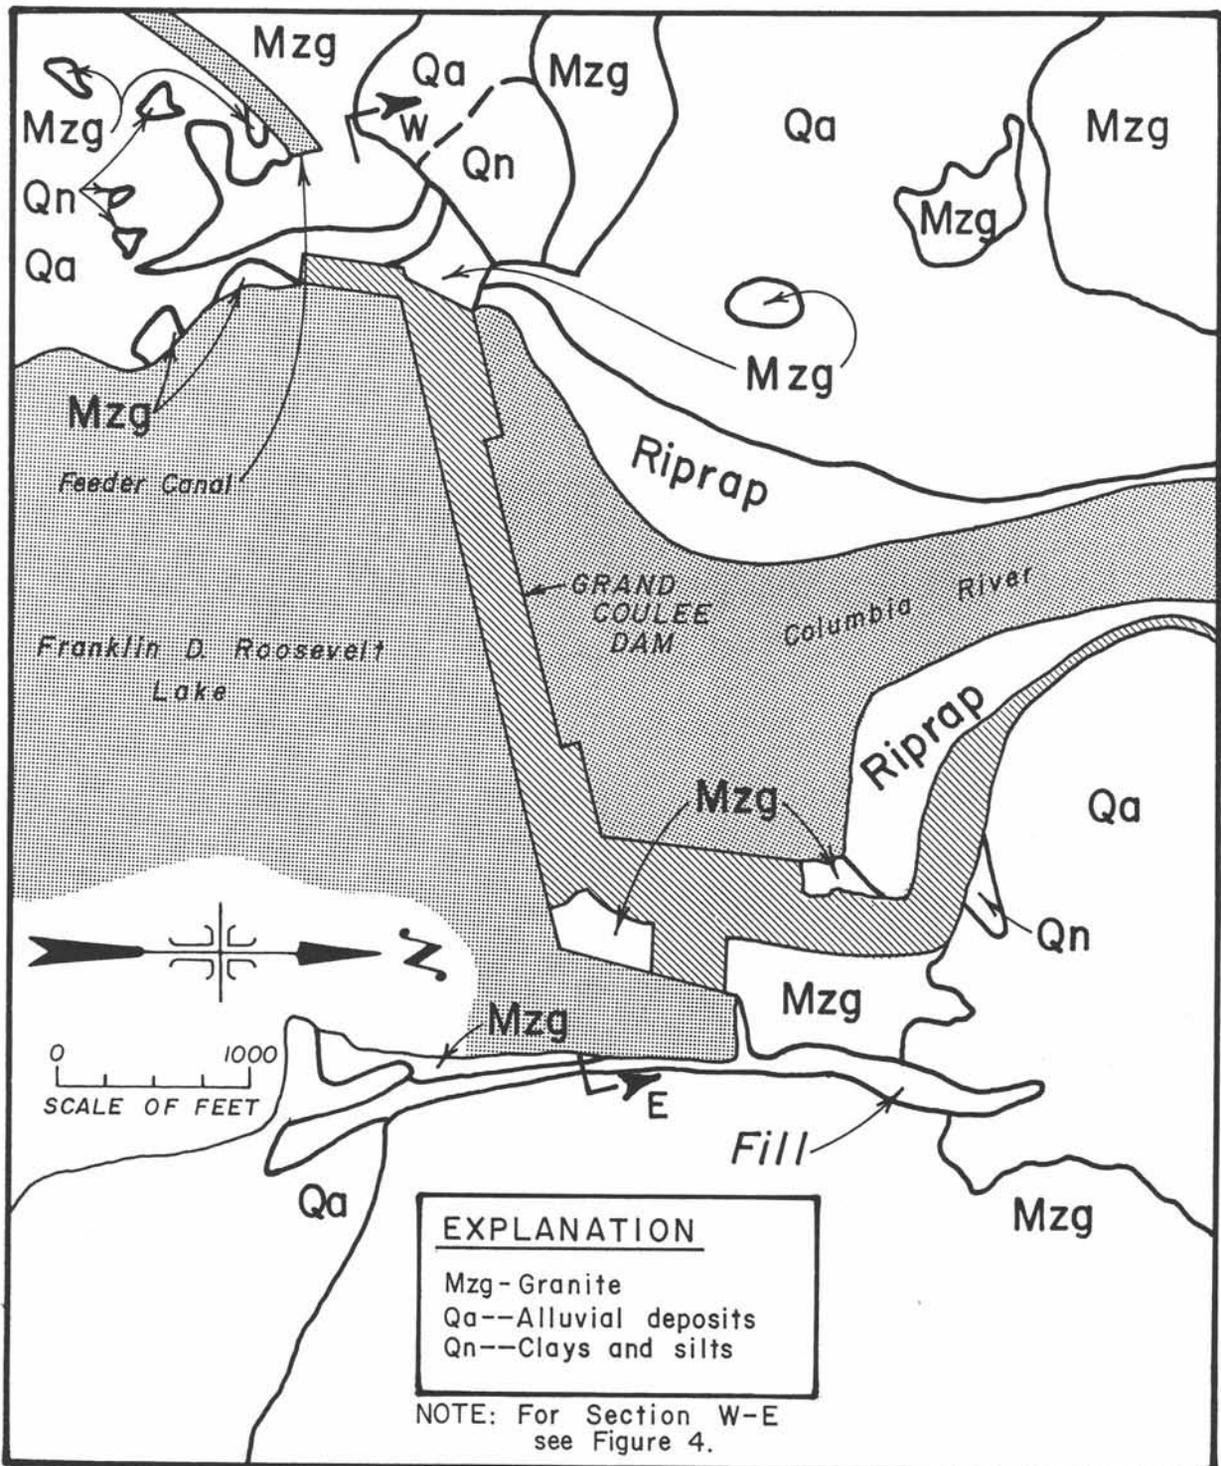
Figure 2. General geologic map of the Grand Coulee Dam area. Mzg, granite of the Colville batholith and related intrusive rocks; Qa, alluvial and colluvial deposits; Qn, clay and silt of the Nespelem Formation.

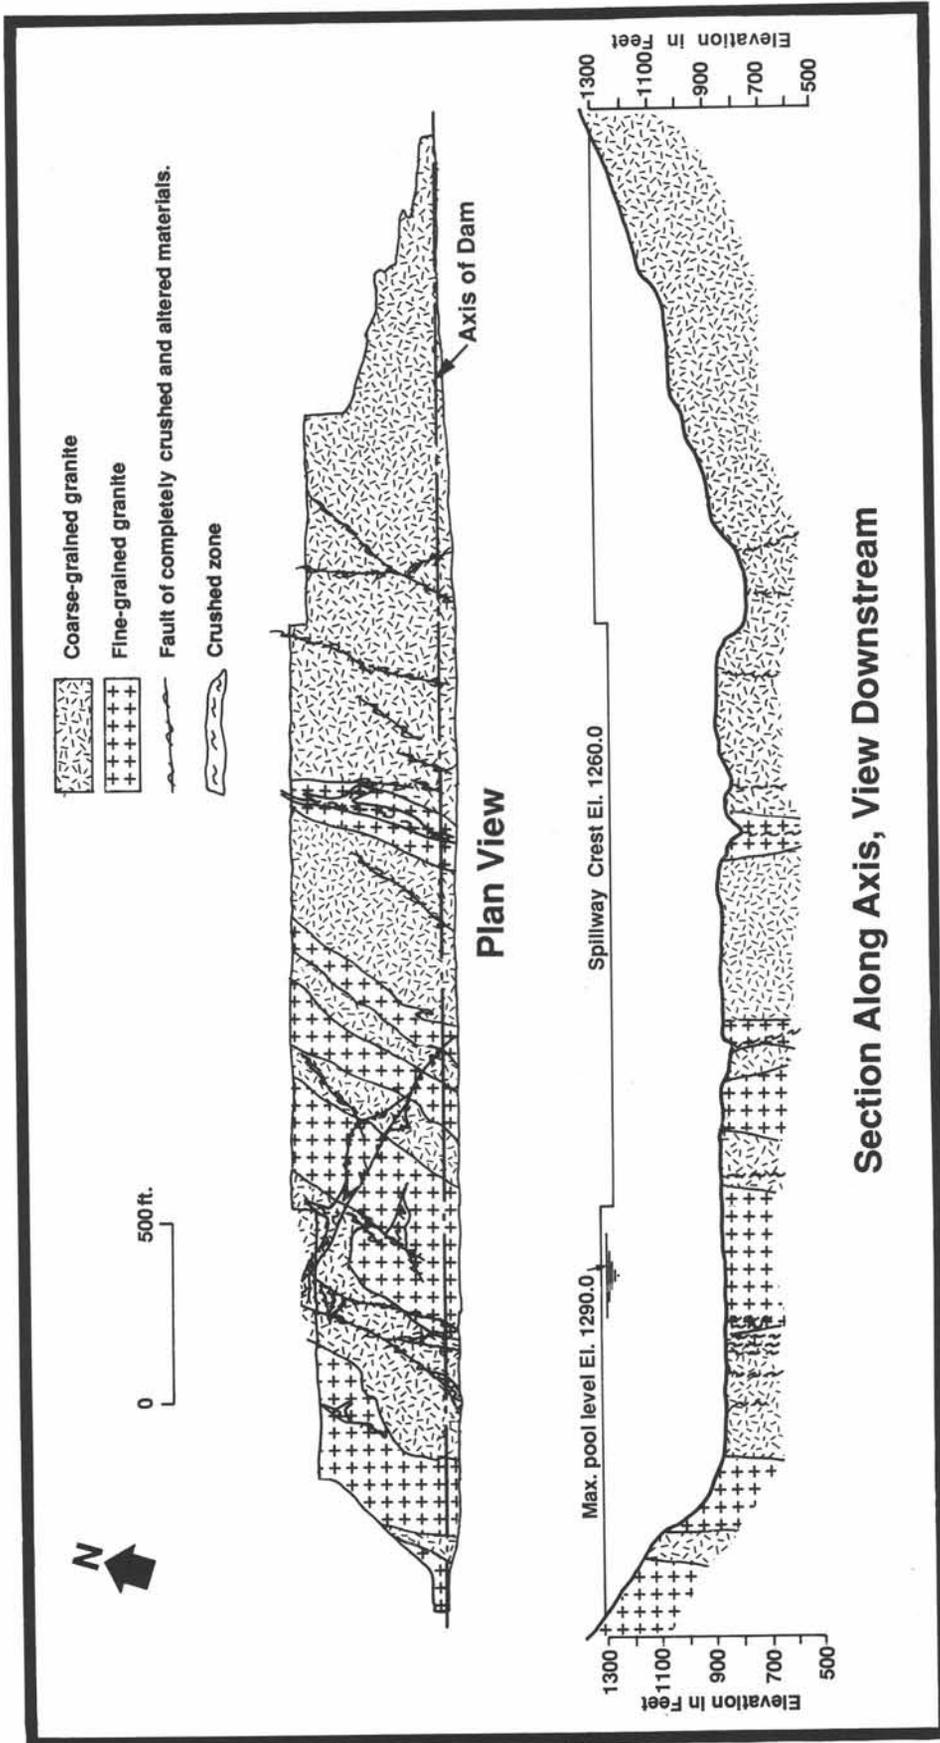
Figure 3. Grand Coulee Dam. Geologic plan and section of original dam prior to addition of Forebay Dam and Third Powerplant. Geology by W. H. Irwin, Grant Gordon, and R. L. Nichols. After Nickell (1942).

Most of the eastern part of the foundation is the older gray biotite granite with roughly equigranular fabric. Some alteration of the feldspars and biotite is usually apparent. The western part of the foundation is the younger, finer grained granite with minor syenite and monzonite. It is light gray and porphyritic and has feldspar, quartz and chloritized biotite phenocrysts in a fine-grained groundmass of the same composition (Figure 3).

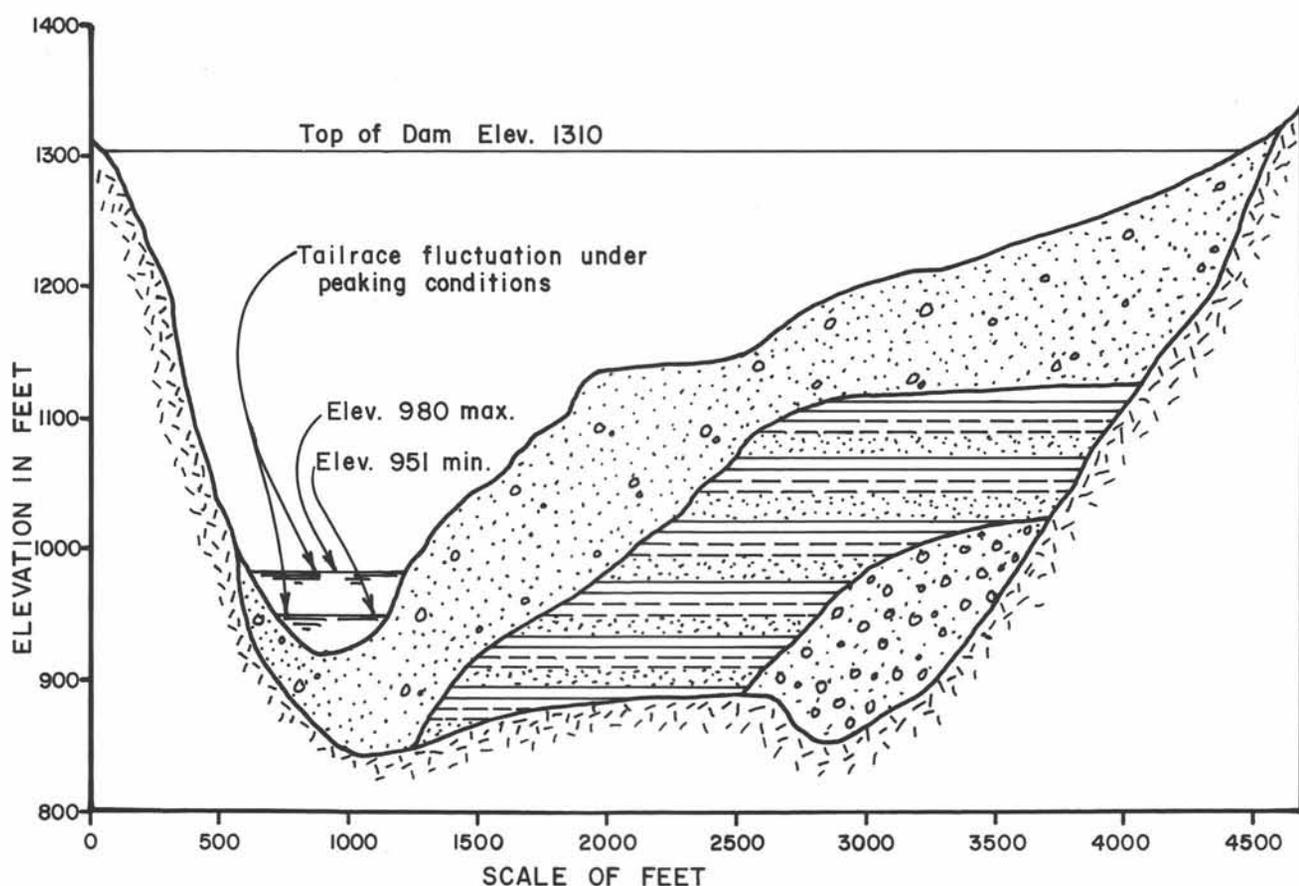
- Alluvial sand and gravel
- Varved clay and silt with sand interbeds
- Basal gravel
- Granite bedrock, base of foundation excavation

Figure 4. Generalized geologic section at Grand Coulee Dam; view downstream, west is on the left. All overburden sediments were removed from the foundation area during construction. Under peaking conditions the allowable daily maximum tail-race elevation fluctuation is 22 ft between the maximum and minimum elevations shown.

The overburden varied in thickness from about 40 ft in the river channel to almost 300 ft in parts of the right abutment area. Preparation of the foundations of the original dam involved excavation of 17.5 million cy of alluvial sands and gravels and varved clays and silts. Figure 4 depicts materials excavated and the general geologic conditions along the dam alignment. Additionally, faults and shear zones encountered within the granite required extensive treatment: overexcavation, scaling, and bolting.
