Rock Island Dam

RICHARD W. GALSTER
Consulting Engineering Geologist

PROJECT DESCRIPTION

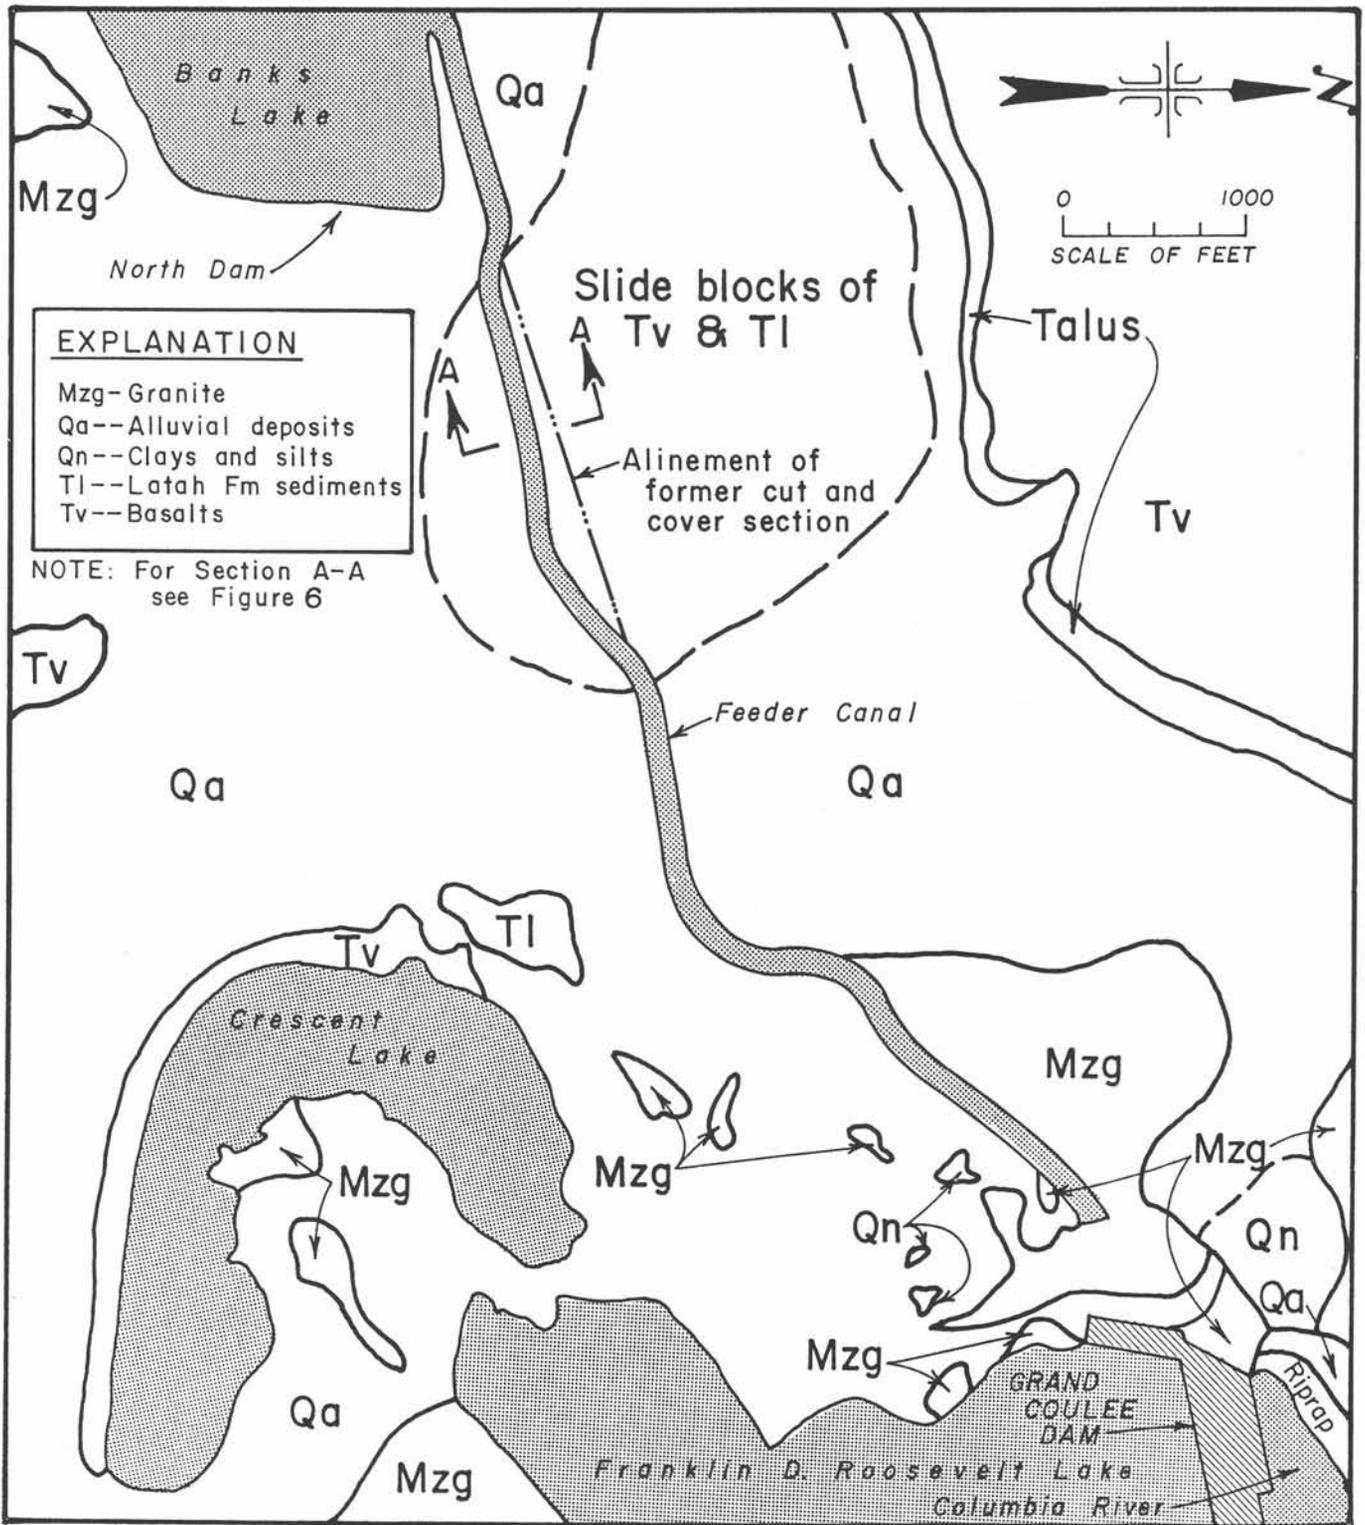
Figure 5. General geologic map of the Feeder Canal area adjacent to Grand Coulee Dam. Mzg, granitic rocks of the Colville batholith and associated intrusive rocks; Qa, alluvium and colluvium; Qn, silt and clay of the Nespelem Formation; Tl, sediments of the Latah Formation; Tv, Columbia River basalt. Cross section A-A is shown in Figure 6.

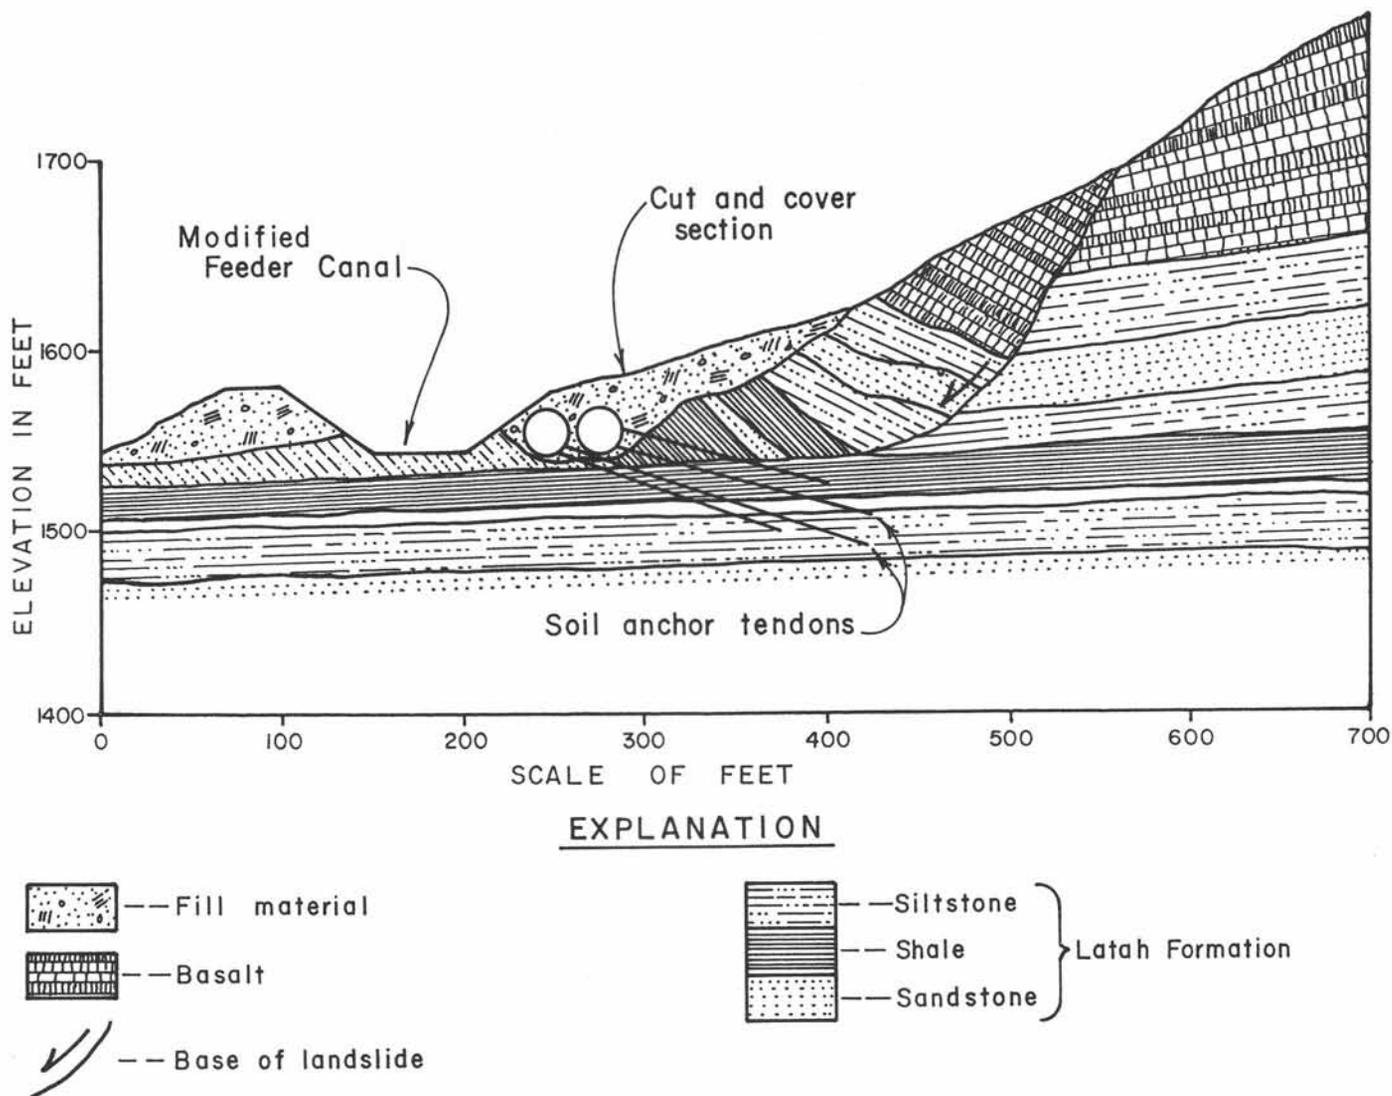
Figure 6. Generalized geologic section A-A of the Feeder Canal. See Figure 5 for location of section.

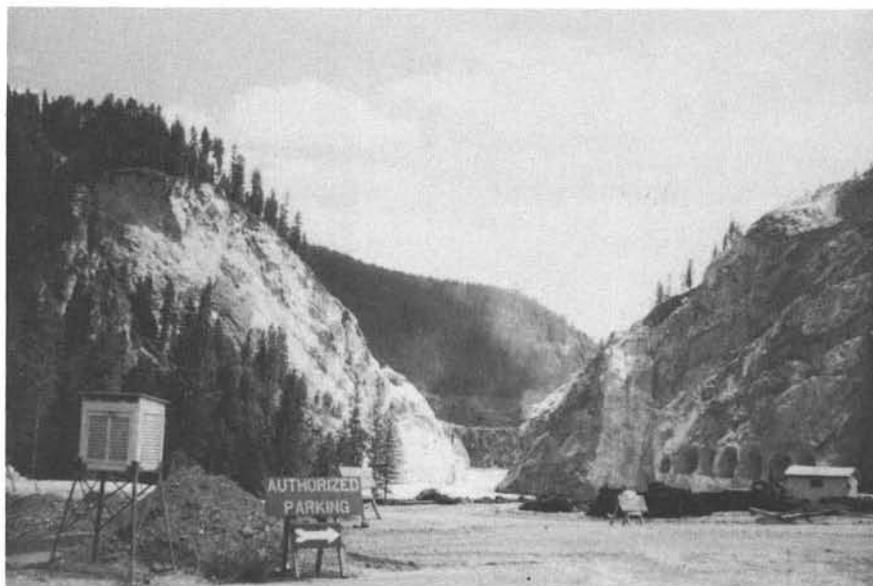
Boundary Dam site, Pend Oreille River; view up the river. Underground powerhouse tailrace tunnels at the right center.

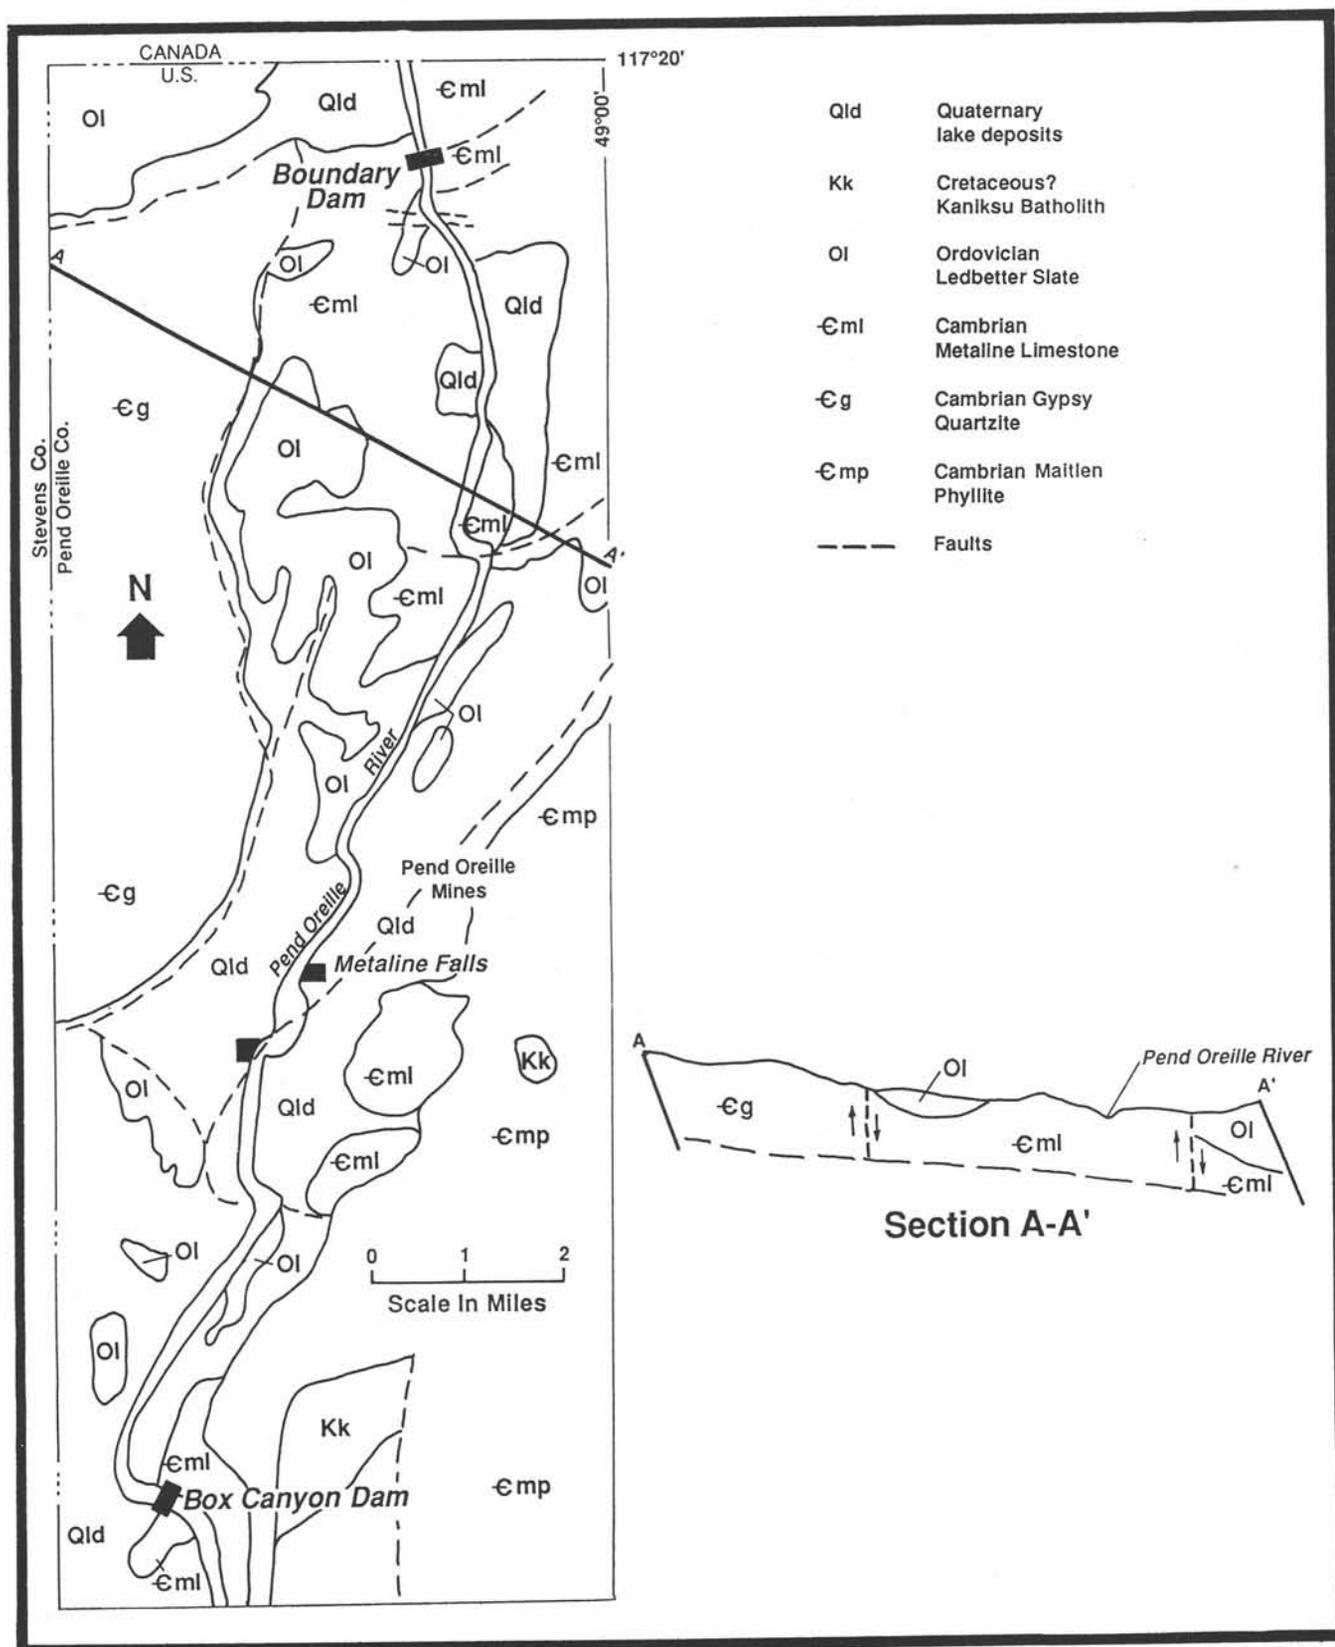
Figure 2. Generalized geologic map of the area of Boundary and Box Canyon dams. After Park and Cannon (1943).

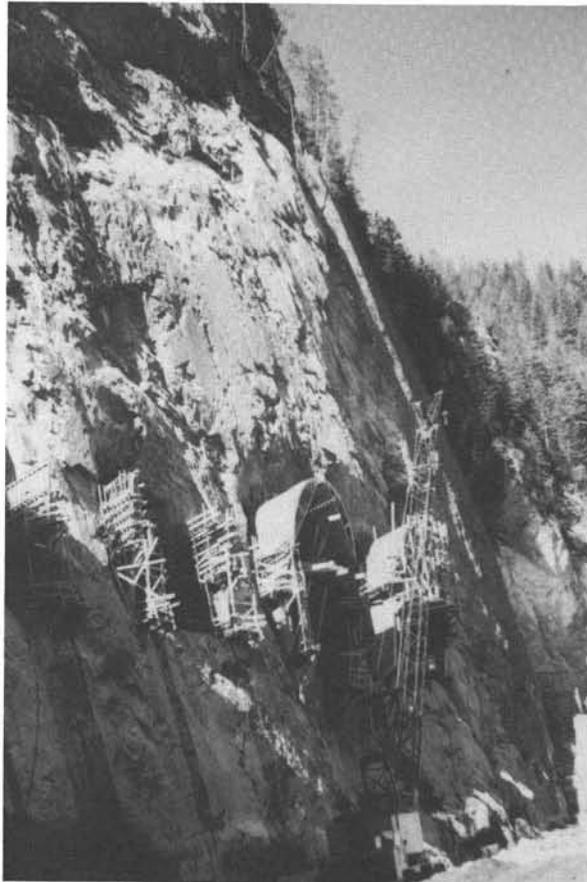
Boundary Dam site, Pend Oreille River. Construction of transformer adits in Metaline Limestone. Photograph By H. A. Coombs, September 1965.

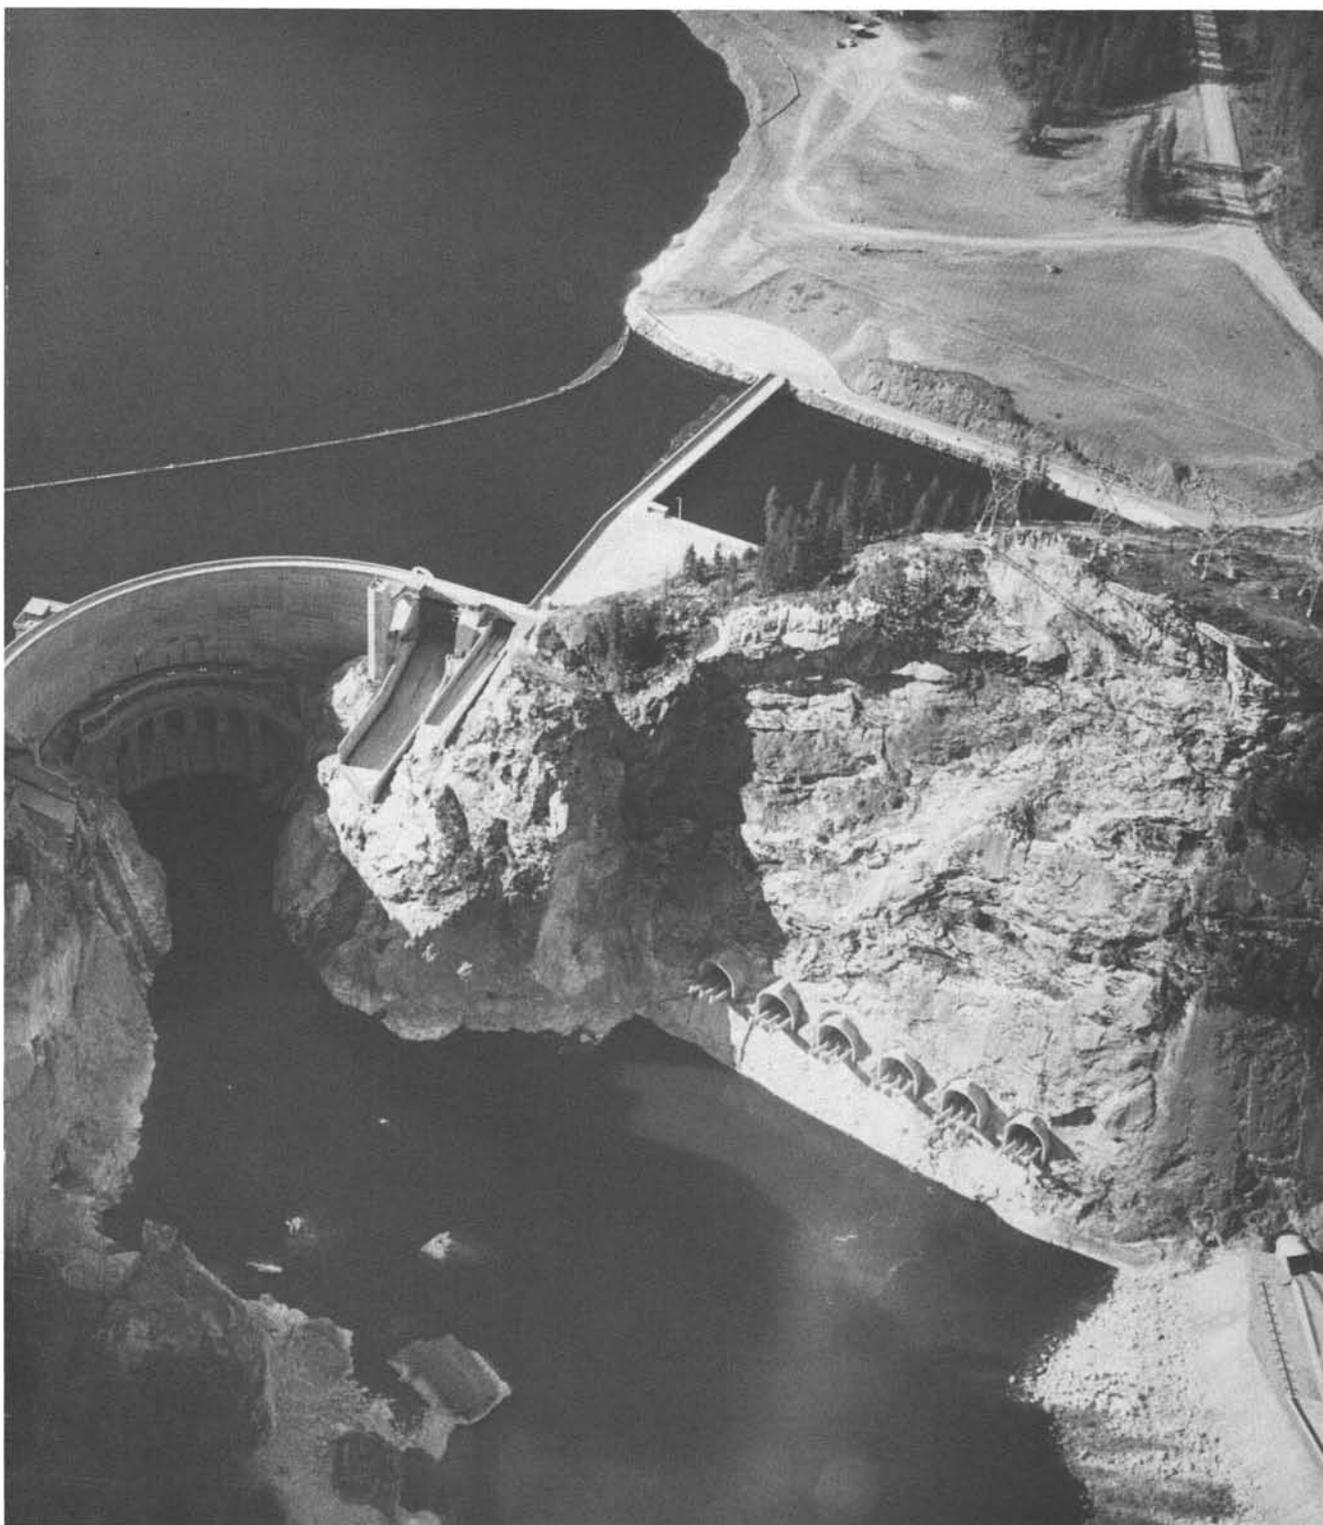
Figure 1. Aerial view south of Boundary dam. The underground powerhouse is contained in this bold mass of Metaline Limestone. The transformer bays emerging from the cliff will orient the diagram shown in Figure 3. Photograph by Seattle City Light.

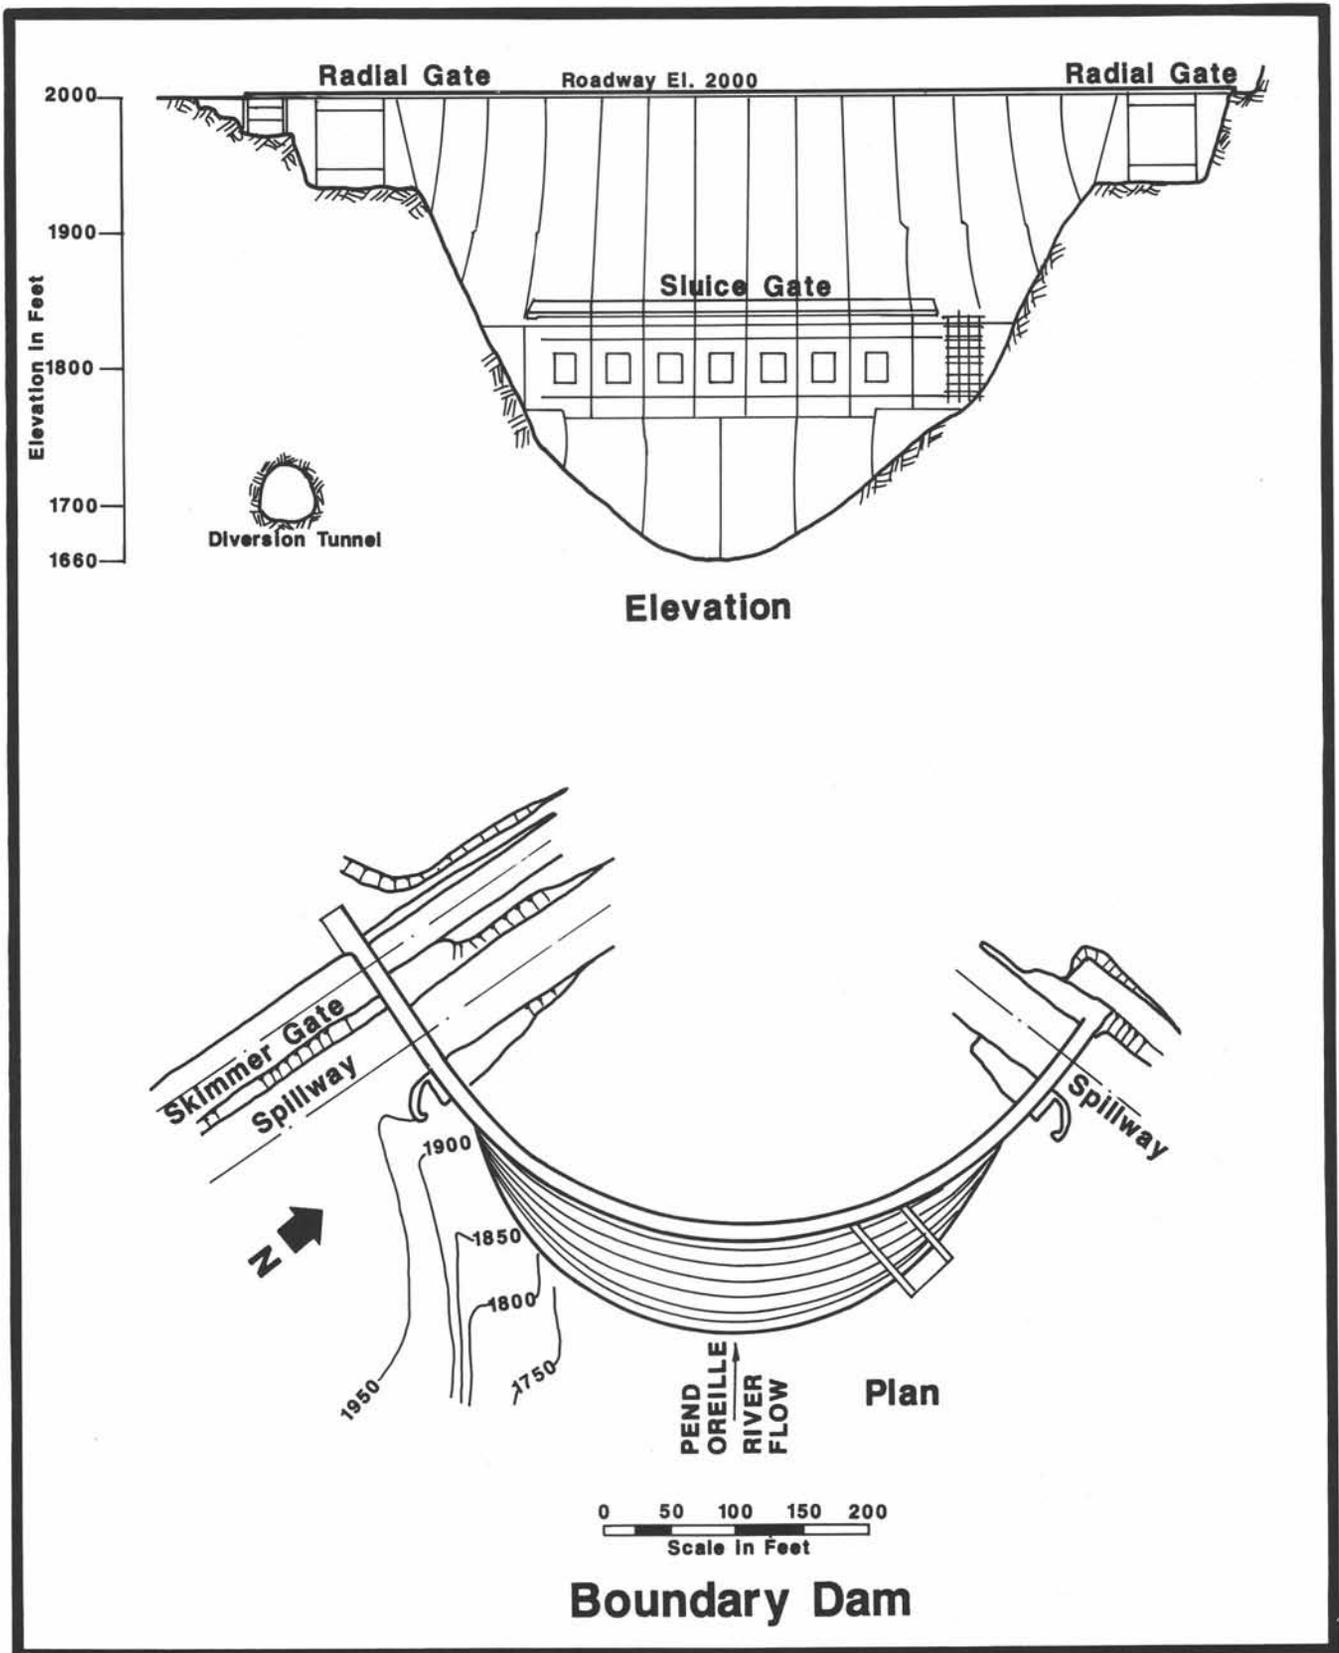
Figure 2. Plan and elevation of Boundary Dam; view downstream.

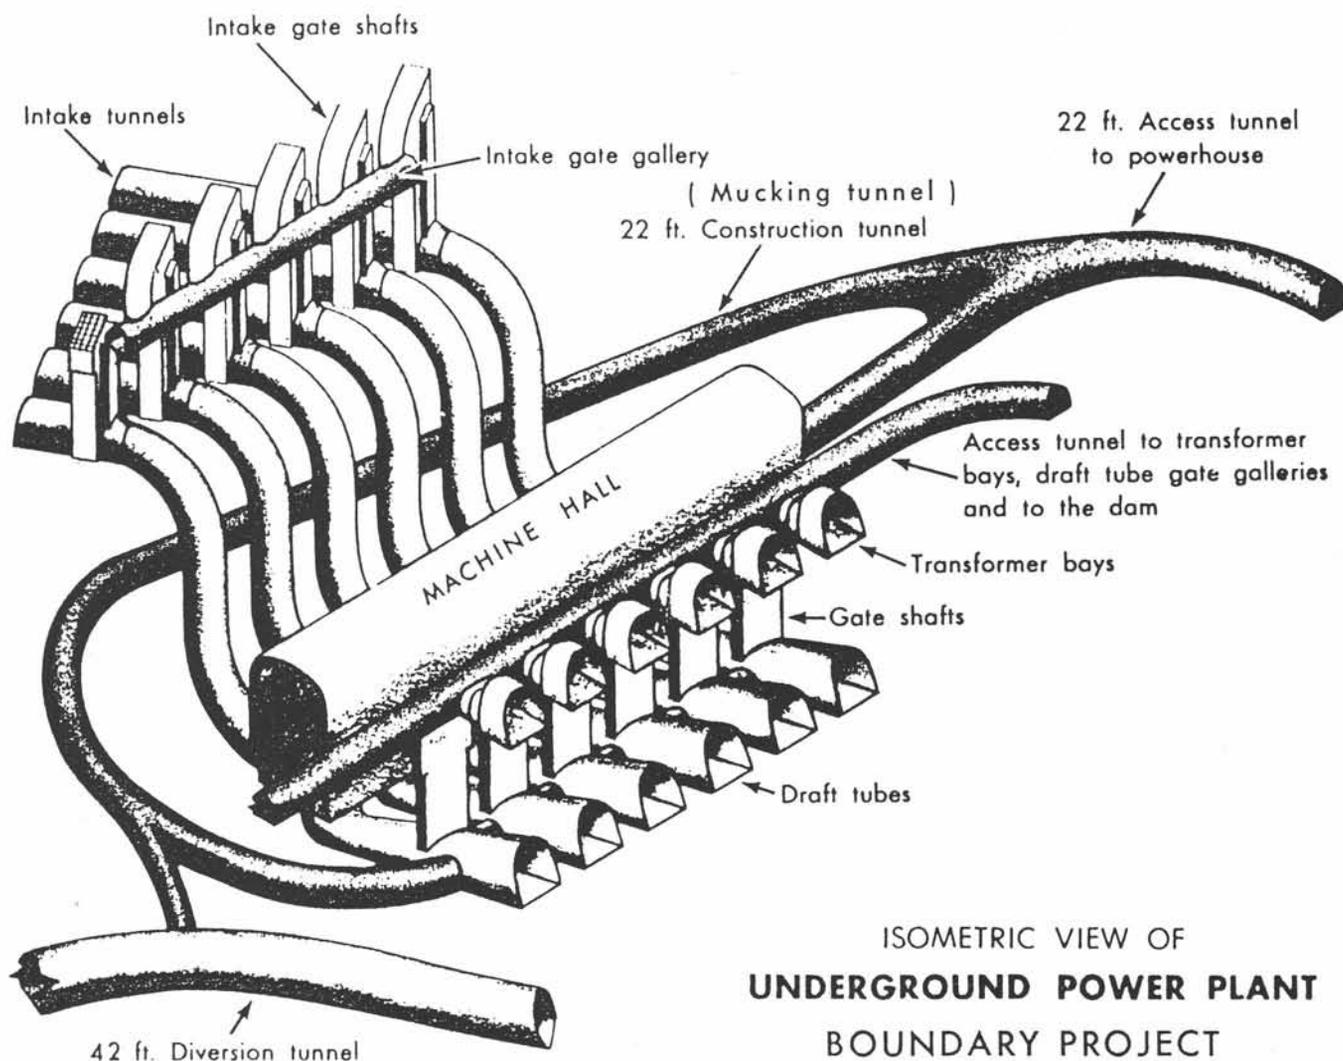
ISOMETRIC VIEW OF
UNDERGROUND POWER PLANT
 BOUNDARY PROJECT

Figure 3. Isometric view of the underground power plant at Boundary dam. Courtesy of Seattle City Light.

The downstream face of the powerhouse is essentially a fault face. Just inside this face and parallel to it is a fault zone from which some of the fault breccia was removed by solution. Advantage was taken of this condition in establishing entrance haulways into and out of the powerhouse. The Metaline Limestone at the site dips 40° to the south and stands in near-vertical cliffs more than 500 ft high. A 6-ft x 8-ft exploratory tunnel was driven along the axis of the powerhouse to test the rock; flatjack, deformer, and plate bearing tests were conducted *in situ* to determine the physical properties of the rock. Numerous calcite-filled joints and fractures were found in the machine hall rocks; however, they did not materially affect the roof and wall stability. The roof and walls of the machine hall are permanently reinforced by grouted rock bolts. Bolts 15 ft long and on 6-ft centers support the 75-ft-wide roof which is more than 175 ft above the bottom of the drainage tunnels. The

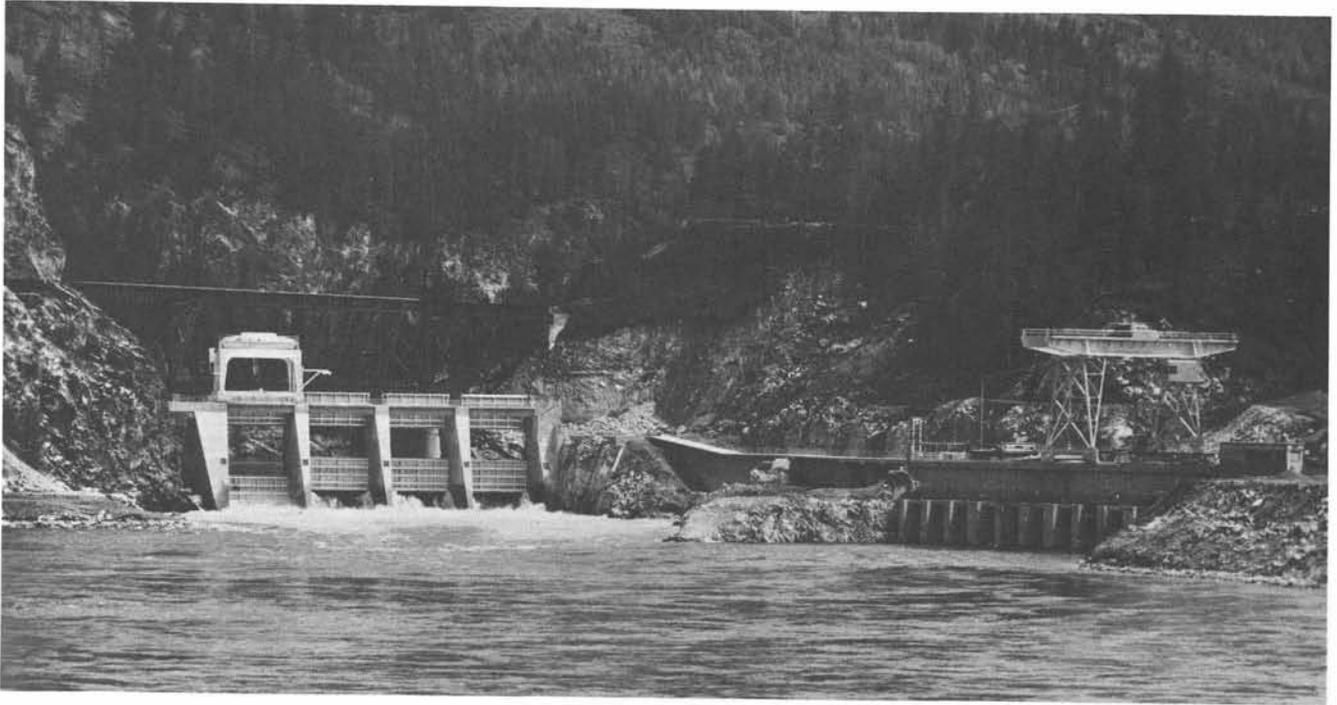
Figure 1. Main spillway of Box Canyon Dam. Chicago, Milwaukee, St. Paul & Pacific Railroad bridge in the left center; auxiliary spillway in the right center. Photograph courtesy of Harza Engineering Co.

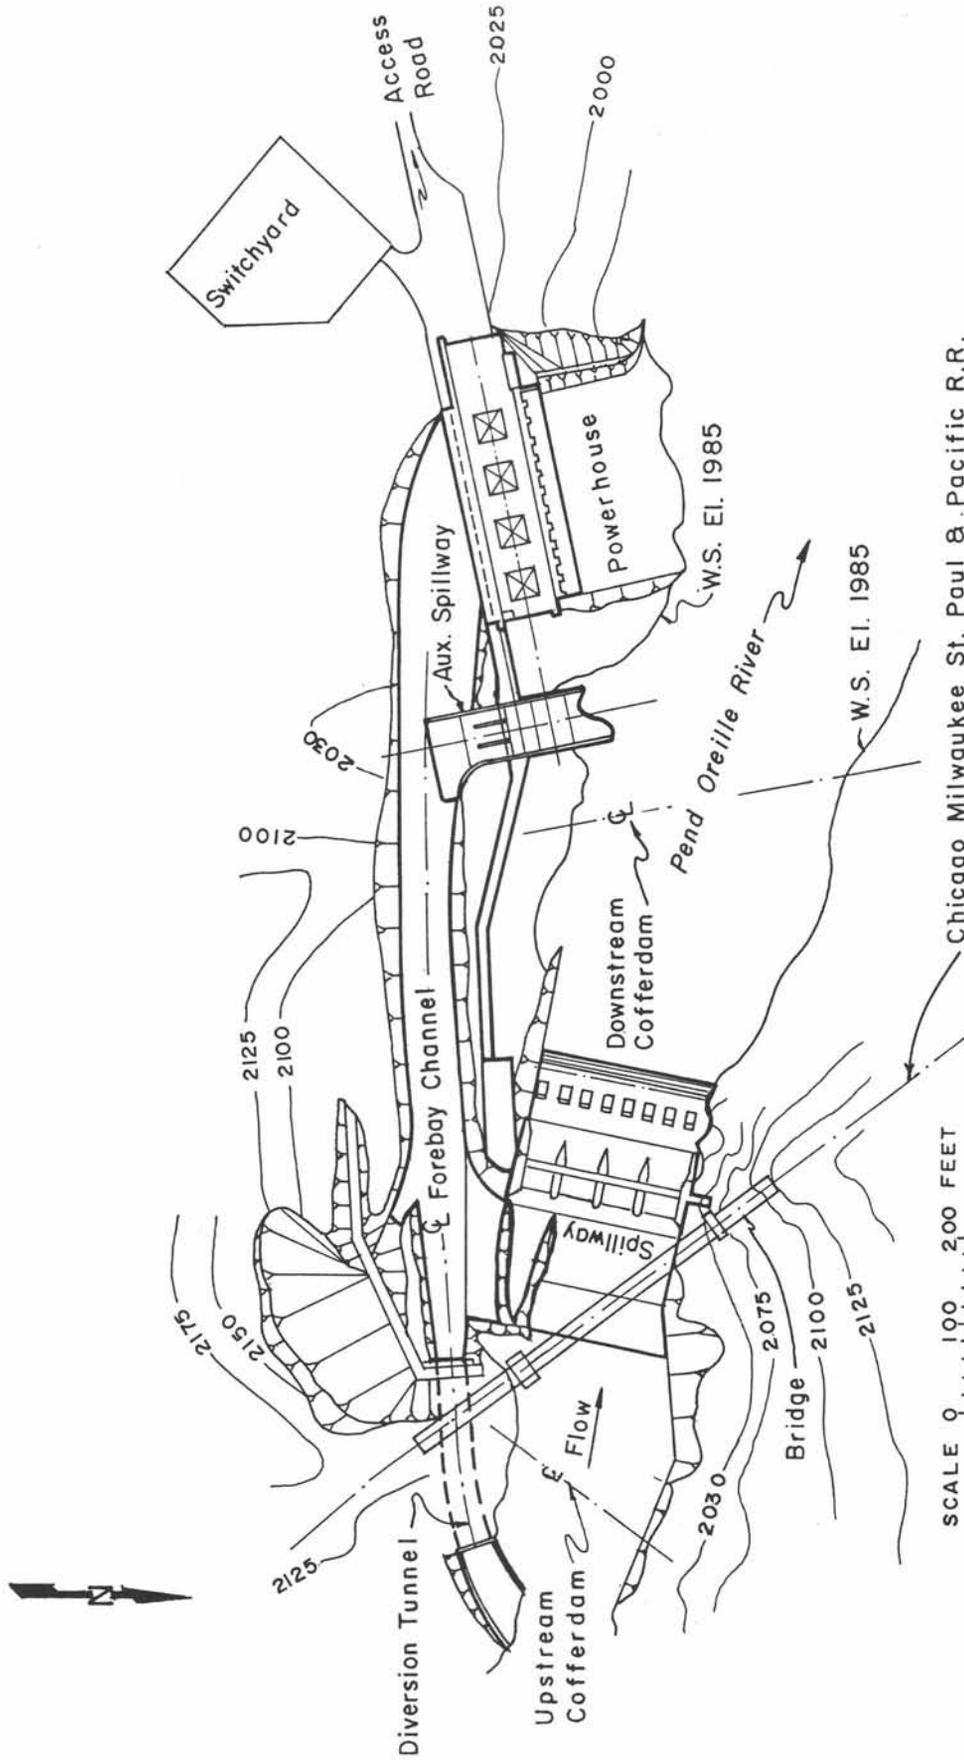
Figure 2. Plan of project works at Box Canyon Dam. Adapted from Geuss (1958).

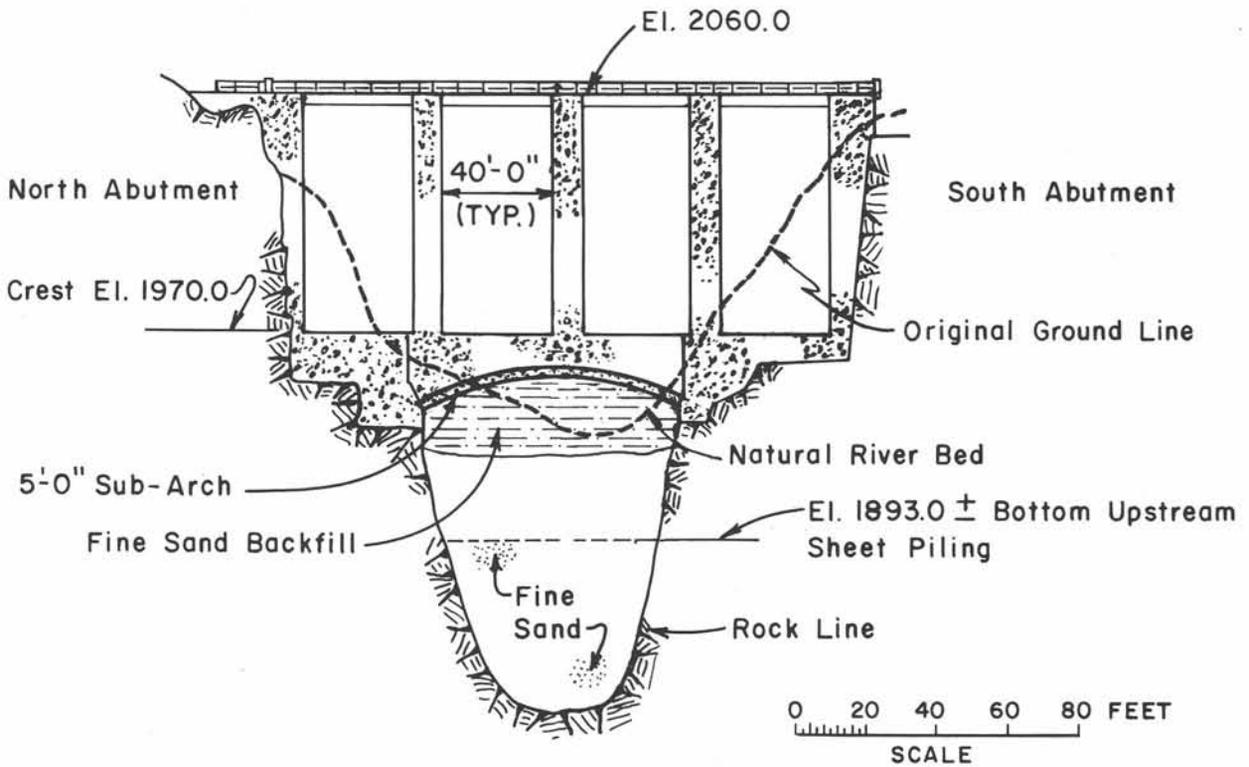
Figure 3. Geologic section at the main spillway of Box Canyon Dam. Adapted from Geuss (1958).

The major geologic feature affecting project design and construction was the deep infilled channel beneath the river and at the site of the main dam and spillway structure. Since the project was low head, it was not economical or necessary to construct a positive cut-off to bedrock in the channel area. The main spillway structure has four bays; the center two bays are located over the channel area. The design solution was to support the center two spillway bays on an arch founded on bedrock at the channel edges and spanning the fine sand infill material. The spillway crest was constructed as part of the arch structure. Three rows of sheet piling were driven and terminated at one-half the depth of the infilled channel. The depth of the sheet piles was determined to be sufficient to contain the foundation materials and increase the seepage path so that the exit velocity of the seepage was within safe limits (Geuss, 1958). Sections through the main dam and spillway structure are presented in Figures 3 and 4.

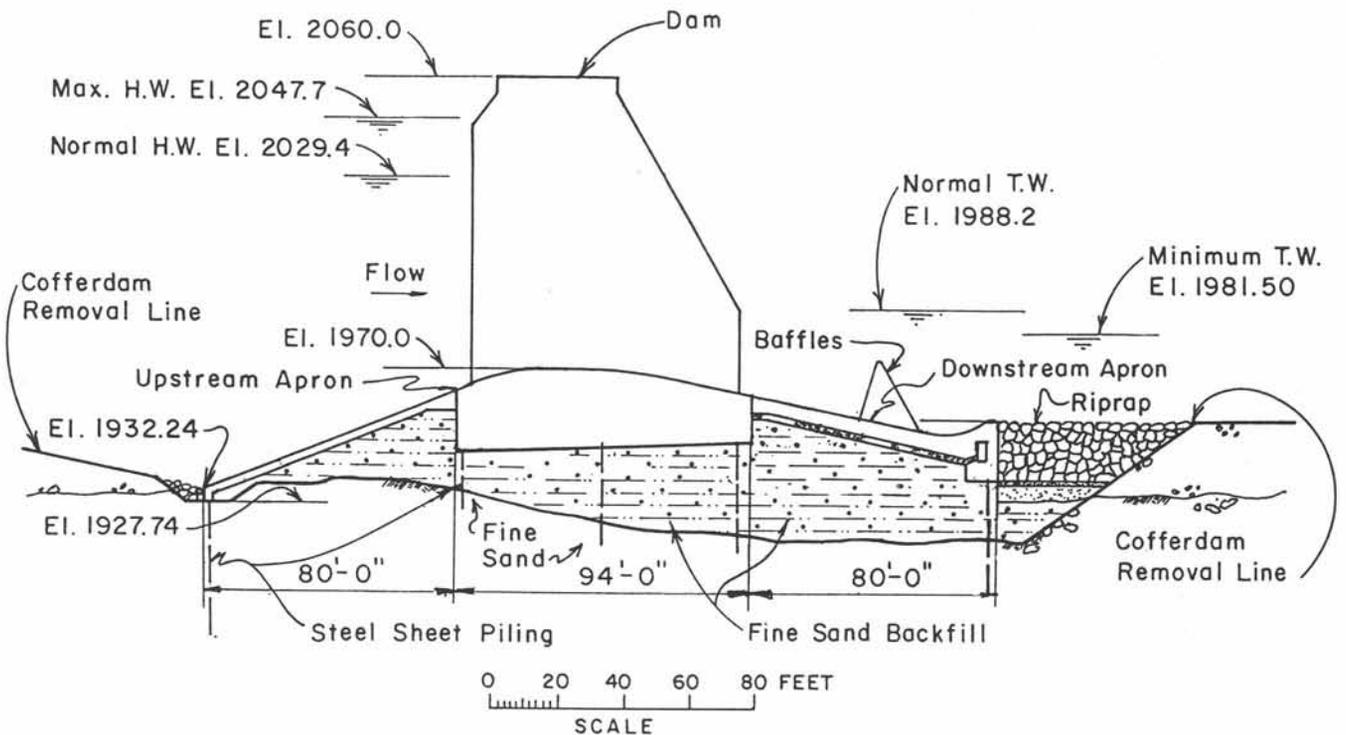
Figure 4. Section at the main spillway, Box Canyon Dam. Adapted from Geuss (1958).

The upstream and downstream aprons were constructed on the channel infill materials after foundation improvement. A special watertight construction joint was installed between these aprons and the arch-supported crest so that settlement could take place without

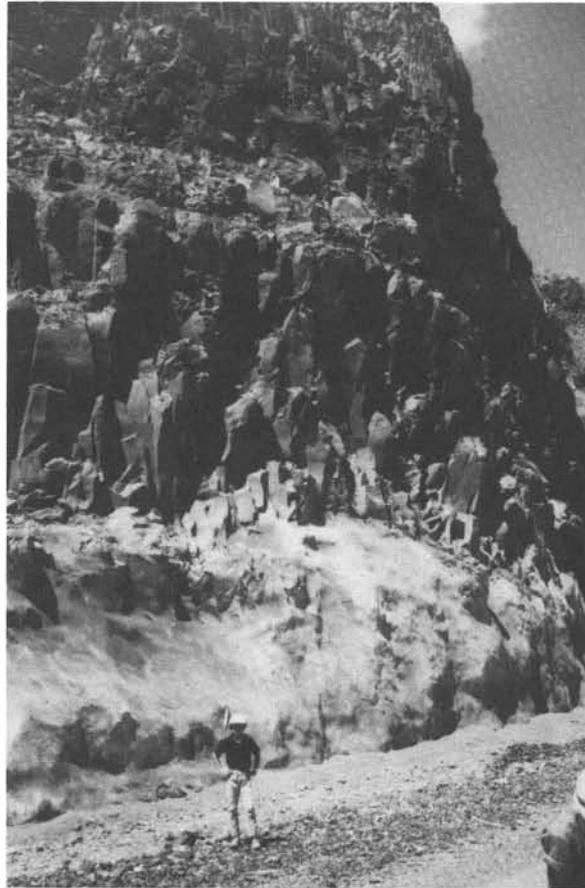
Rock cut on the relocated line for the Union Pacific Railroad at Lyons Ferry on the Snake River. Gunnite covers a weak volcanic breccia zone beneath columnar basalt. Photograph by R. W. Galster, June 1968.

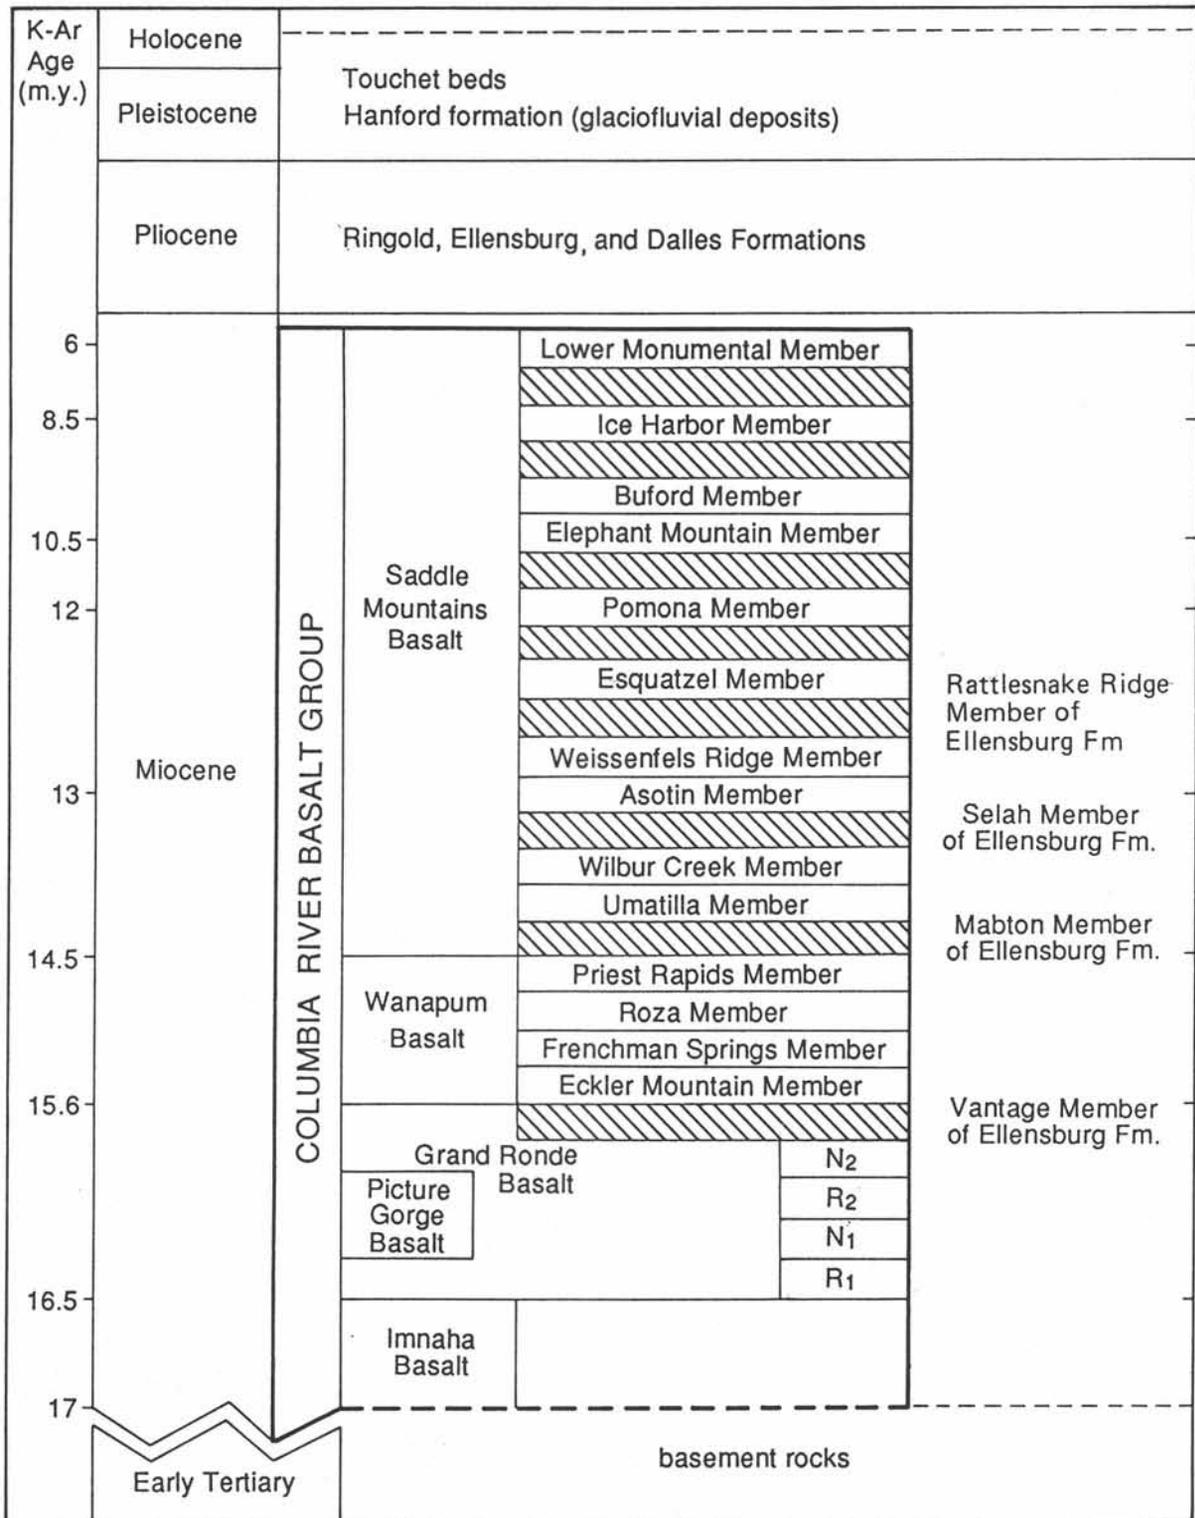
Figure 2. Stratigraphic column for the Columbia Plateau. Modified from Hooper and Swanson (1987) and Swanson (1979).

The basalt of the CRBG is tholeiitic, characterized by silica oversaturation; olivine basalt is also present. Flow breccias and other contact characteristics such as pillow lavas, baked soil horizons, and interbed layers are used to distinguish units on a stratigraphic and lithologic basis. The CRBG in the lower Snake River region includes flows of the Imnaha, Grande Ronde, Wanapum, and Saddle Mountains basalts (Figure 2).

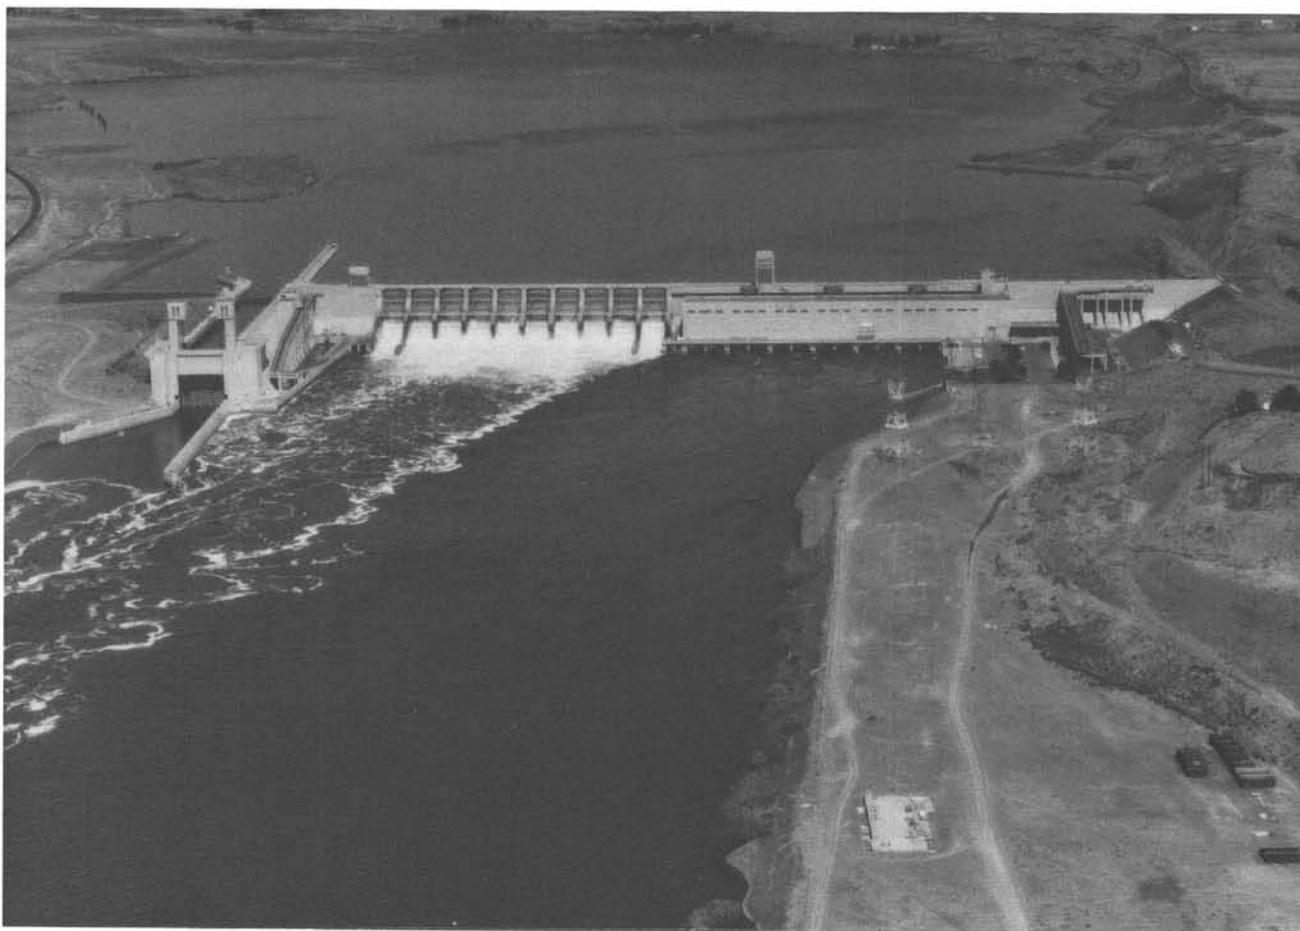
Figure 1. Ice Harbor Dam; view upstream (east). Components of the project, from left to right, are right (north) embankment dam, navigation lock, spillway dam, powerhouse, and south nonoverflow dam. Fish-passage facilities can be seen adjacent to navigation lock and downstream of south nonoverflow dam. Photograph by U.S. Army Corps of Engineers.
