Rock Island Dam

RICHARD W. GALSTER
Consulting Engineering Geologist

PROJECT DESCRIPTION

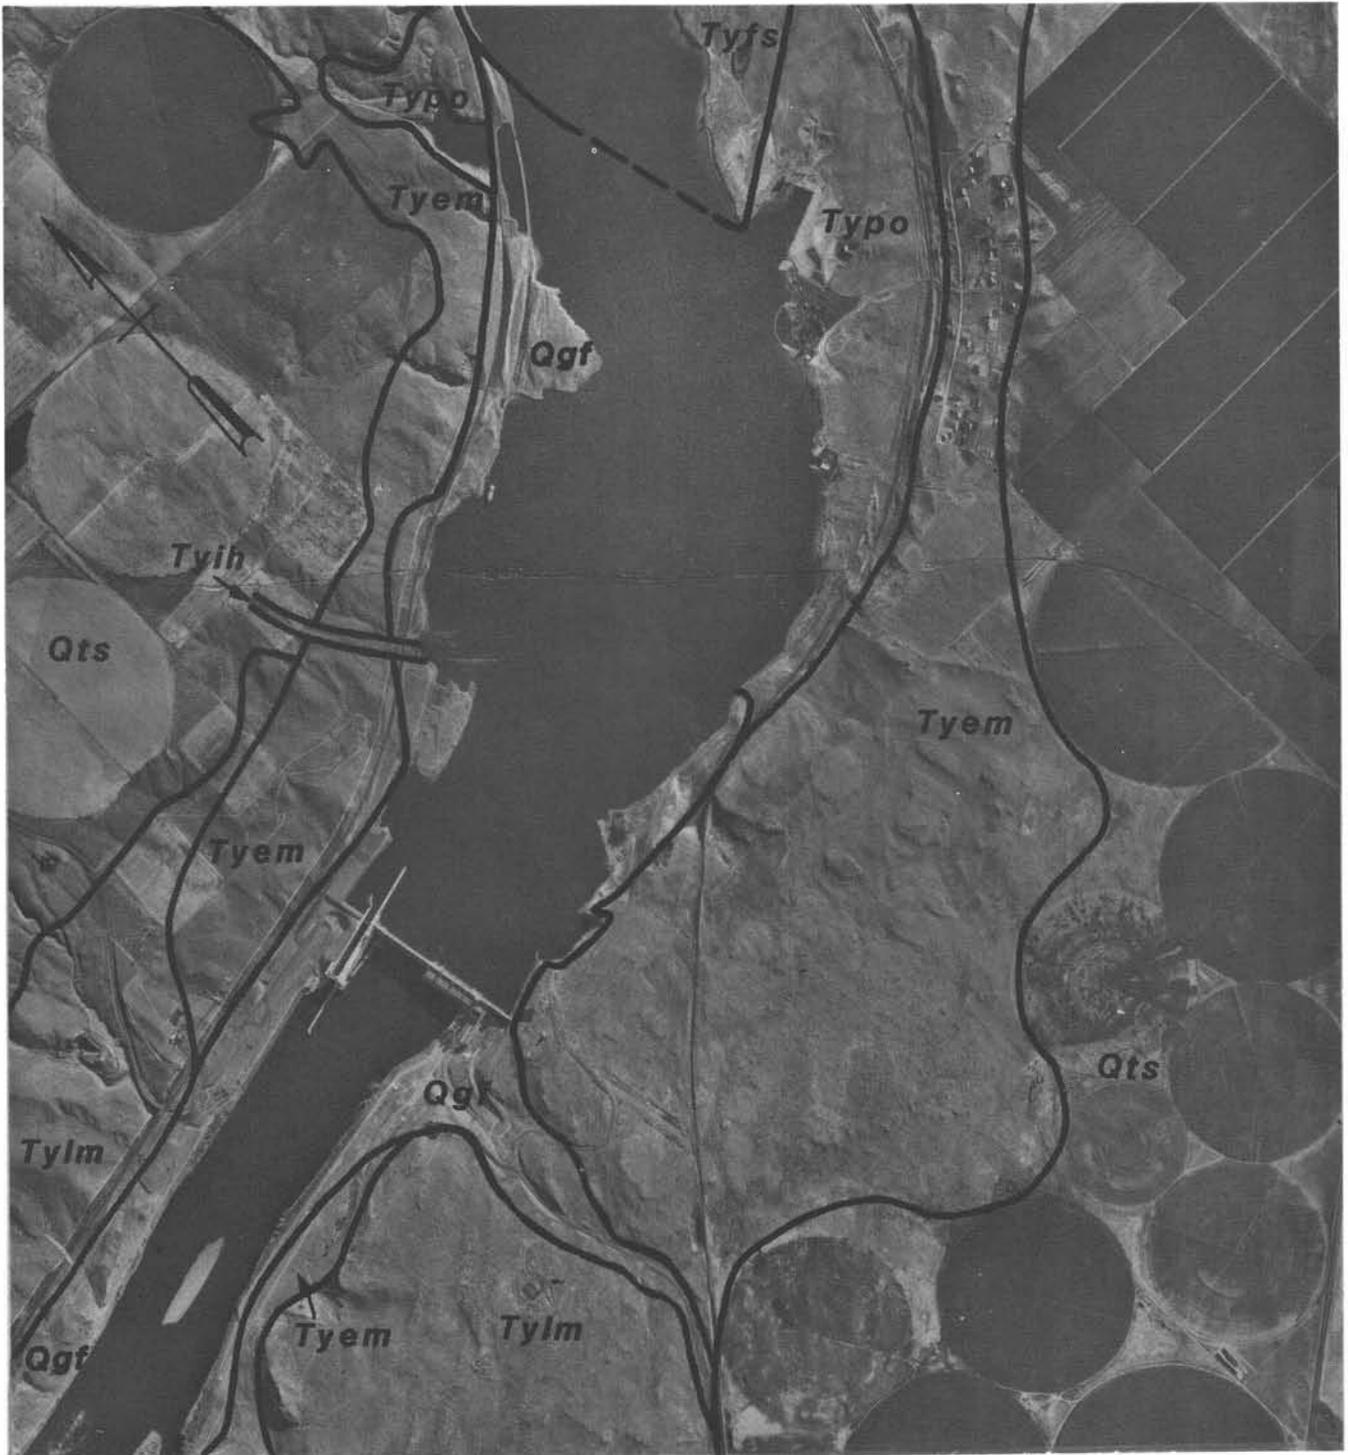
Figure 2. Photogeologic map in vicinity of Ice Harbor Dam. Heavy solid lines indicate approximate geologic contacts. Qts, sand; Qgf, glaciofluvial deposits; Tyilm, Tyih, Tyem, and Typo, Lower Monumental, Ice Harbor, Elephant Mountain, and Pomona members of the Saddle Mountains Basalt; Tyfs, Frenchman Springs Member of Wanapum Basalt. Scale: 1 in. = approx. 2,000 ft.

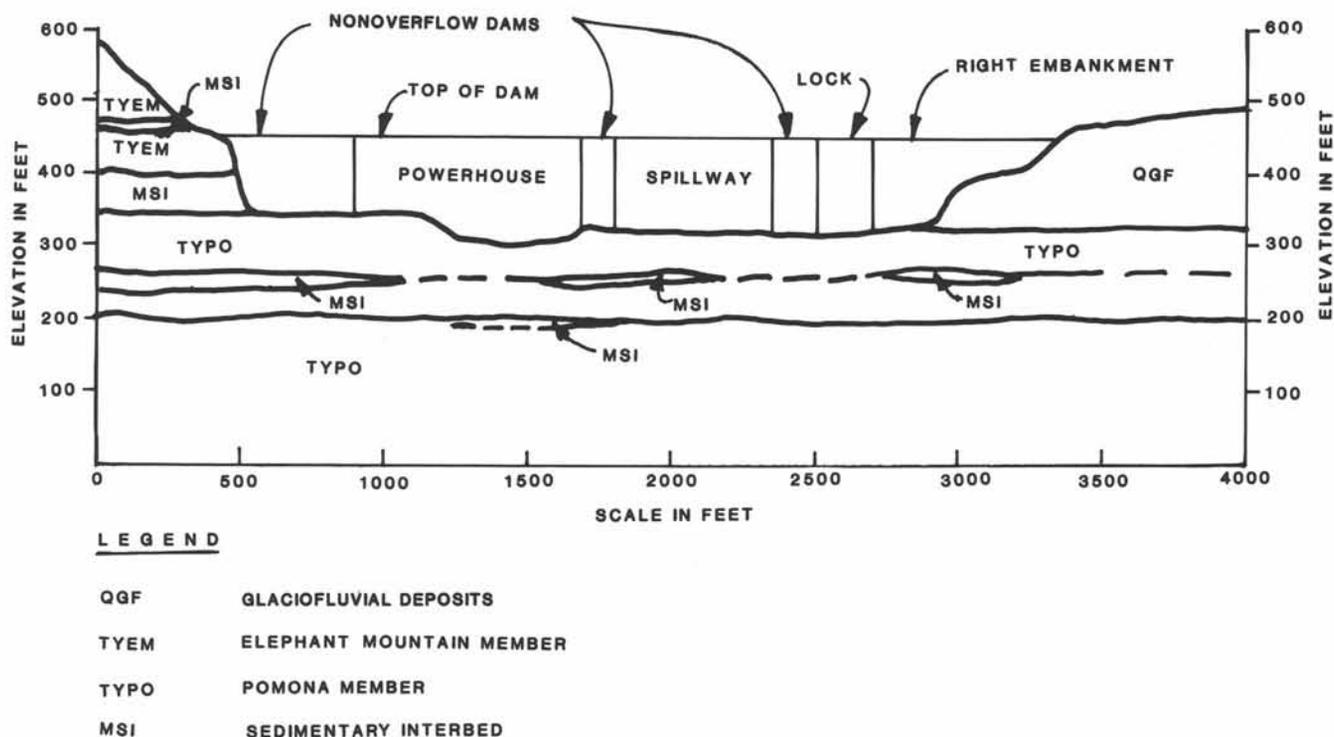
Figure 3. Geologic section of Ice Harbor Lock and Dam; view downstream.

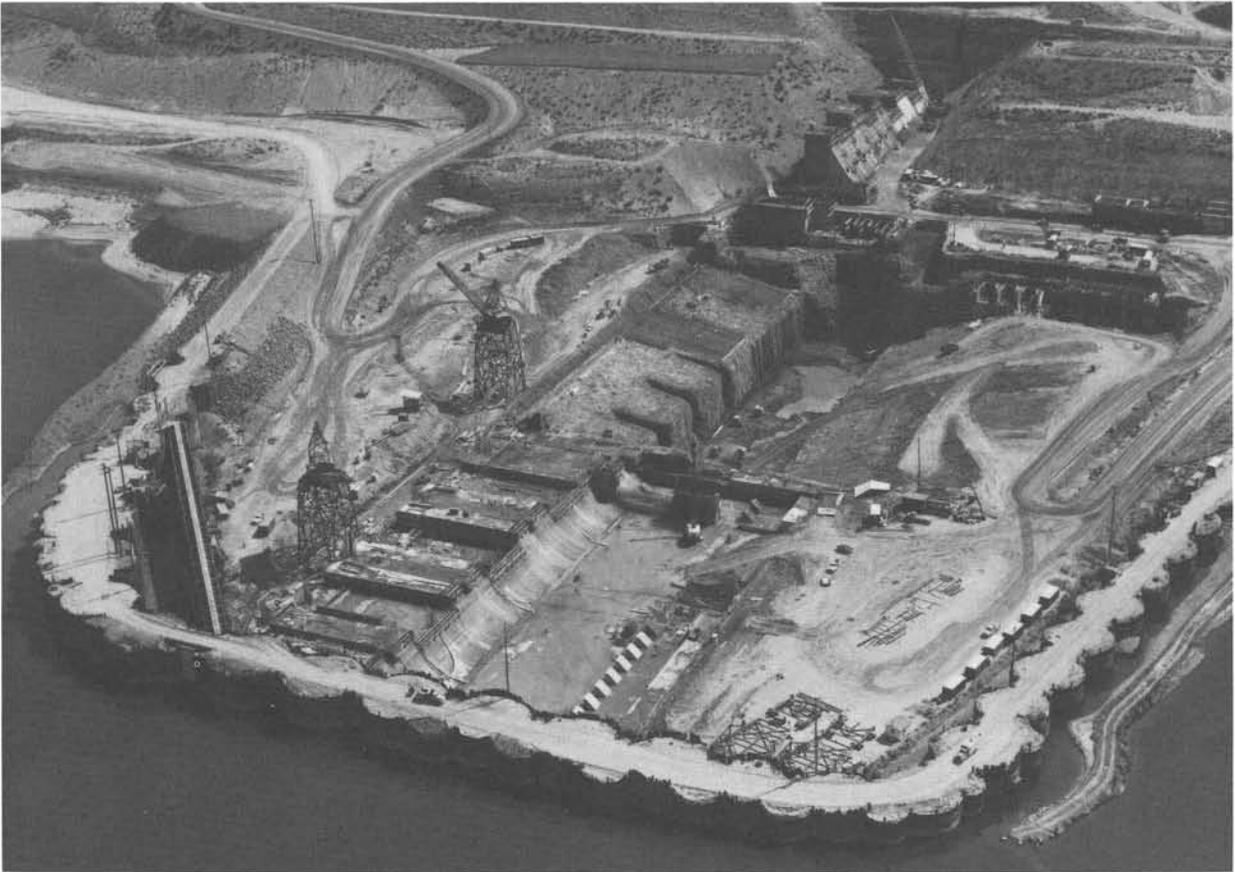
Ice Harbor Dam. A general view of the foundation excavation and partially completed concrete structures contained within the second-step cofferdam on the left (south) shore. The Snake River is being diverted through the area of the future embankment dam. Photograph by U.S. Army Corps of Engineers, September 1957.

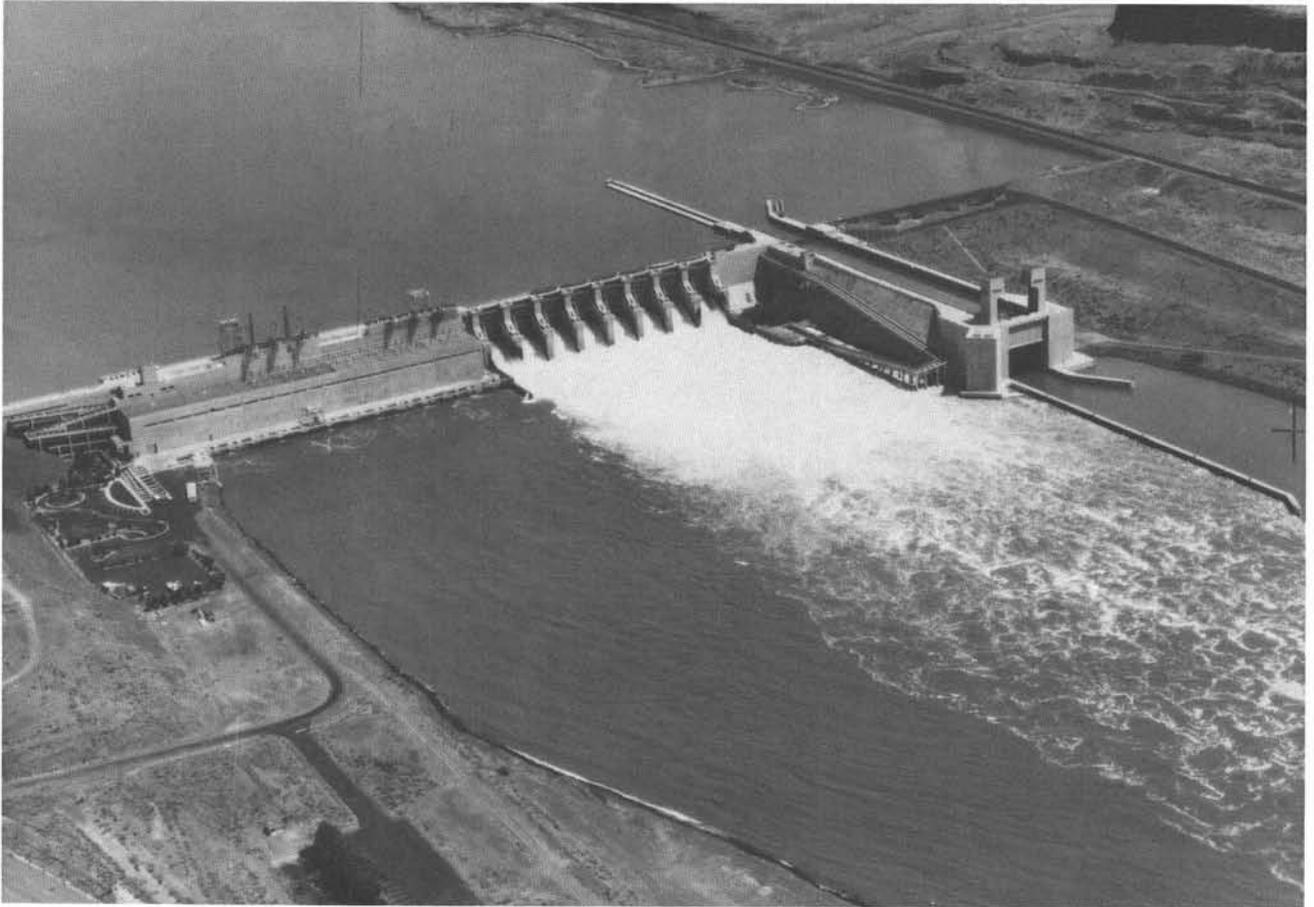
Figure 1. Lower Monumental Dam; view upstream (east). Components of the project, from left to right, are right (north) embankment dam, powerhouse, spillway dam, navigation lock, and left (south) embankment dam. Fish-passage facilities can be seen to the left of the powerhouse and adjacent to the navigation lock. Photograph by the U.S. Army Corps of Engineers.

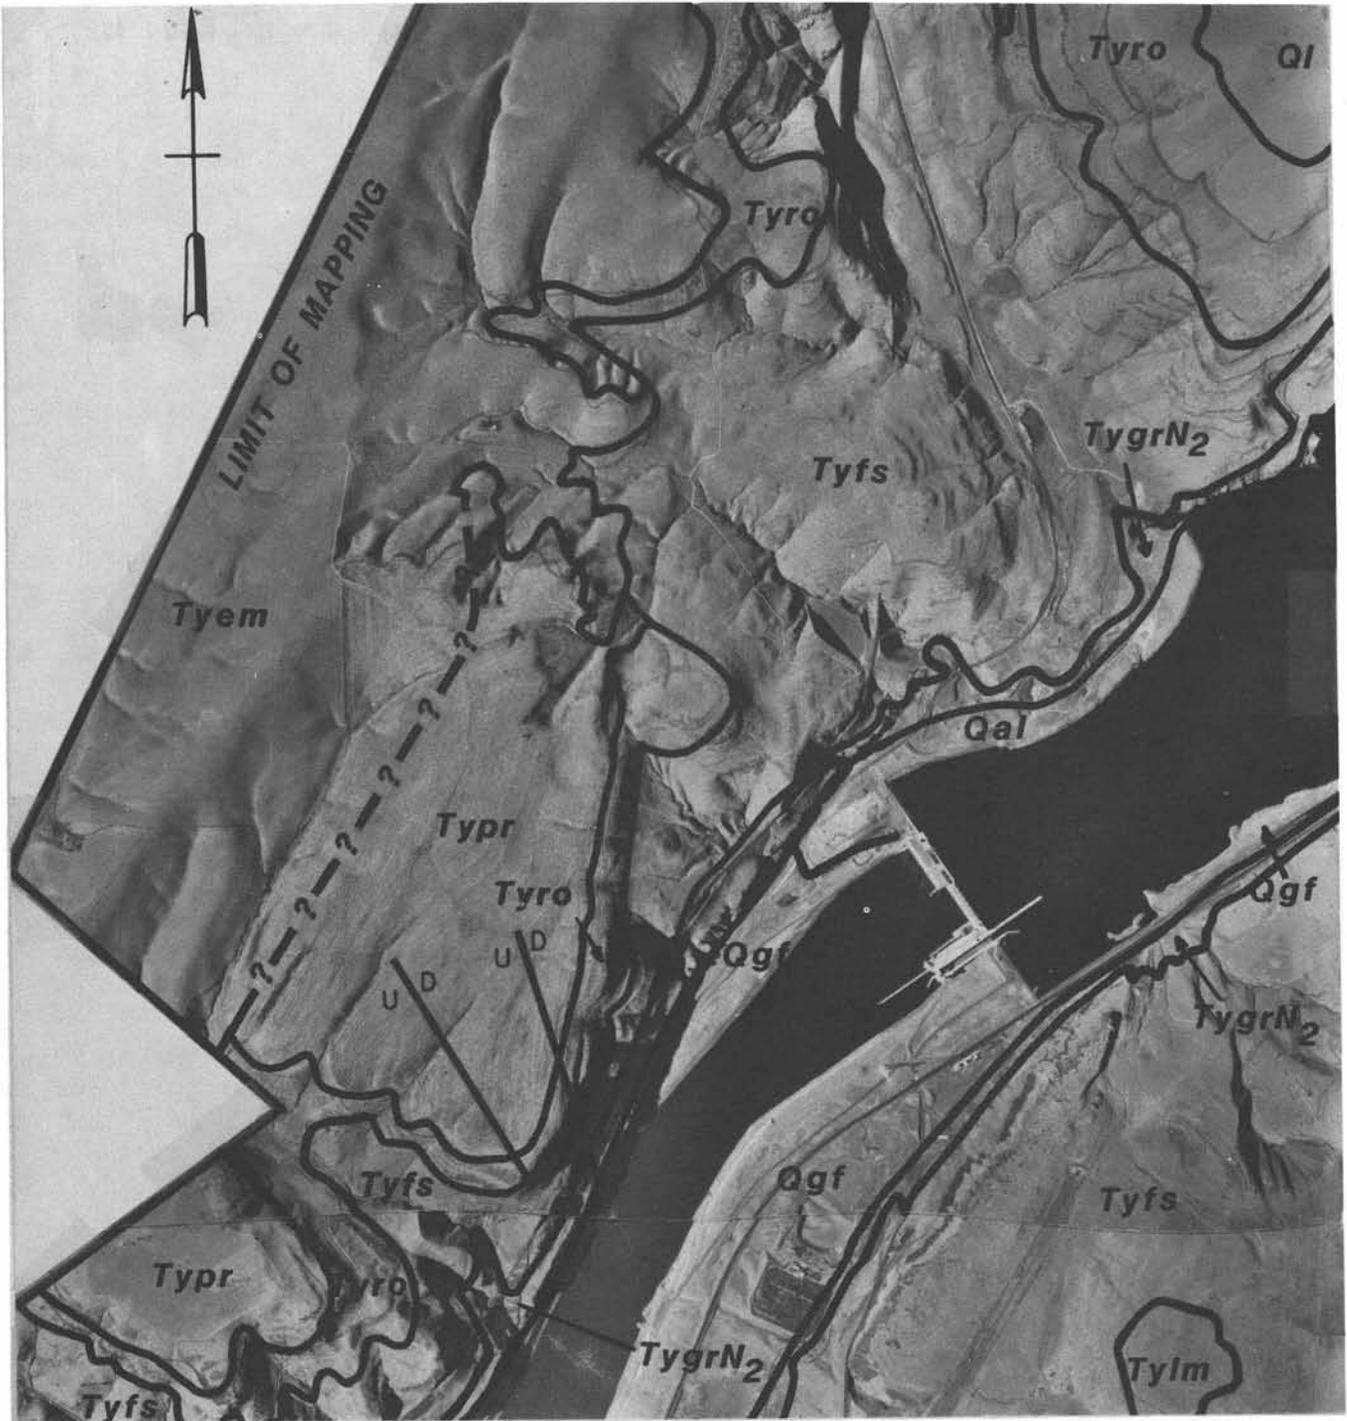
Figure 2. Photogeologic map in the vicinity of Lower Monumental Dam. Heavy solid lines indicate approximate geologic contacts. Q1, loess; Qal, recent alluvium; Qgf, glaciofluvial deposits; Tyem and Tyem, Lower Monumental and Elephant Mountain members of the Saddle Mountains Basalt; Typr, Tyro, and Tyfs, Priest Rapids, Roza, and Frenchman Springs members of the Wanapum Basalt; TygrN₂, Grande Ronde Basalt (upper flows of normal magnetic polarity). Scale: 1 in. = approx. 2,000 ft.

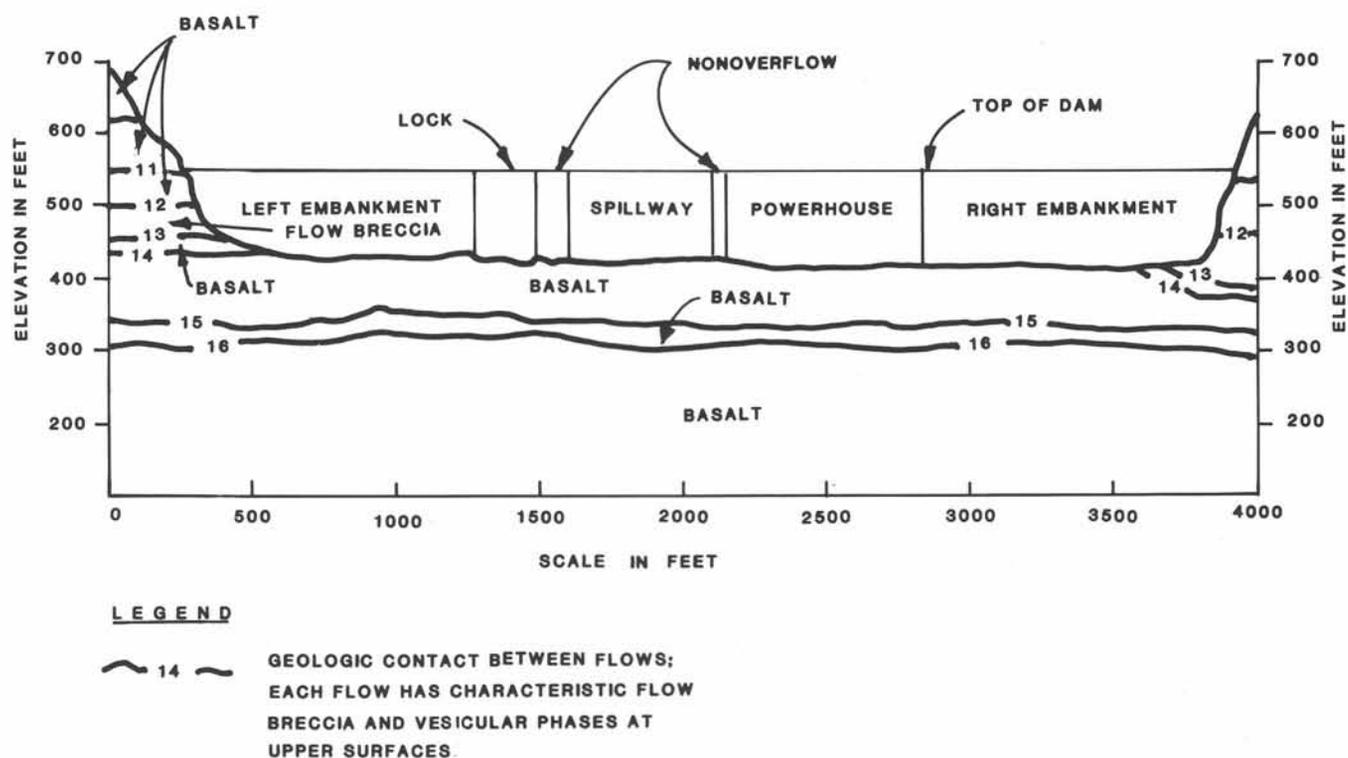
Figure 3. Geologic section of Lower Monumental Lock and Dam; view downstream.

A drain curtain was installed along the downstream side of the drainage and grouting gallery to relieve any excessive water pressure that would result from the effects of the full reservoir. The specified depth of 60 ft in the contract was modified to preclude penetrating contact 15, which is the principal artesian aquifer zone. Penetration of this zone would have resulted in a volume of water greater than the design capacity of the drainage system; drainage of contact 15 was not determined necessary for required reduction of hydrostatic uplift pressures. The source of the large flows would be from tailwater, the assumption being that the grout curtain would adequately seal this zone from effects of the Lower Monumental Pool (U.S. Army Corps of Engineers, 1969).

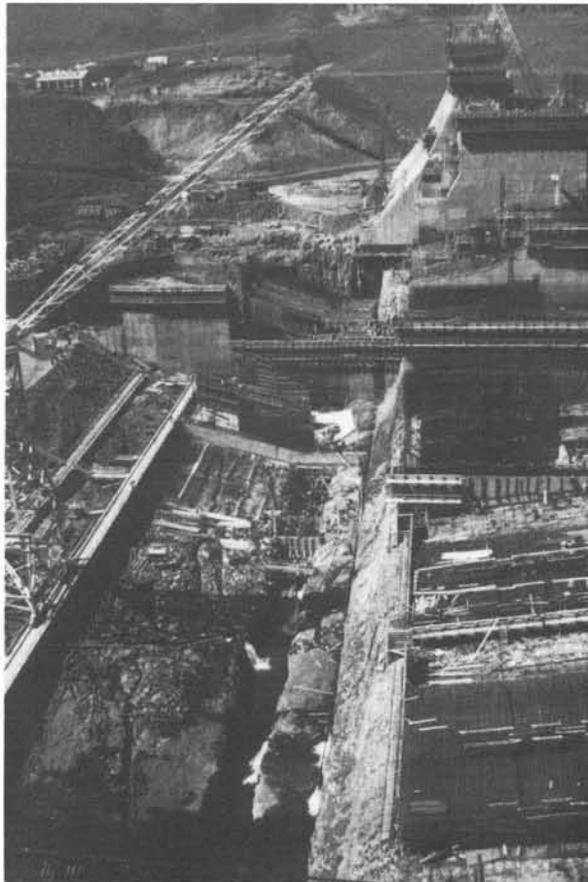
Lower Monumental Dam. View to the north from the top of the completed spillway dam showing the power-house excavation on April 12, 1966. Photograph by R. W. Galster.

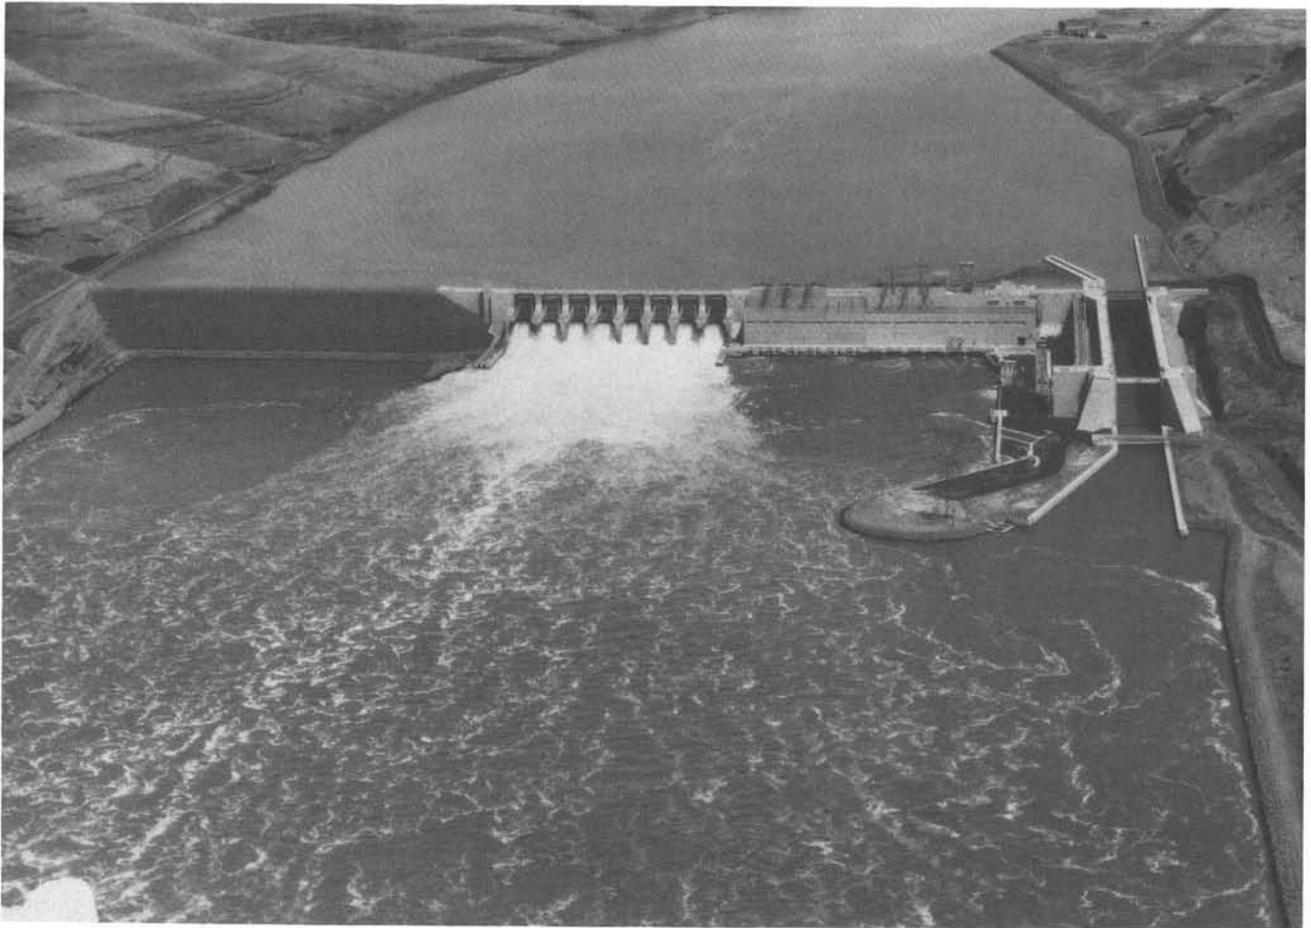
Figure 1. Little Goose Dam; view upstream (east). Components of the project from left to right are right (north) embankment dam, spillway dam, powerhouse, and navigation lock. Fish-passage facilities are adjacent to navigation lock. Photograph by U.S. Army Corps of Engineers.

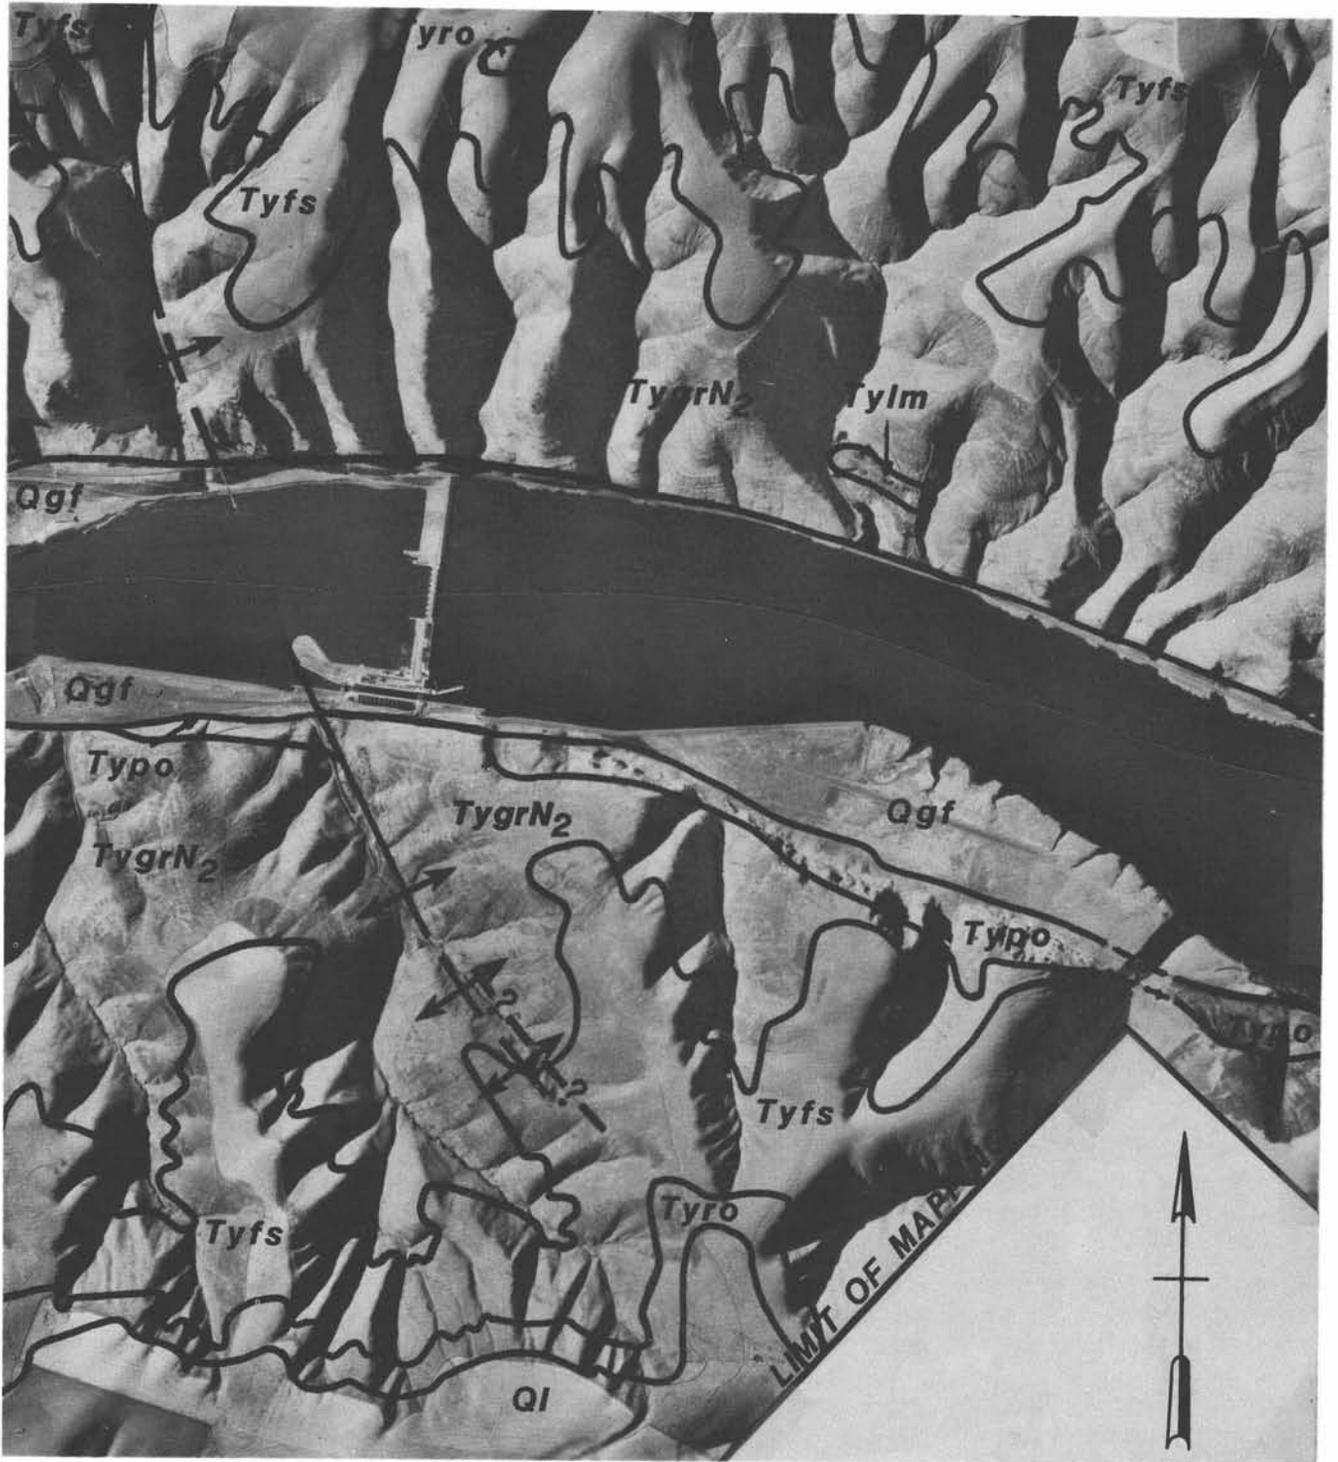
Figure 2. Photogeologic map of the Little Goose Dam area. Solid line indicates approximate geologic contacts. Ql, loess; Qgf, glaciofluvial deposits; Tylm and Typo, Lower Monumental and Pomona members of Saddle Mountains Basalt; Tyfs and Tyro, Frenchman Springs and Roza members of the Wanapum Basalt; TygrN₂, Grande Ronde Basalt (upper flows of normal magnetic polarity). Scale: 1 in. = approx. 2,000 ft.

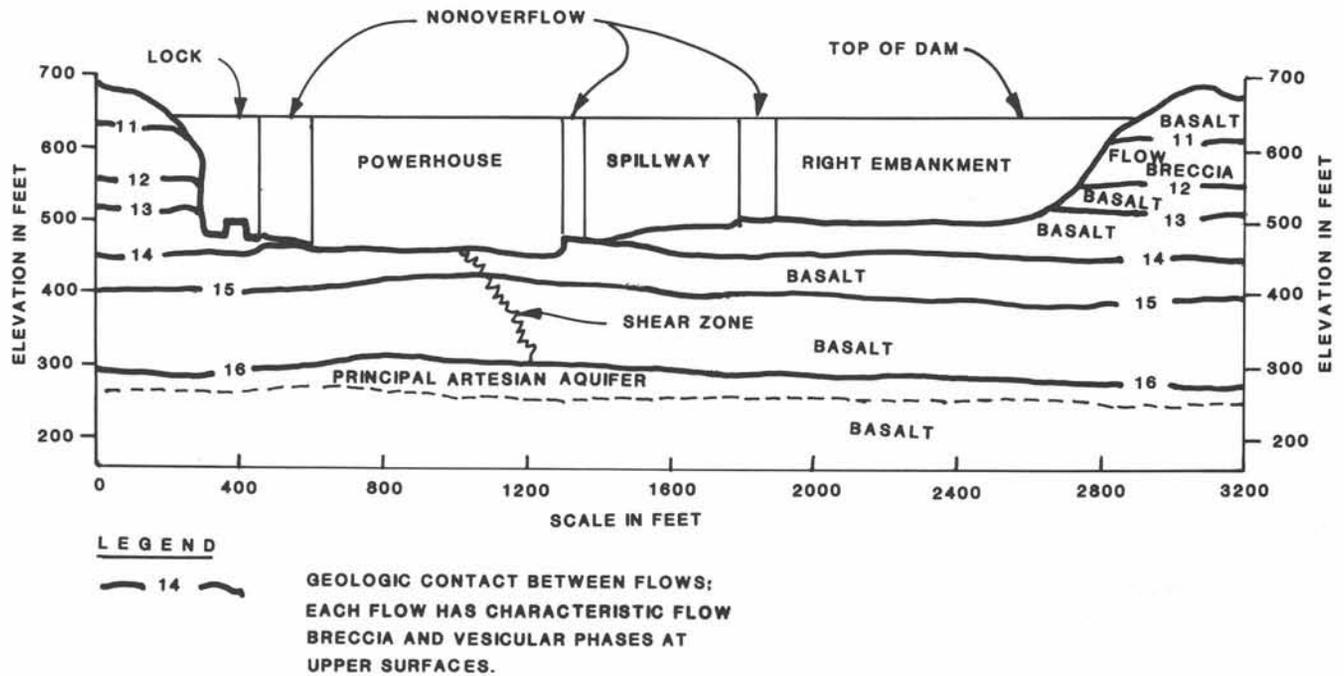
Figure 3. Geologic cross section at Little Goose Dam; view downstream.

The Little Goose Dam is located approximately 10 mi upstream of the confluence of the Palouse River with the Snake River at Lyons Ferry. At the dam site, the Snake River has cut a 1,100-ft-deep, 3,600-ft-wide canyon. The dam is founded on a sequence of basalt flows that form the upper part of the Grande Ronde Basalt. The surficial geology in the immediate vicinity of the project is shown on Figure 2. A geologic cross section along the centerline of the dam is shown on Figure 3.

The regional dip of the basalt flows is very gentle, 1°-3° southwest, although local variations and dip reversal are common due to faulting and minor deformation both upstream and downstream of the site. Excavation for the powerhouse exposed a major thrust fault that has a northeast strike and a 26° dip to the southeast. Other shear zones and faults with general northwest trends were exposed throughout the foundation area for the concrete structures. Generally, these reflect the regional trend on a local scale, and they presented no difficulties for foundation stability. A major artesian aquifer passes beneath the foundation at a depth of approximately 150 feet; this was one of the prime concerns during design (Figure 3).

The principal artesian aquifer occurs in the foundation at approximately elevation 300 ft, or about 150 ft below design grade. This aquifer zone was studied in great detail during design phases, first to determine if the high pressures (140 psi) calculated to be exerted on the foundation from below could rupture the overlying confining basalt flows that make up the foundations for the dam, and secondly, to determine uplift pressures and drainage requirements for the completed project. The study concluded that it would be safe to excavate to the design depths and that there would be no rupture of the basalt between the excavation and the aquifer. However, it was concluded that the artesian zone could be expected to transmit water vertically through faults, broken zones, or other open pathways; this water would be mixed with any water entering the two intervening contact zones (contacts 14 and 15, Figure 3). With the

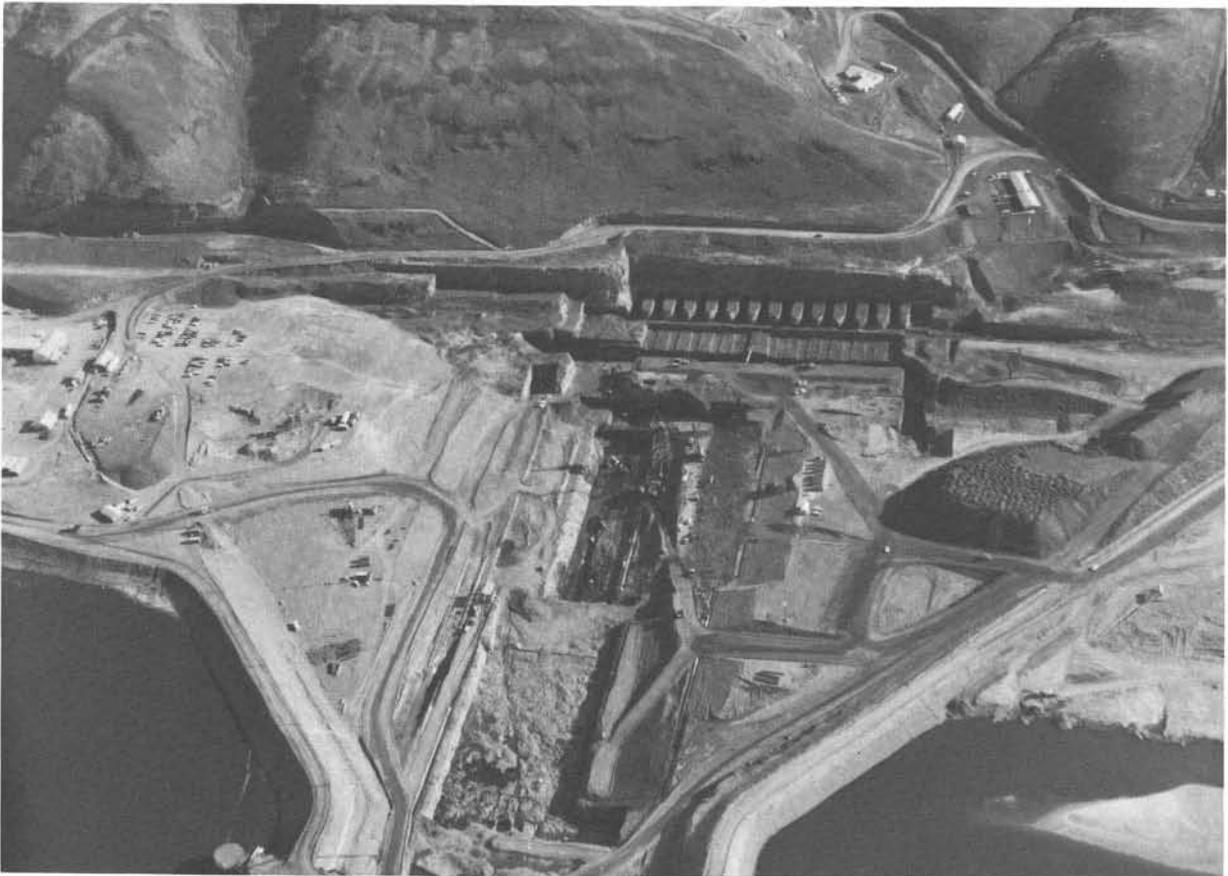
Little Goose Dam. A general view of the foundation excavation for the spillway, powerhouse, and navigation lock, all contained within the first-step cofferdam. The Snake River is being diverted through the area of the future embankment dam. Photograph by U.S. Army Corps of Engineers, March 1966.

The construction of the Little Goose project was actually completed in two phases. The first phase consisted of building a cofferdam for river diversion to the right bank and partial excavation within the cofferdam. The final phase consisted of the major foundation excavation and construction of the main dam.

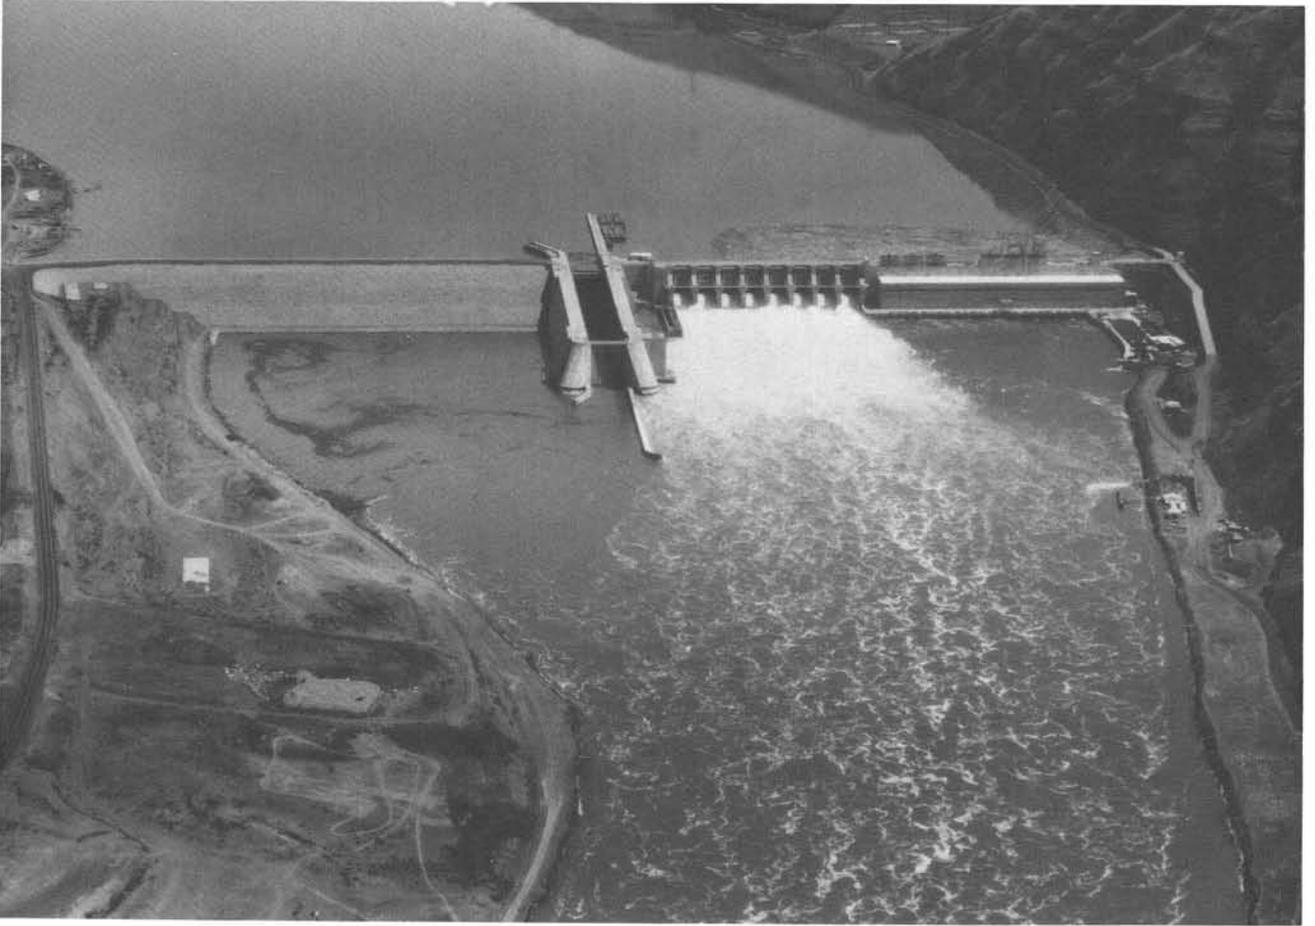
Figure 1. Lower Granite Dam; view upstream (southeast). Components of the project, from left to right, are the right (north) embankment dam, navigation lock, spillway dam, powerhouse, and fish-ladder facilities with overhead south shore access to top of dam. Photograph by U.S. Army Corps of Engineers.

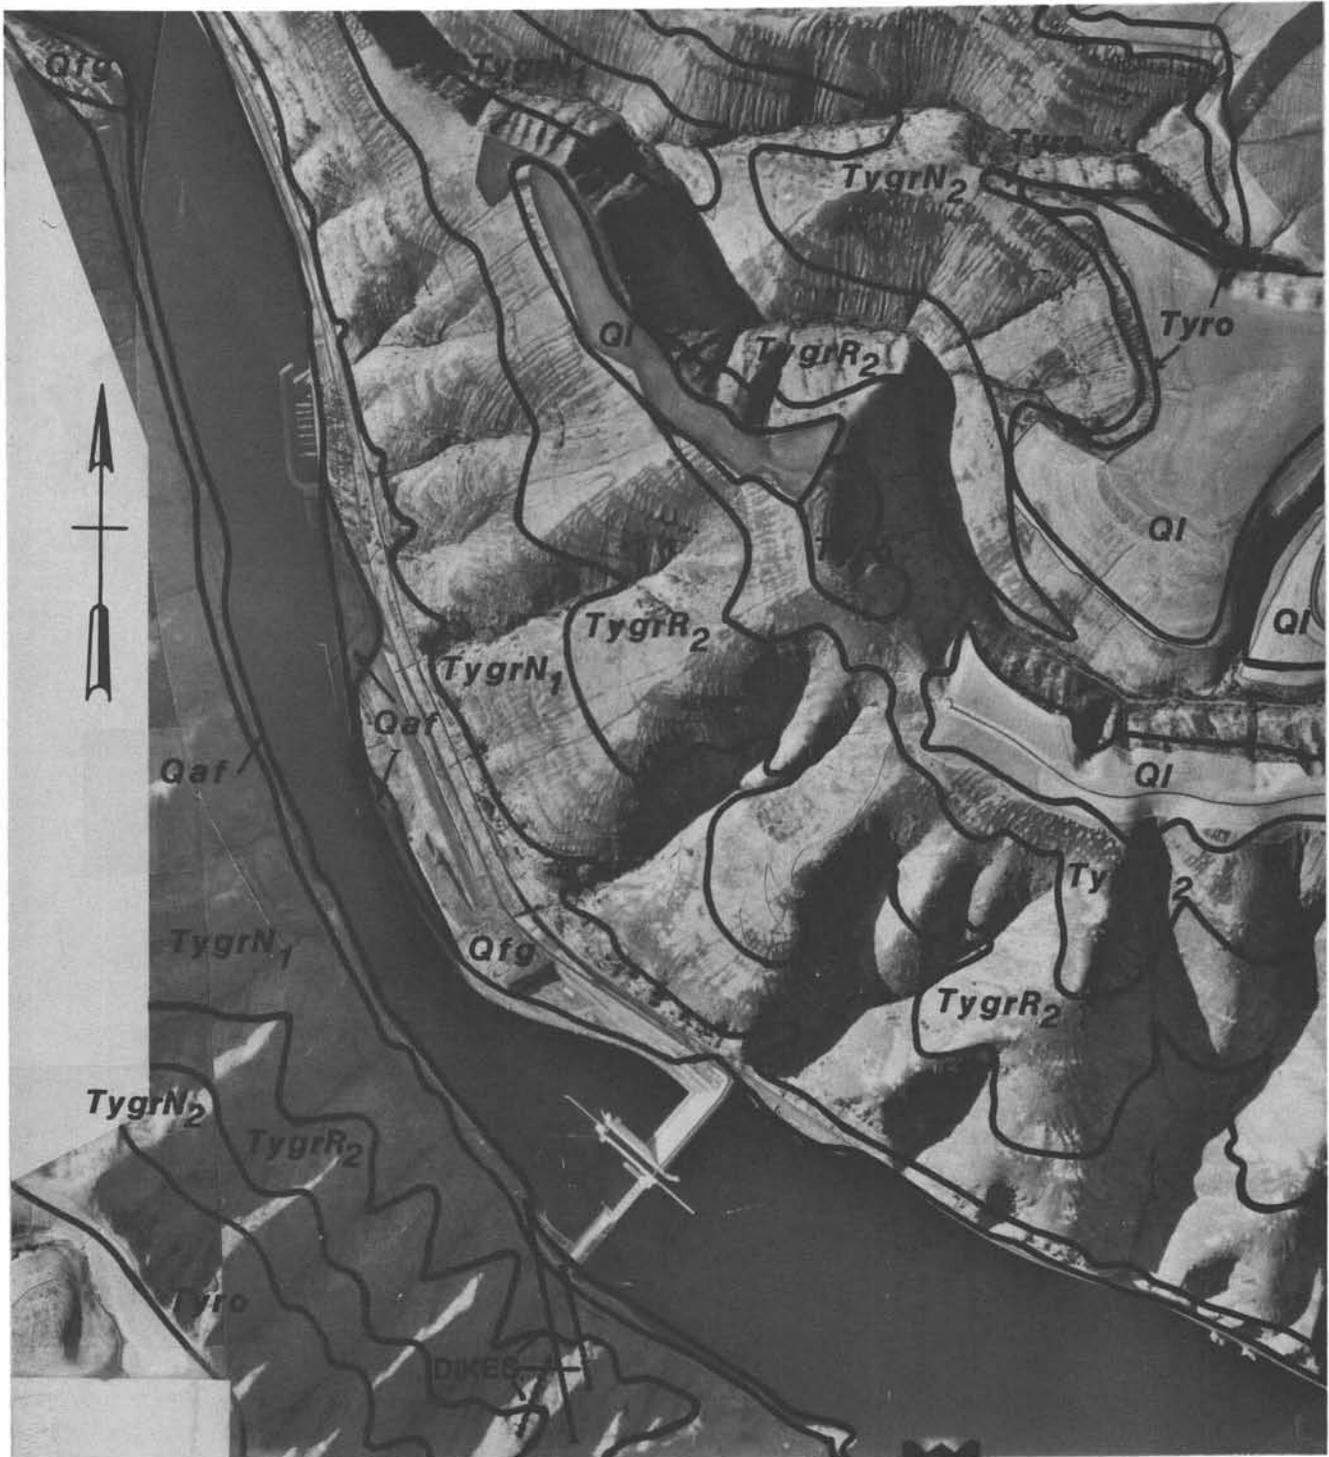
Figure 2. Photogeologic map in vicinity of Lower Granite Dam. Heavy solid lines indicate approximate geologic contacts. Q1, loess; Qaf, recent alluvium; Qfg, glaciofluvial terrace deposits; Tyro, Roza Member, Wanapum Basalt; Tygr, Grande Ronde Basalt (includes lower and upper flows of normal magnetic polarity, N₁ and N₂, respectively, and upper flows of reversed polarity, R₂). Scale: 1 in. = approx. 2,000 ft.

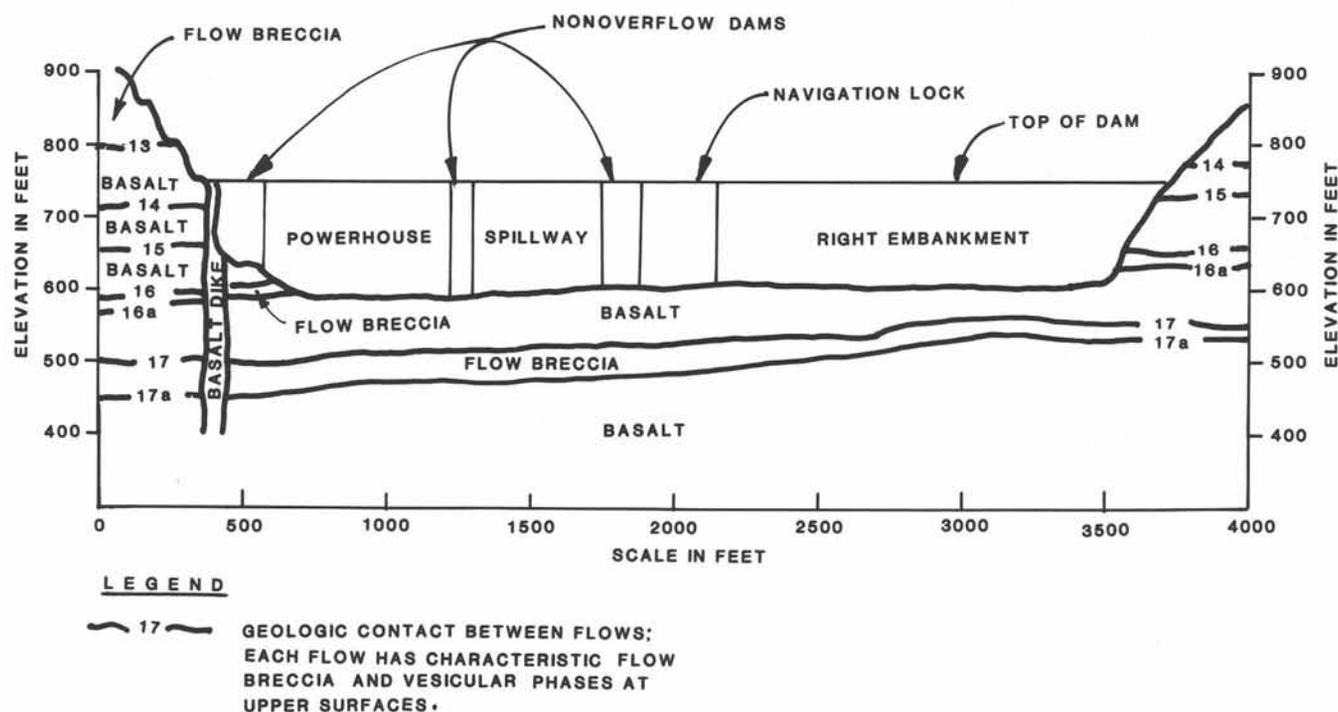
Figure 3. Geologic section at Lower Granite Dam; view downstream.

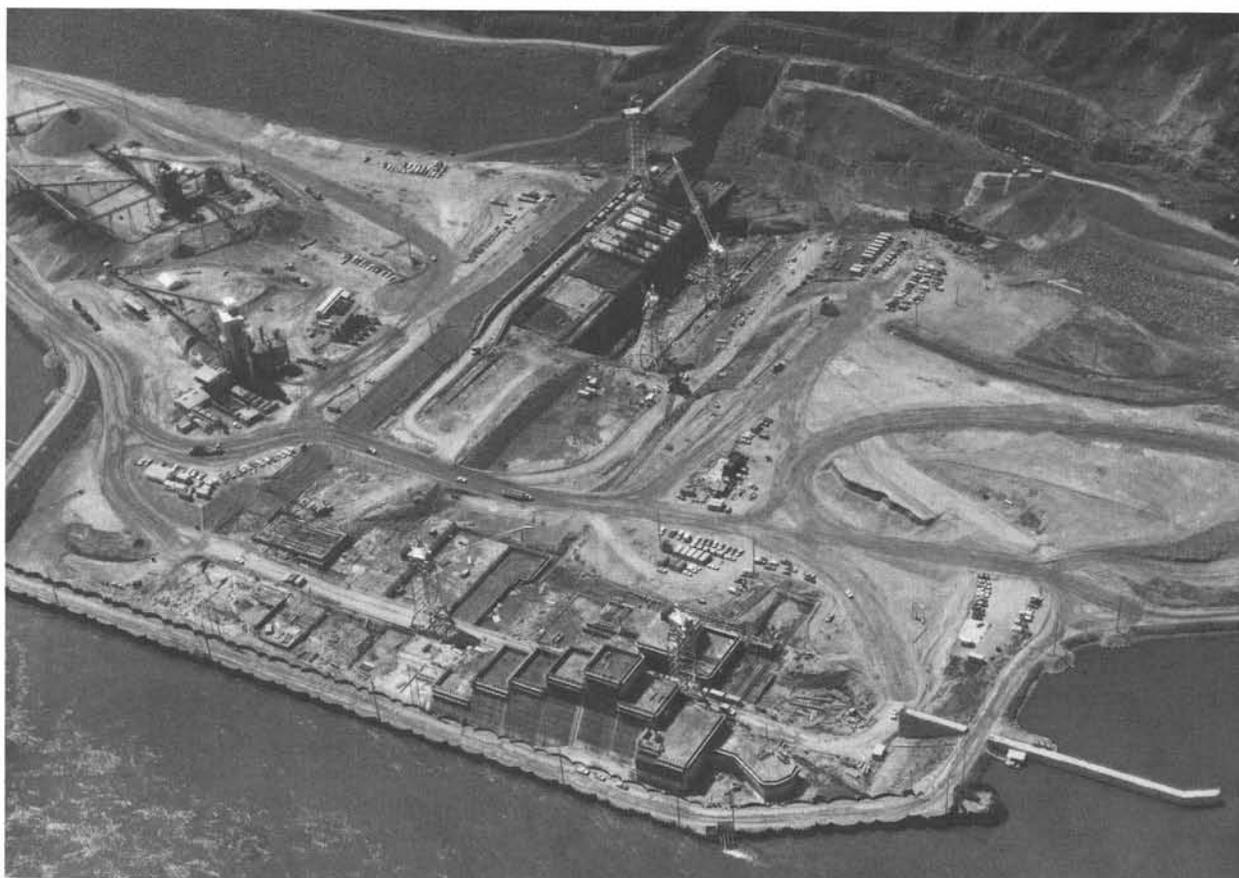
Lower Granite Dam. A general view of the foundation excavation and partially completed concrete structures contained within the first-step cofferdam on the left (south) shore. The Snake River is being diverted through the area of the future embankment dam. Photograph from U. S. Army Corps of Engineers, May 1971.

All foundation excavation for the concrete structures was accomplished within the cofferdam that had been constructed 5 yr earlier. The first excavation removed Recent alluvial gravels, which overlay much of the foundation area. Once overburden was cleared, the rock excavation progressed rapidly. Decisions on final grade had to be made promptly, and in those areas requiring

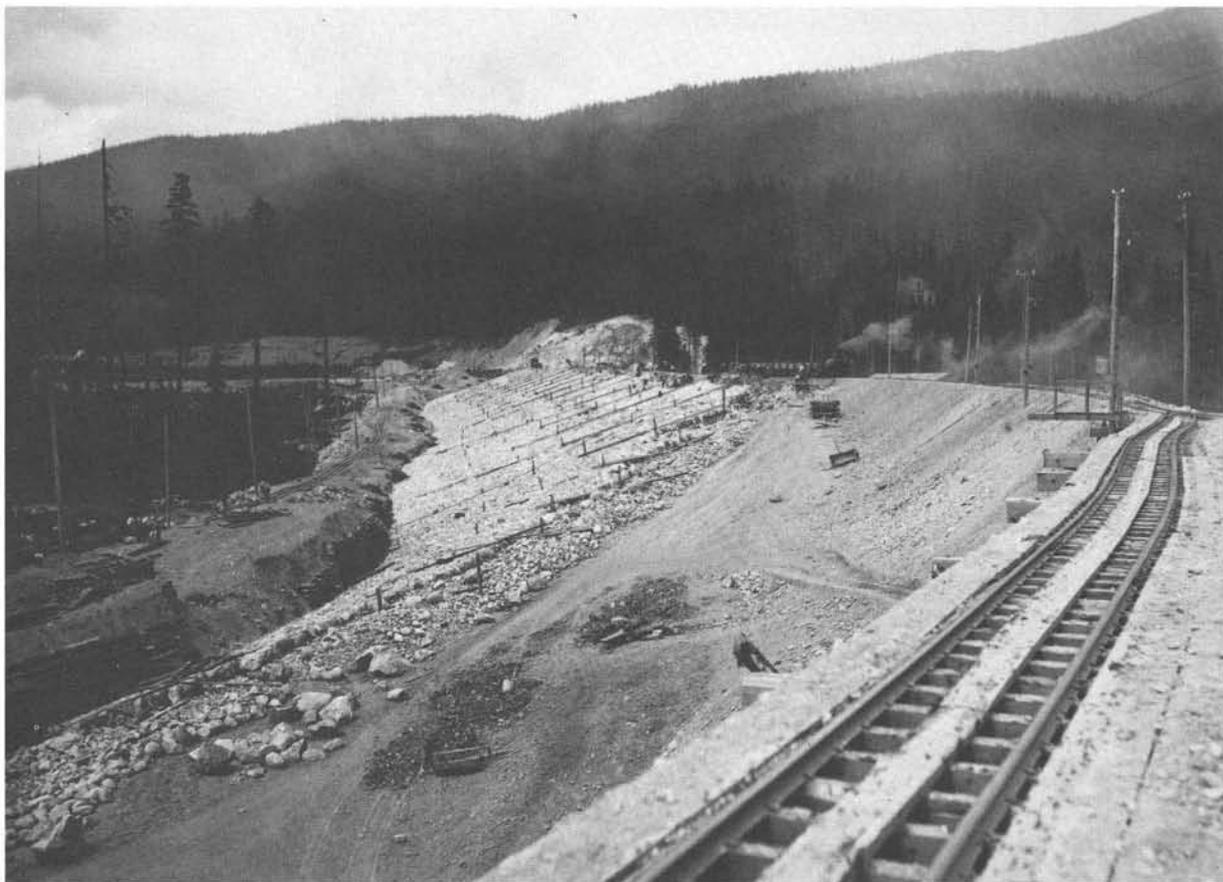
Early construction of the Yakima Basin Irrigation Project at Keechelus Dam; view to the north toward the left abutment. The gravel fill shown here is nearly completed in the maximum section. Topping out of the earthfill and riprap is in progress; the dinkey train is using dump cars. Photograph by U.S. Bureau of Reclamation, July 24, 1916.
