Rock Island Dam

RICHARD W. GALSTER
Consulting Engineering Geologist

PROJECT DESCRIPTION

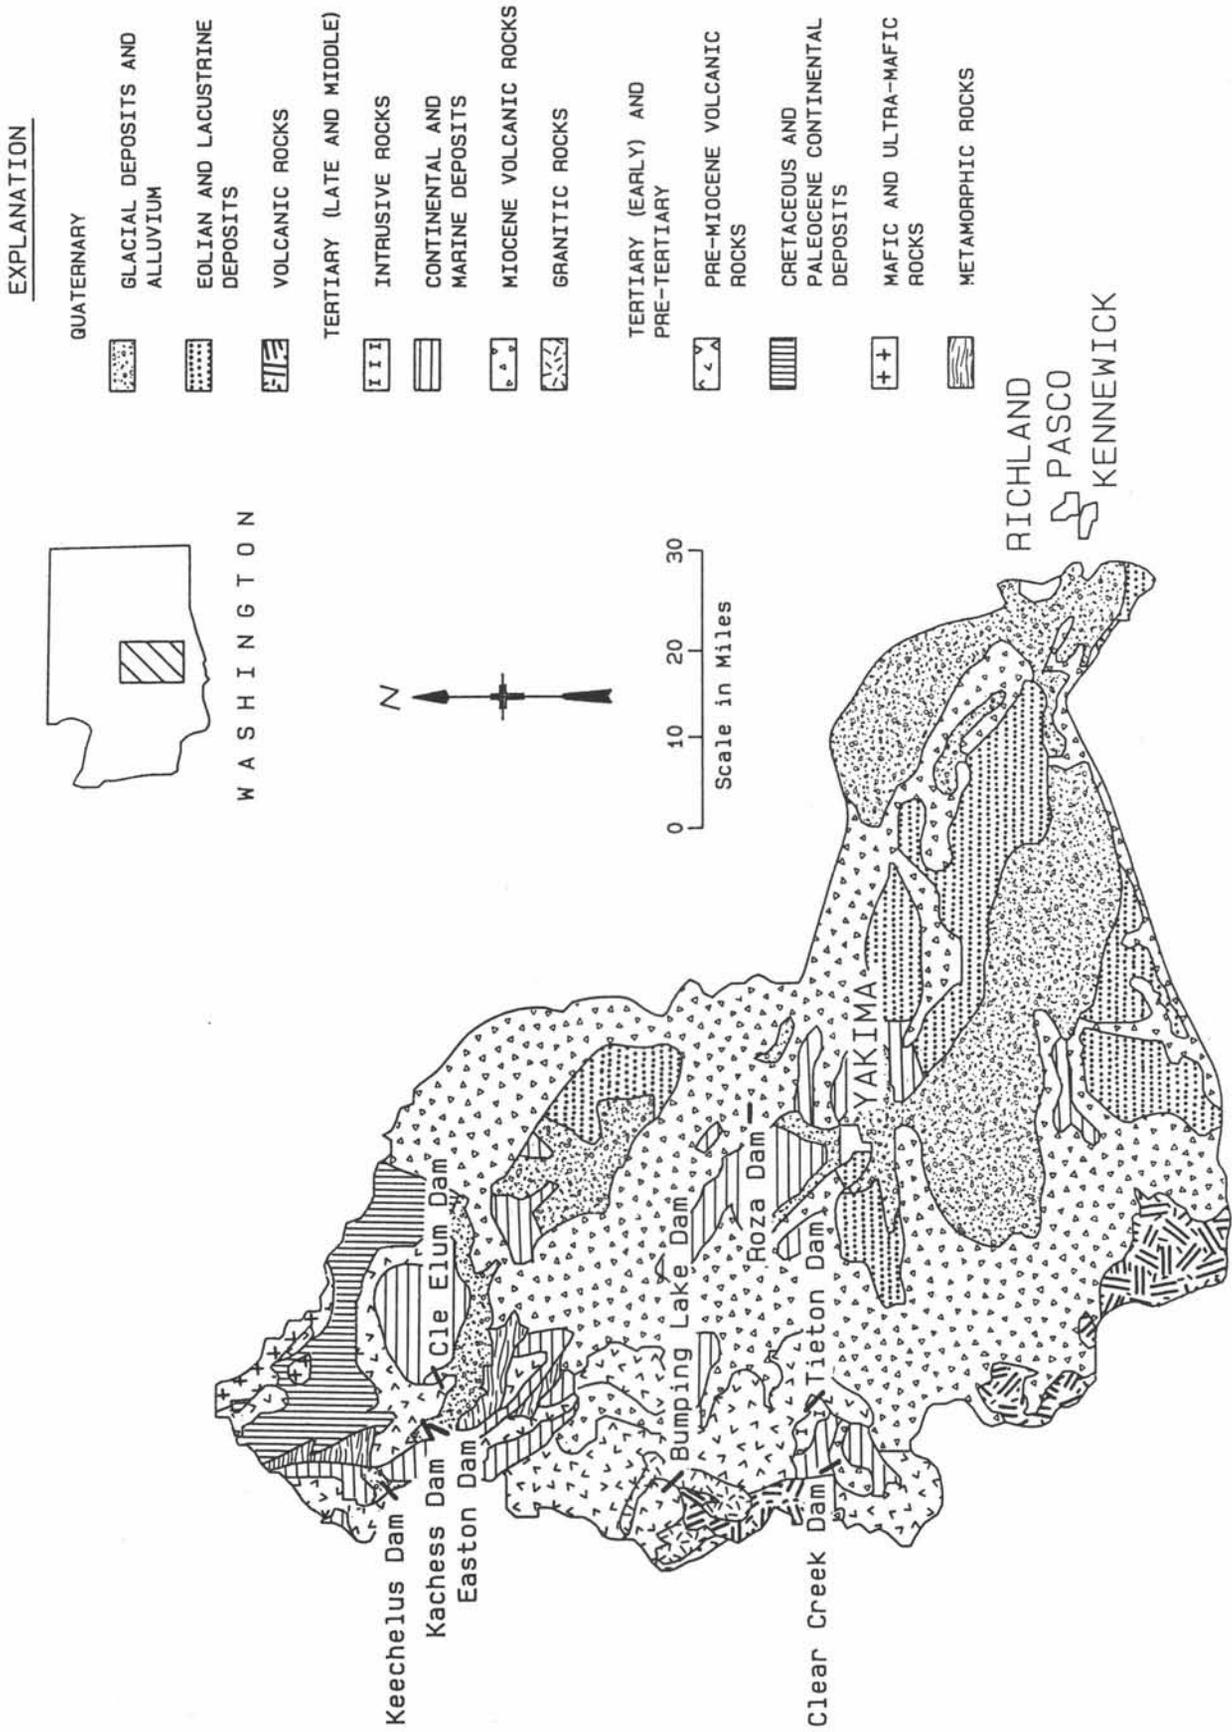
Figure 2. Generalized geologic map of the Yakima River basin, Yakima Project, Washington. Adapted from Weissenborn, 1969).

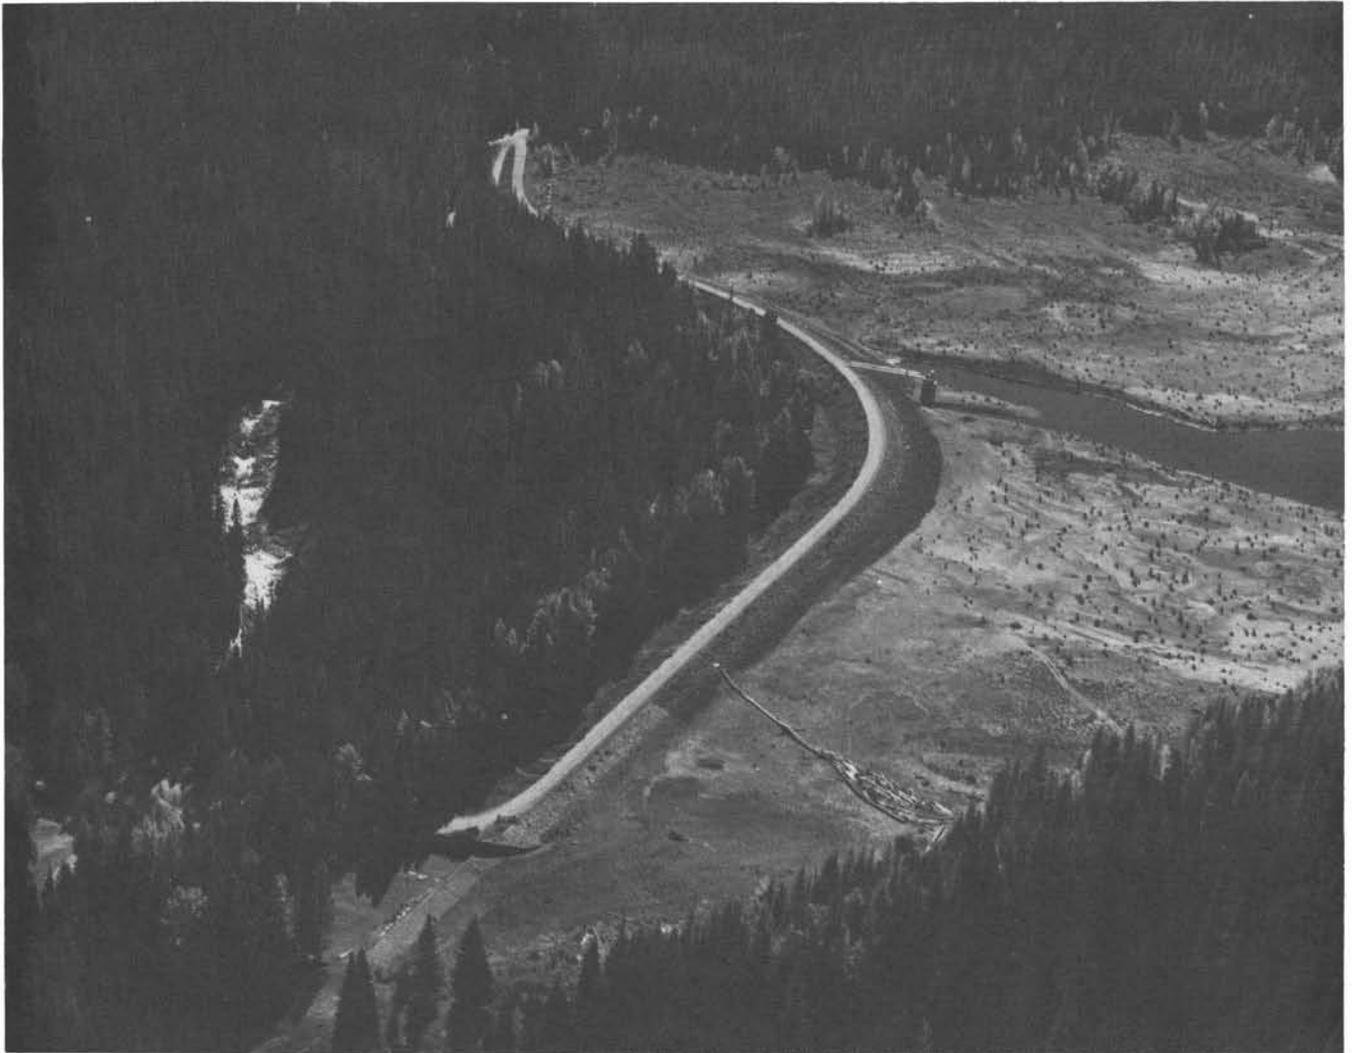
Figure 1. Aerial view to the southeast of Bumping Lake Dam showing the exposed reservoir bottom during a drought year. The entire valley floor is covered with a thick accumulation of glacial drift, which supports a heavy cover of vegetation. U.S. Bureau of Reclamation photograph, October 9, 1979.

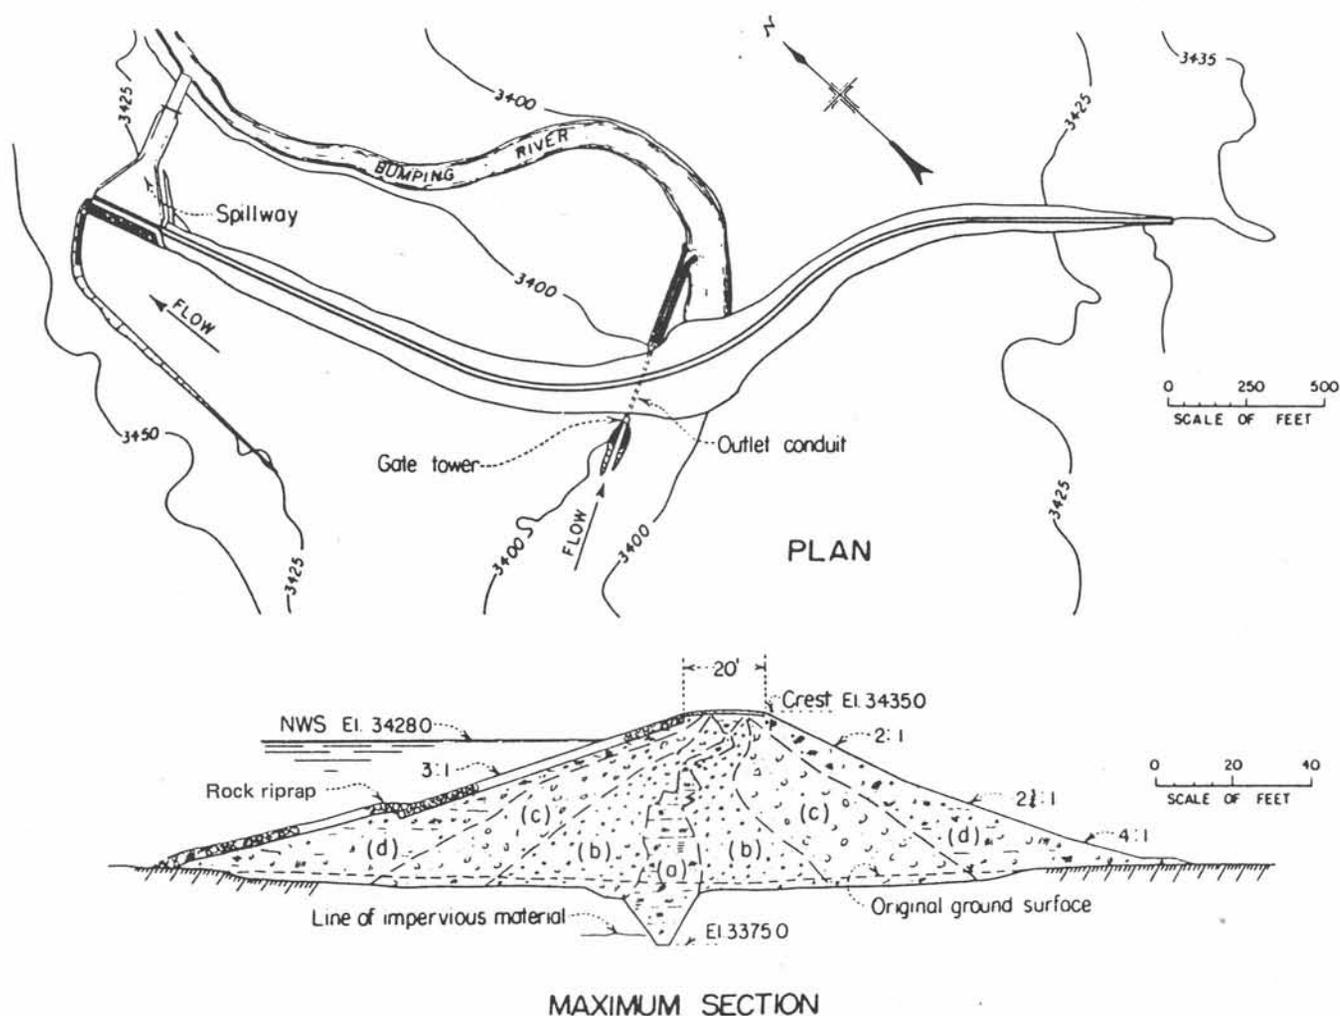
Figure 2. Plan and cross-section, Bumping Lake Dam. Adapted from U.S. Bureau of Reclamation (1981).

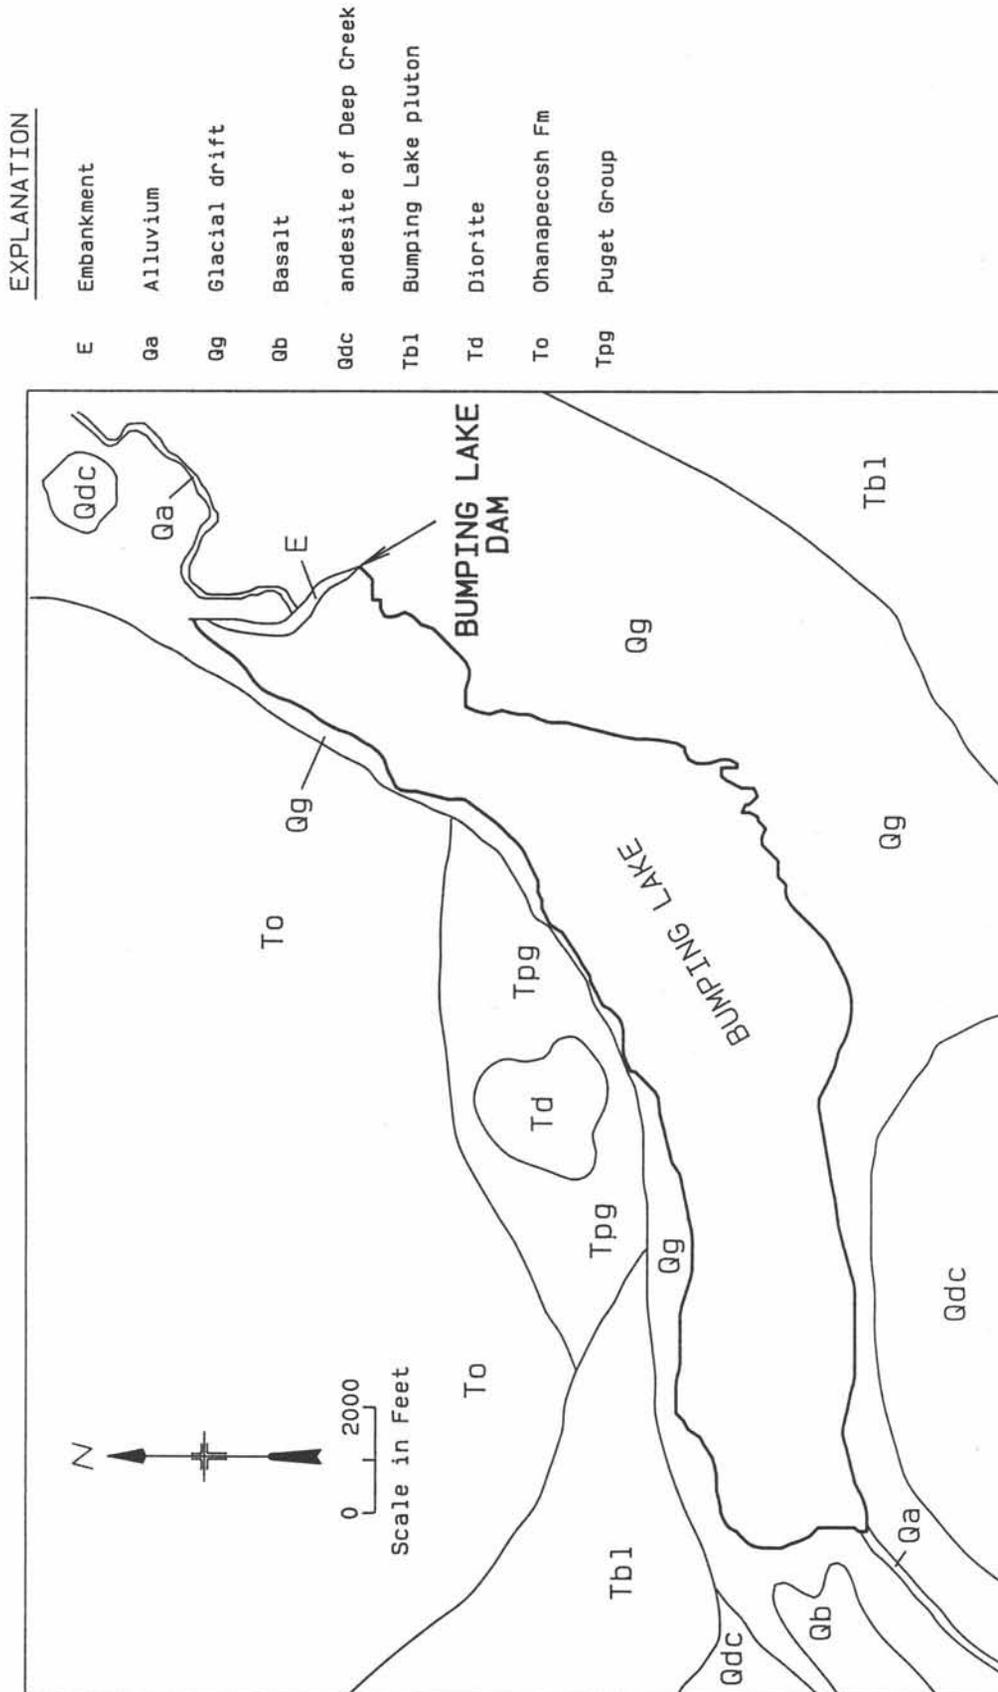
Figure 3. Geology of Bumping Lake Dam area. After Abbott (1953).

The bedrock stratigraphy of the Bumping River valley, from oldest unit to youngest, consists of the Eocene Puget Group sandstone, Oligocene Ohanapecoh Formation, Miocene diorite and Bumping Lake granite, and Pleistocene Deep Creek andesite and basalt (Figure 3). Forming the most extensive bedrock unit in the Bumping River valley is the andesite and brecciated andesite of the Ohanapecoh Formation, which overlies the Puget sandstone, chiefly to the north. These volcanics have been intruded by the Bumping Lake pluton. Overlying the Ohanapecoh Formation is another fairly extensive rock unit, the Pleistocene Deep Creek andesite (Abbott, 1953; Clayton, 1983; Simmons et al., 1983).

originating from the crest of the Cascade Range carved the deep, U-shaped Bumping River valley, which was partially infilled with drift. The glacial events that took place within the Bumping River valley and their resultant drift deposits have not been differentiated, although Hammond (1980) has correlated these deposits with Evans Creek alpine glaciation. The glacial advances probably began approximately 2 Ma, with the last major ice retreat occurring about 10,000 yr ago (USBR, 1985). The surficial geology of the Bumping Lake Dam area is shown on Figure 3 (Abbott, 1953; Simmons et al., 1983).

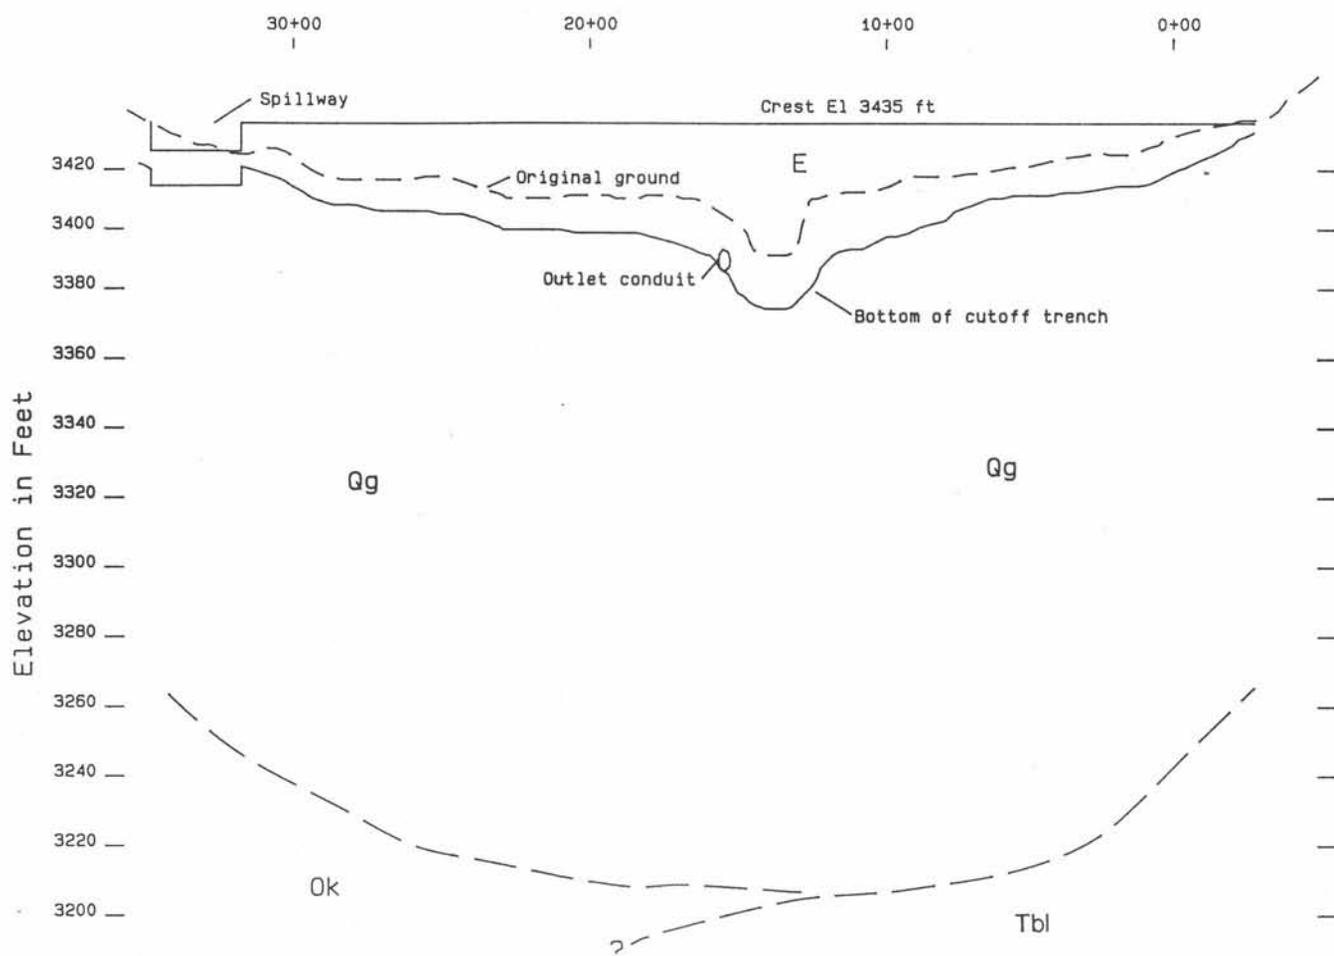
Figure 4. Longitudinal section of Bumping Lake Dam; view downstream. Longitudinal section adapted from unpublished U.S. Bureau of Reclamation sources. E, embankment, Qg, glacial drift; Ok, Ohanapecosh Formation; Tbl, Bumping Lake granite.

Bumping Lake Dam is founded on the drift deposited during the last major ice retreat (Figure 4). The drift is a heterogeneous mixture of gravel, sand, and silt with some cobbles and boulders. The drift in the area of the

dam's foundation is believed to be approximately 200 ft thick near the center of the valley (Figure 4), and it pinches out abruptly at the edges (USBR, 1953). The ancestral Bumping River and the meltwaters of retreating glaciers reworked some of the drift, leaving lenses of stratified silt, sand, and gravel (USBR, 1983).

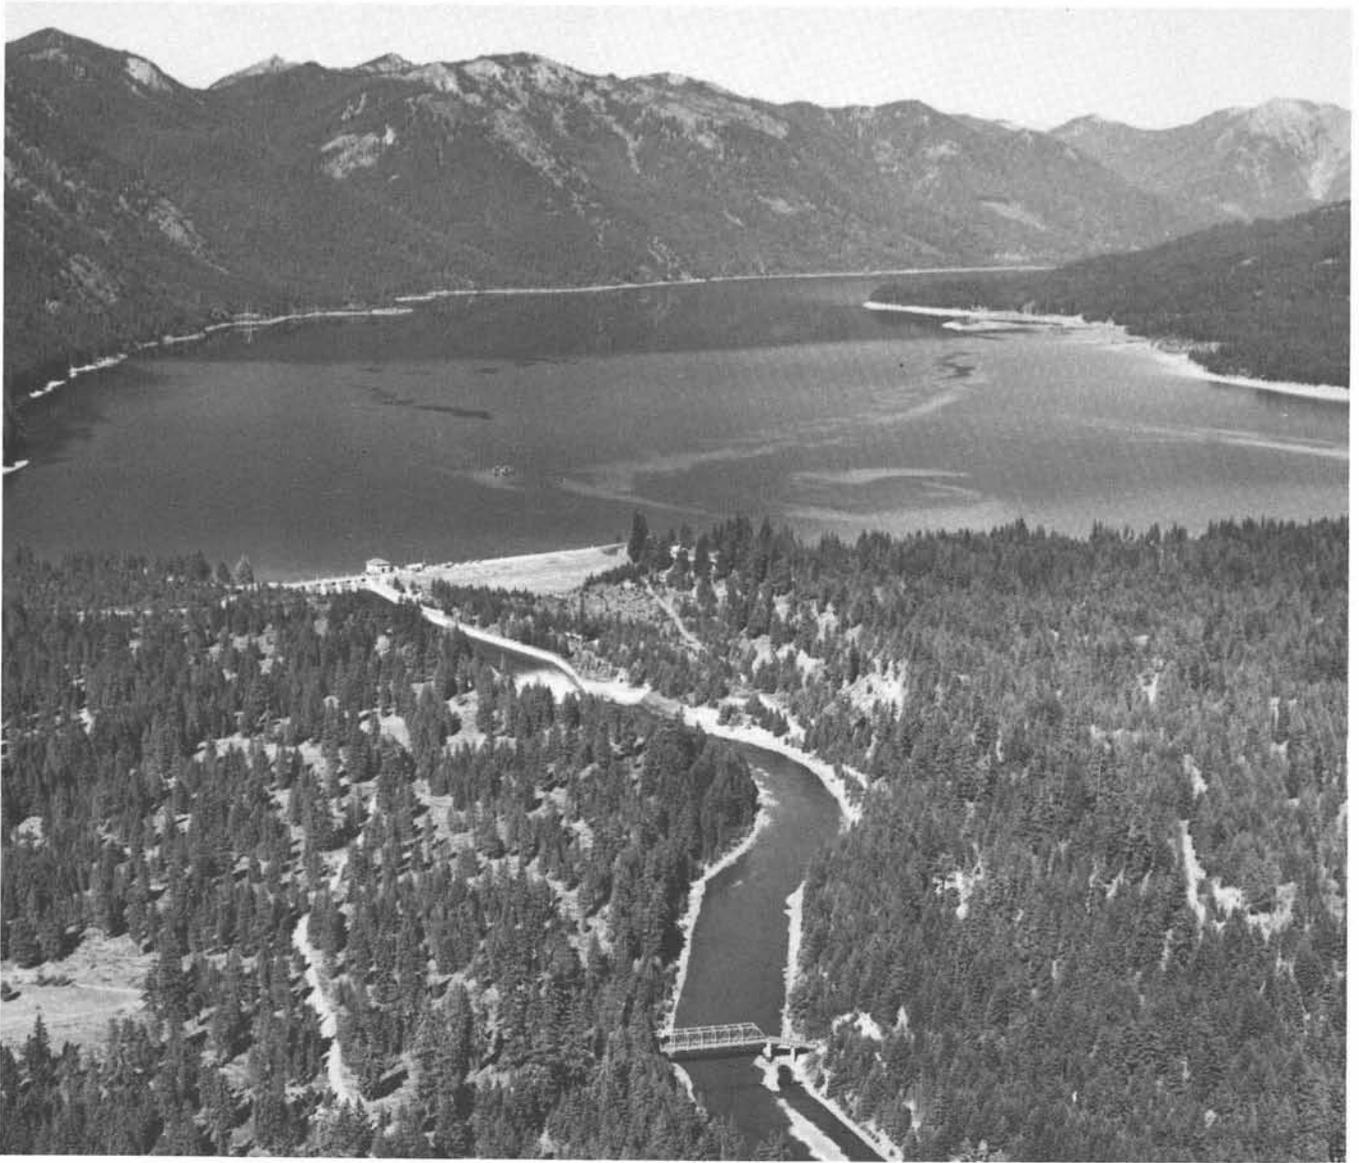
Figure 1. Aerial view to the northwest (upstream) of Cle Elum Dam. The dam is sited on the upstream edge of a large, tree-covered outwash terrace known as Domerie Flats, in the foreground. Outcrops of silty, stony till occur along the rim of the terrace and margin of the reservoir; they represent remnants of the terminal moraine marking the last advance of the Pleistocene glaciers in the Cle Elum River valley. U.S. Bureau of Reclamation photograph, October 5, 1979.

The modern dam, main dike, and three smaller saddle dikes were sited along the crest of the youngest moraine. A rock-filled, timber crib dam was constructed across the channel outlet in 1905 and was later replaced by the present structure in 1931 to 1933. The modern reservoir surface very closely approximates the high-stand water level of the glacial Lake Cle Elum.

The bulk of the Lakedale Drift forming the foundation of Cle Elum Dam consists of glacial outwash deposited along the margin and downstream of the Domerie ice front. The outwash forms a large apron below the dam and has a relatively uniform slope downstream to the Yakima River (Bryan, 1927; Ransome, 1930). The materials in the outwash range from large boulders to rock flour but generally consist of pervious, crudely stratified sand and gravel with interbeds of variously compact clay and silt. Till forms the innermost morainal crest and caps the steeply sloping upstream edge of the outwash apron along the southern margin of Lake Cle Elum. Till is absent along and adjacent to the former river channel, suggesting erosion of the till during breaching of the morainal dam and subsequent incising of the outlet channel by the Cle Elum River. The moraine includes considerable deformed

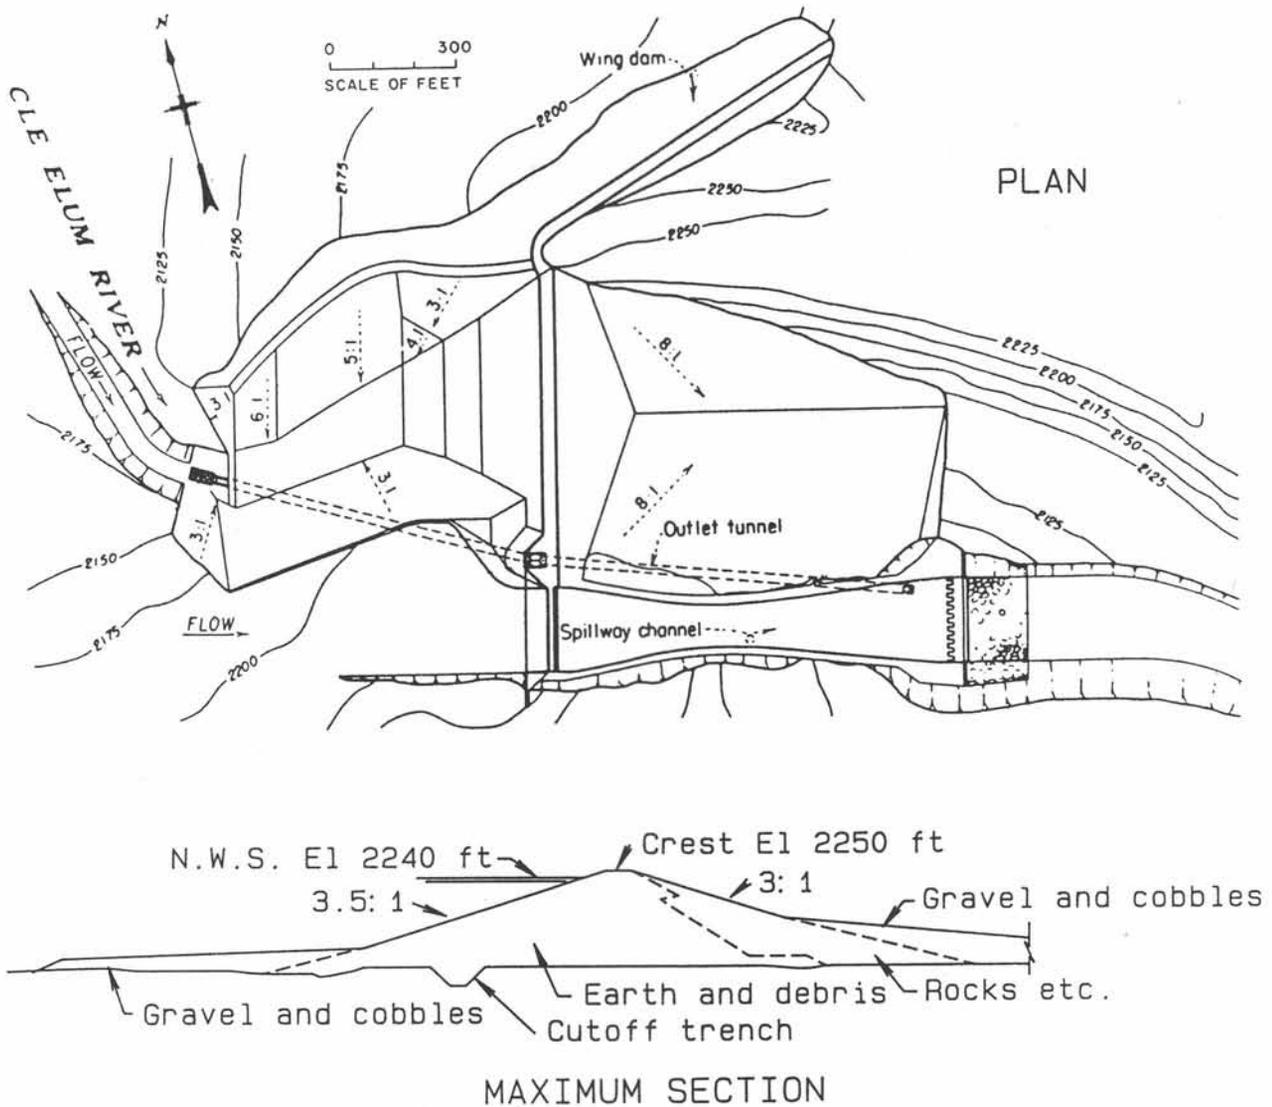
Figure 2. Plan (a) and section (b) of Cle Elum Dam. Adapted from U.S. Bureau of Recamation (1981).

The design of Cle Elum Dam included a provision to tap the upper 10 ft of the natural lake by means of the outlet works tunnel to provide additional storage. An open approach channel was excavated through the lake sediments upstream of the dam to the trashrack located at the intake of the outlet works tunnel (Figure 2). The river channel downstream from the dam was enlarged and deepened for a distance of about 5,168 ft where the natural grade of the river was intercepted. The spillway was excavated through the right abutment; the bulk of the structure is founded on outwash, although the inlet is constructed in part on till deposits. A drain envelope was installed beneath both the chute section and the reinforced stilling basin at the toe of the slope. The outlet works were constructed through outwash materials through much of the length of the structure; the intake and part of the outlet tunnel are founded on a blue clay exposed underneath the channel alluvium during excavation of the inlet channel.

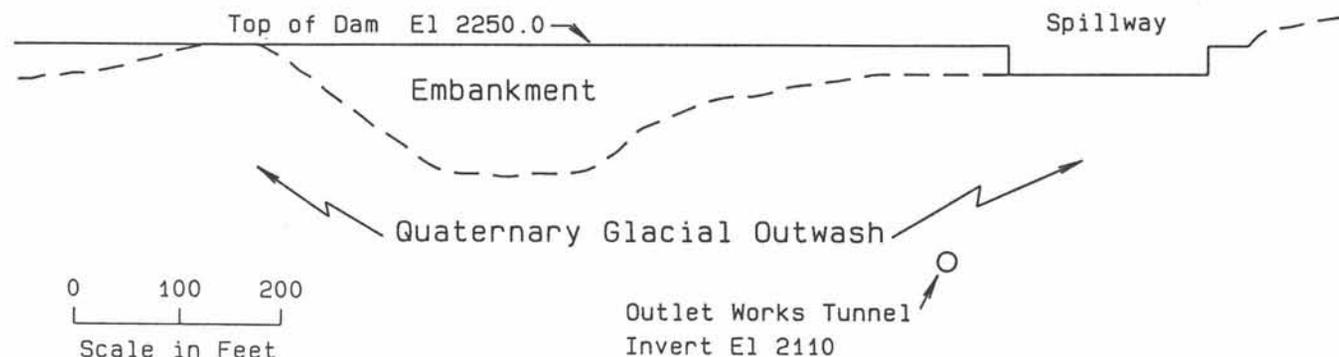
Figure 3. Longitudinal section of Cle Elum Dam; view downstream.

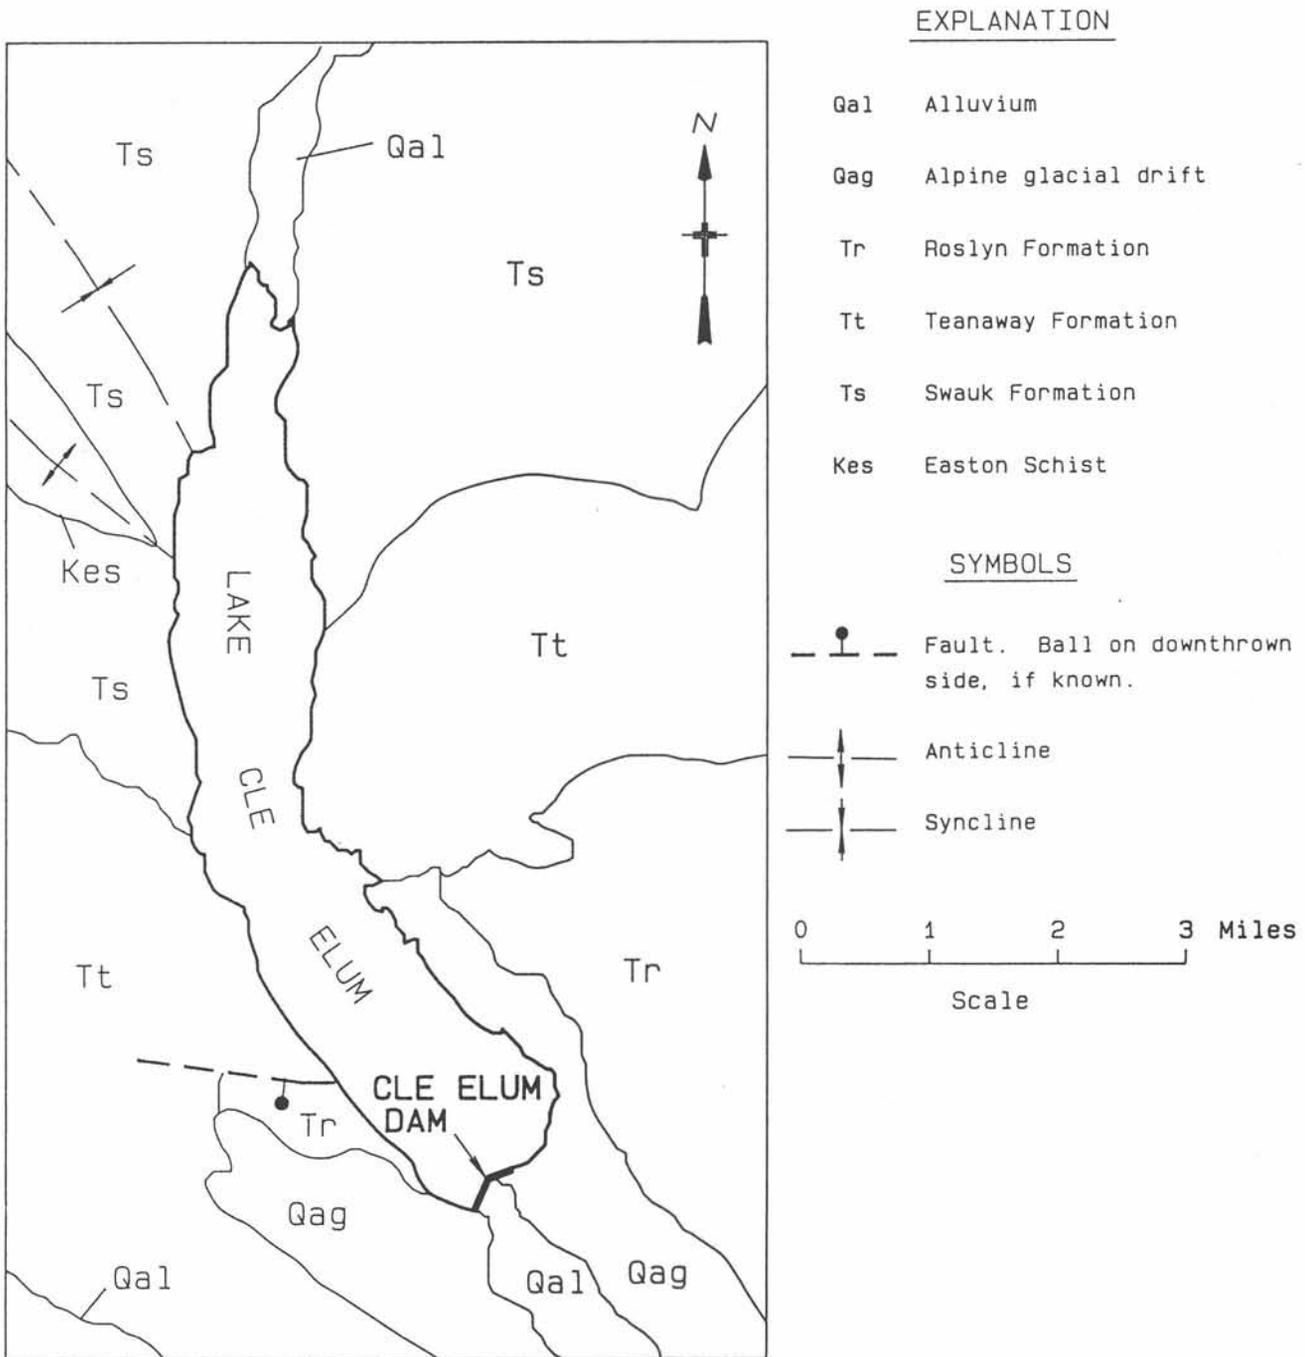
Figure 4. Generalized geologic map of the Cle Elum Dam area. After Frizzell et al. (1984). Kachess Ridge is located about 5 mi west of the reservoir, beyond the area shown in this map.

Exposures of phyllite, greenschist, and blue amphibole schist crop out west and north of the reservoir along Kachess Ridge (Figure 4). These rocks are part of the Easton Schist and form the base of the stratigraphic section in the Cle Elum Reservoir area. The Easton Schist has a probable age of Late Jurassic and has subsequently undergone metamorphism and strong deformation which continued into the Early Cretaceous (Frizzell et al., 1984).

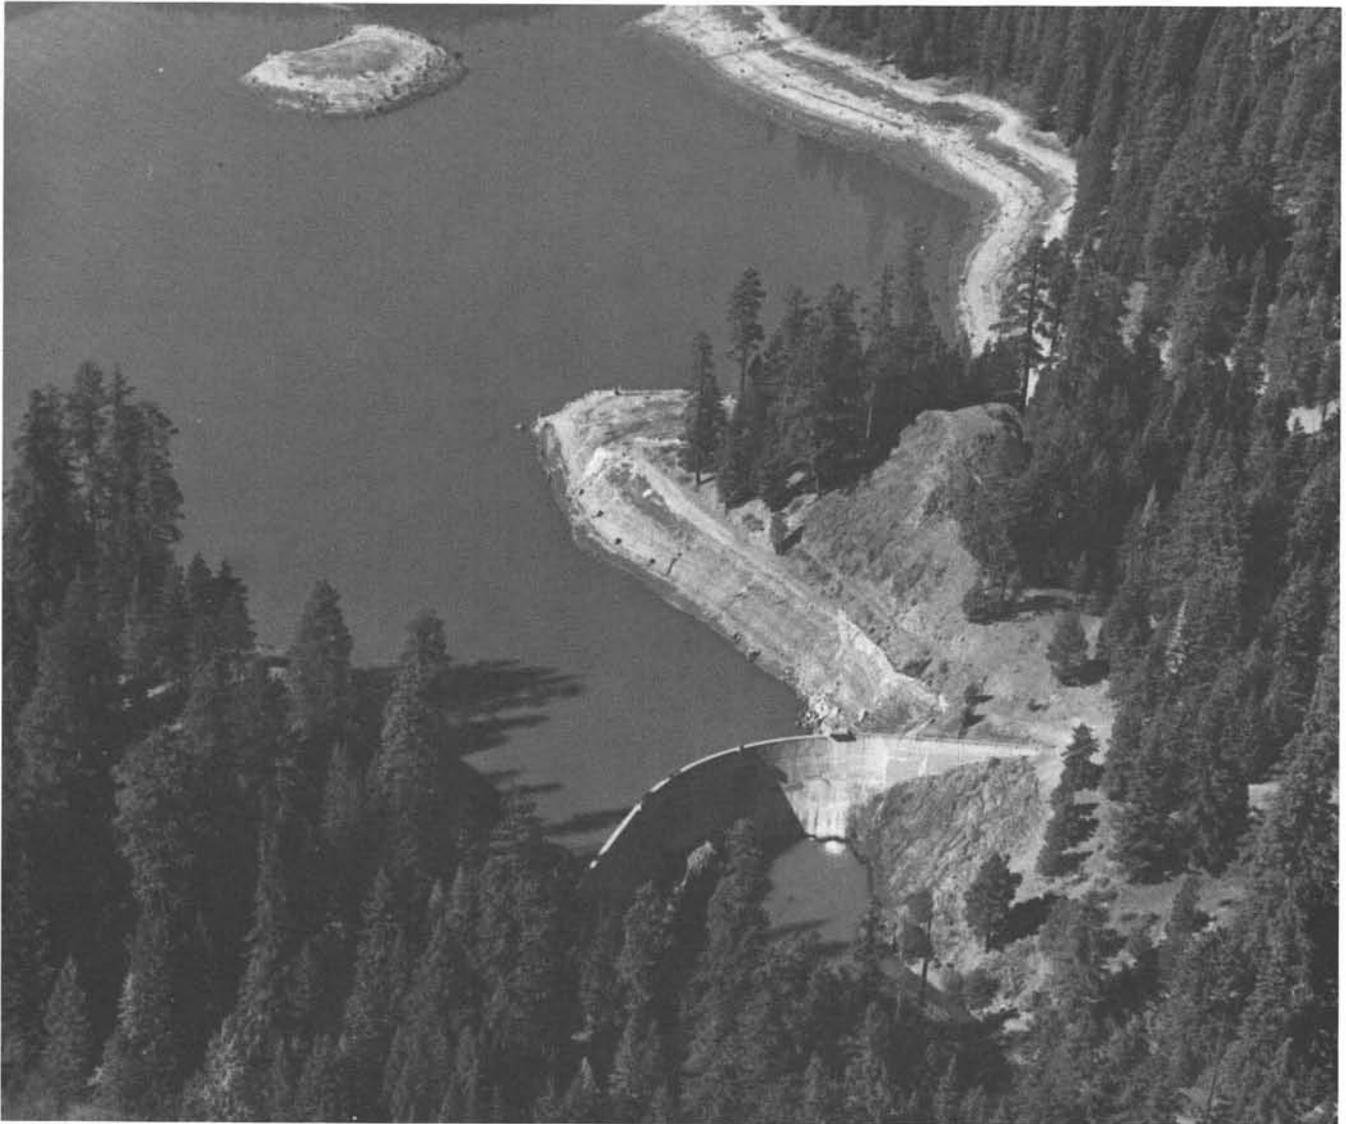
Figure 1. Aerial view to the west (upstream) of Clear Creek Dam showing the crest of the concrete thin-arch dam. The exposure on the left abutment is a basic porphyry that has been altered to serpentine and epidote. U.S. Bureau of Reclamation photograph, October 5, 1979.

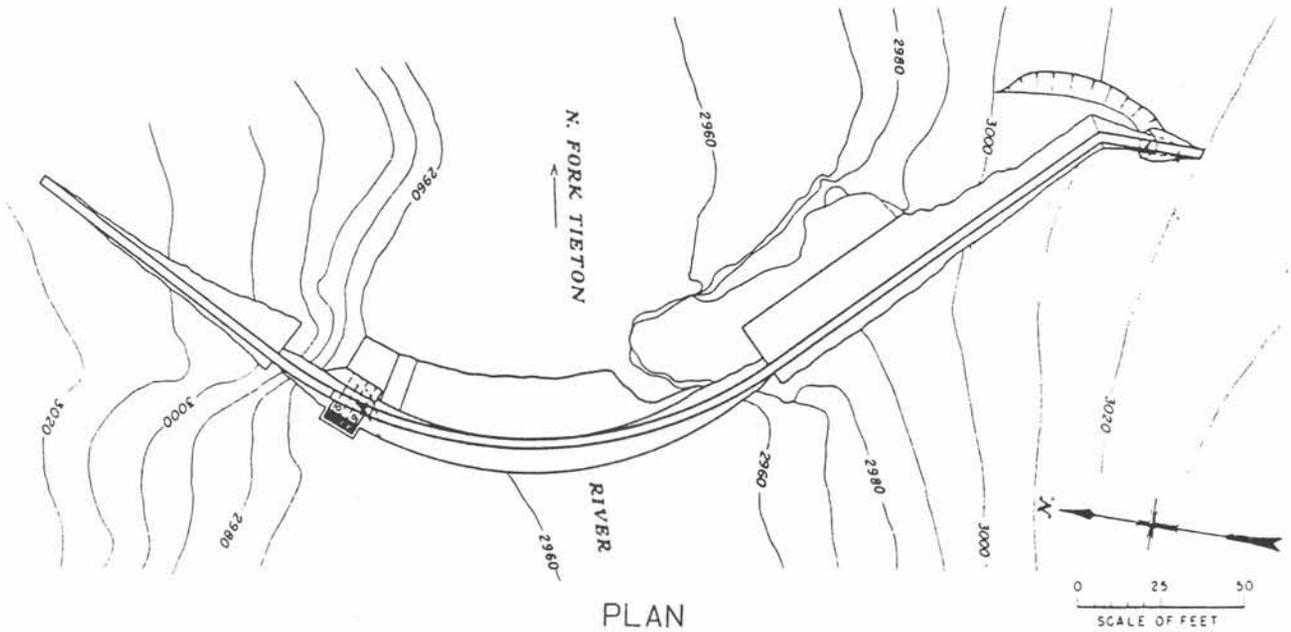
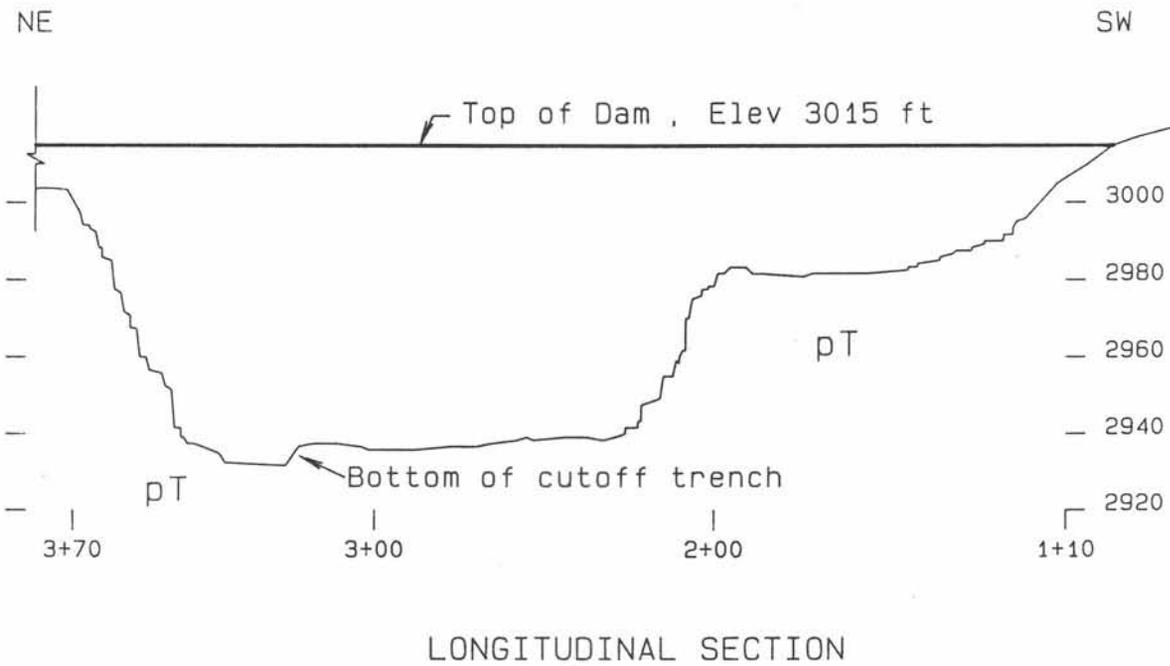
Figure 2. Plan and longitudinal section of Clear Creek Dam. Plan view adapted from U.S. Bureau of Reclamation (1983); longitudinal section adapted from unpublished Bureau sources.

The foundation of Clear Creek Dam (Figure 2) is composed mostly of a basic porphyry which has been moderately to intensely altered to a greenstone. This rock was probably an andesitic porphyry or basalt before propylitization (hydrothermal alteration). The basic porphyry is reddish purple to green and moderately jointed and intensely fractured. The rock is cross-cut by numerous thin quartz stringers. A marine shale, which has been partly metamorphosed, is also present in the damsite area. Though none of this metashale is exposed in the dam-site area, inclusions were excavated in the cut-off trench under the center of the dam. The metashale is fissile, black, and greasy in appearance (Birch, 1961; Miller, 1985).

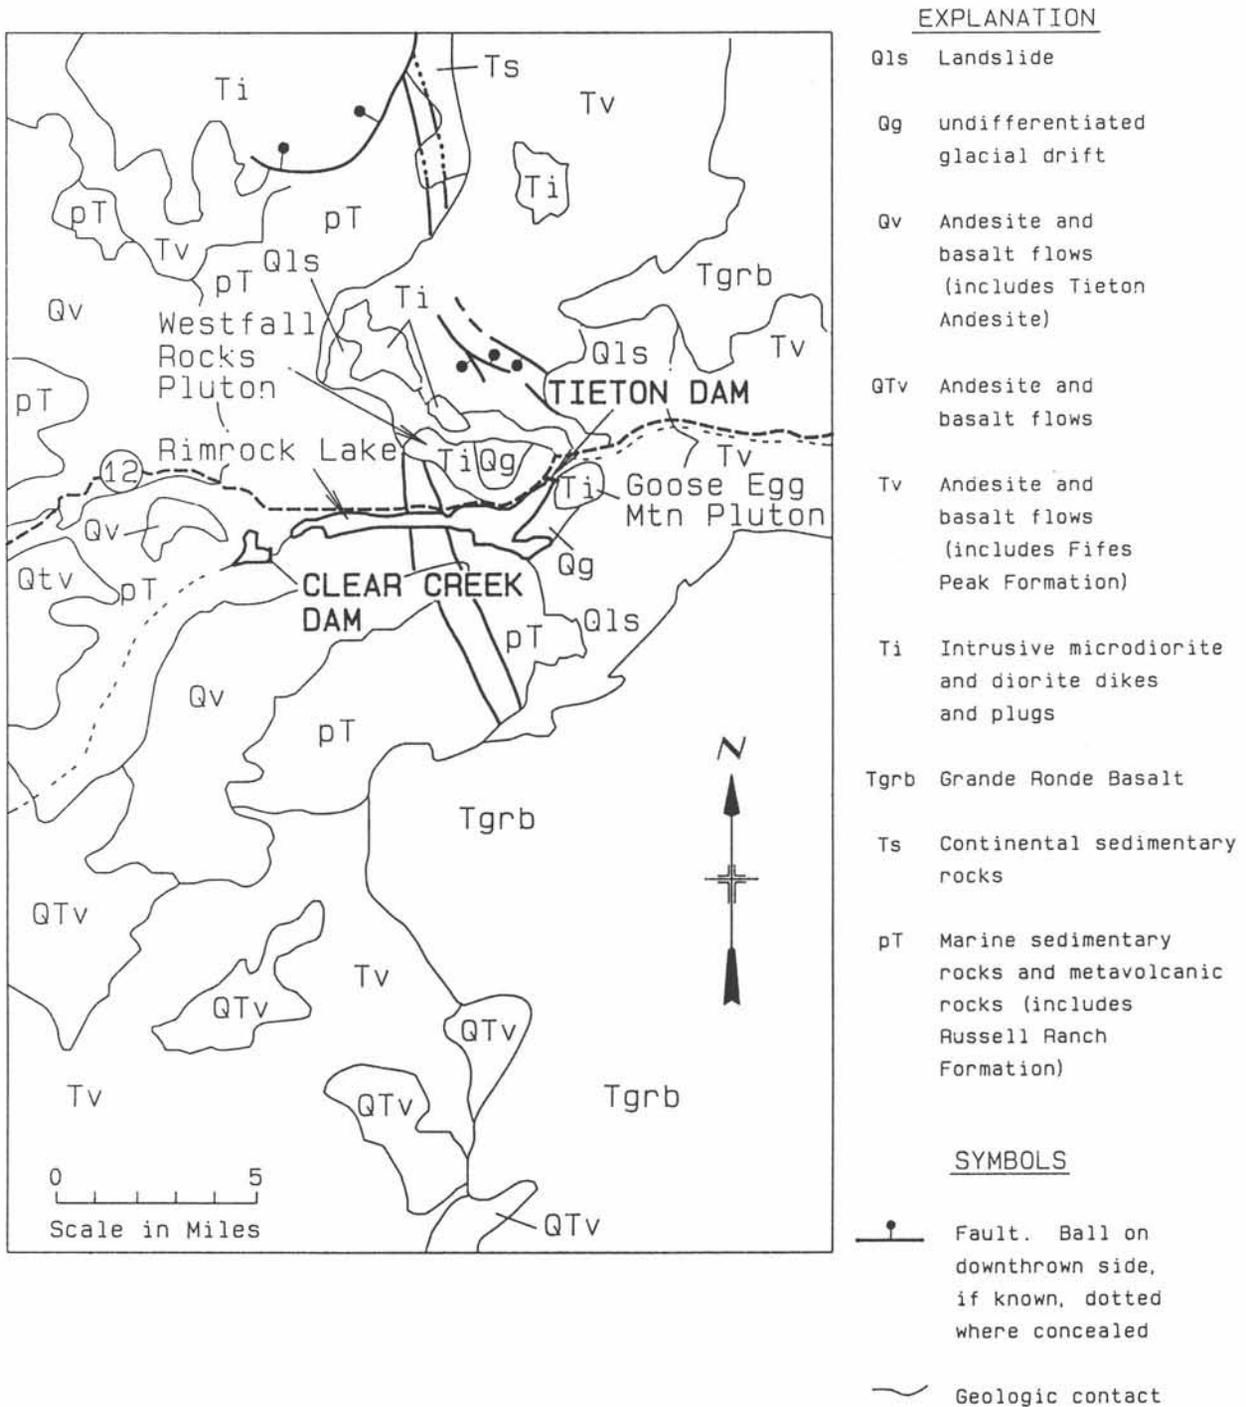
Figure 3. Generalized geologic map of the Clear Creek Dam and Clear Lake area. Adapted from Walsh et al. (1987).

The general area of Clear Lake reservoir consists of Cenozoic volcanic rocks and strongly deformed and metamorphosed, pre-Tertiary rocks of the Russell Ranch Formation (Figure 3). Argillite and feldspathic graywacke that represents a turbidite assemblage comprise the bulk of the formation. Also common are pre-Tertiary greenstone and lesser amounts of chert, chert-pebble conglomerate, and metatuff, all part of the Rimrock Lake inlier (Miller, 1985). The bedding is graded and, where undeformed, planar and continuous. Younger sediments unconformably overlie the Russell Ranch Formation (Swanson, 1978).

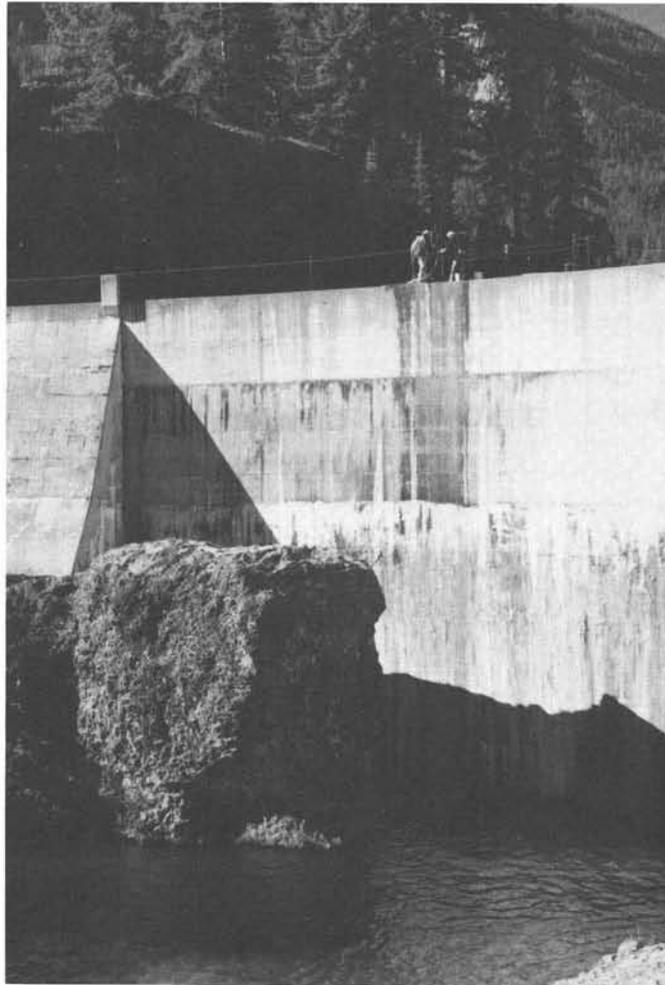
Diamond core hole drilling in September 1988 on the channel section of Clear Creek Dam. Drillers were using a portable drill motor to obtain NX-size samples for laboratory testing to determine the extent of concrete deterioration. The foundation rock exposed is greenstone. U.S. Bureau of Reclamation photograph.

In 1987 and 1988, concrete core samples were obtained to aid in determining the extent of any further deterioration of the structure at Clear Creek Dam. Approximately 216 ft of concrete core samples from five drill holes were examined. Core evidence indicates that bonding between the 1964 concrete and 1914-1918 concrete is excellent. Some seepage was noted in an unbonded lift line in the 1964 concrete about 10 ft below

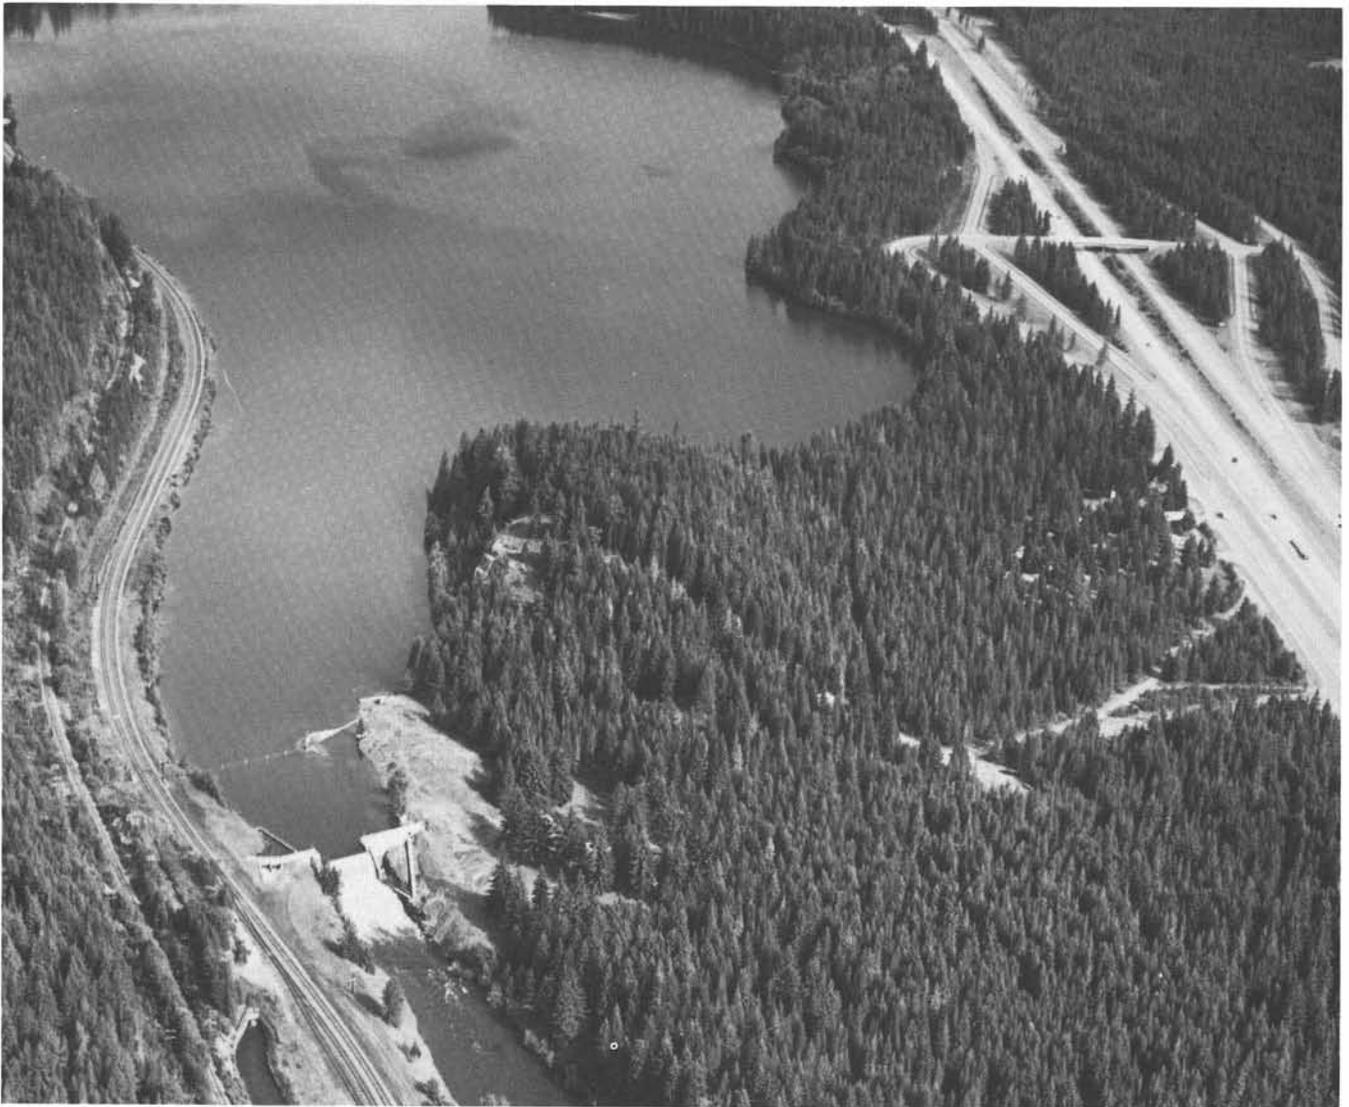
Figure 1. Aerial view upstream of the Easton Dam and Reservoir. Interstate Highway 90 is on right side of photo. The Kittitas Main Canal diverts from the dam through a tunnel beneath the railroad tracks (left). The rock exposed at the left and right abutments of dam is the Easton Schist. U.S. Bureau of Reclamation photograph, July 20, 1979.
