Rock Island Dam

RICHARD W. GALSTER
Consulting Engineering Geologist

PROJECT DESCRIPTION

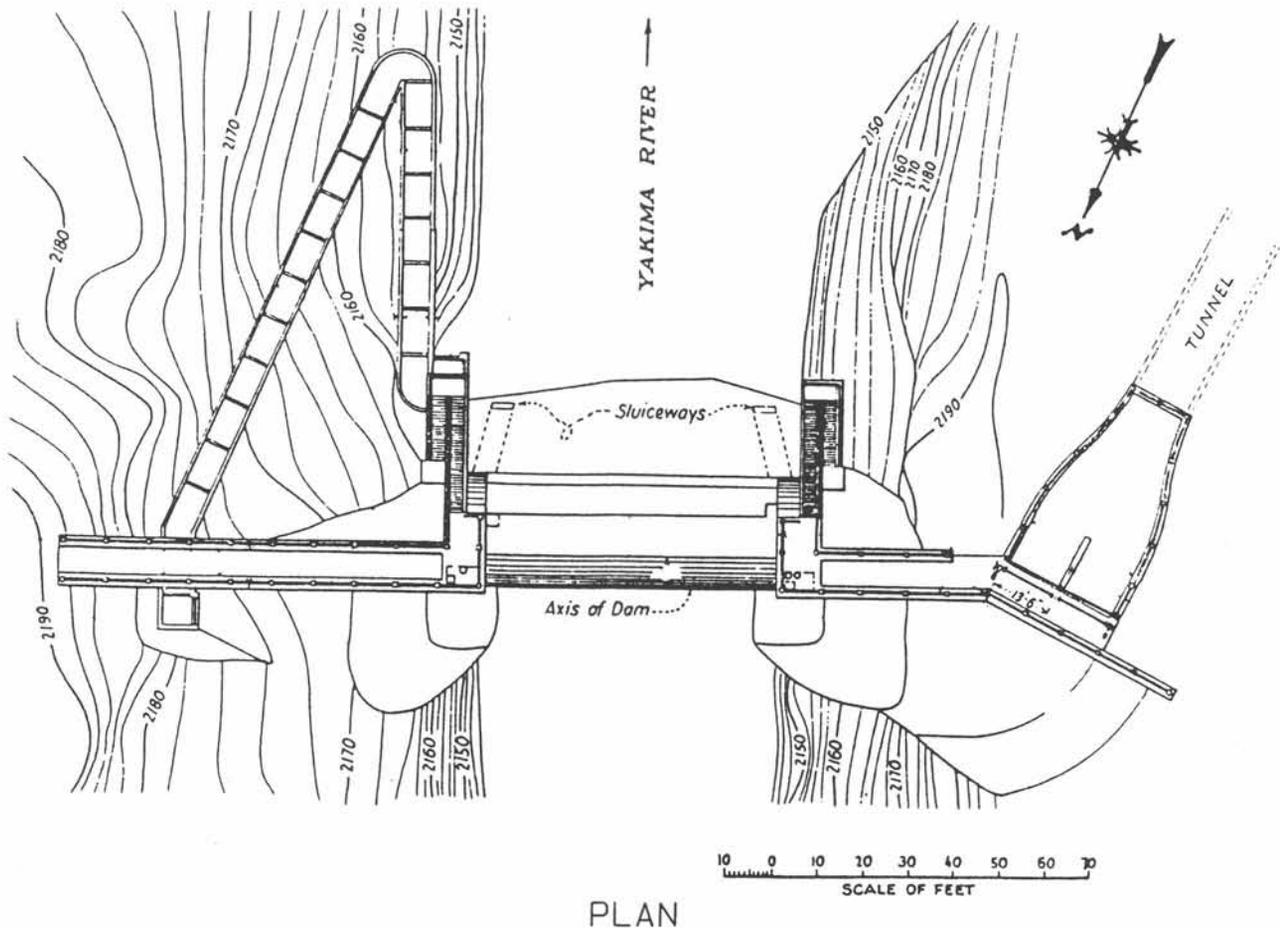
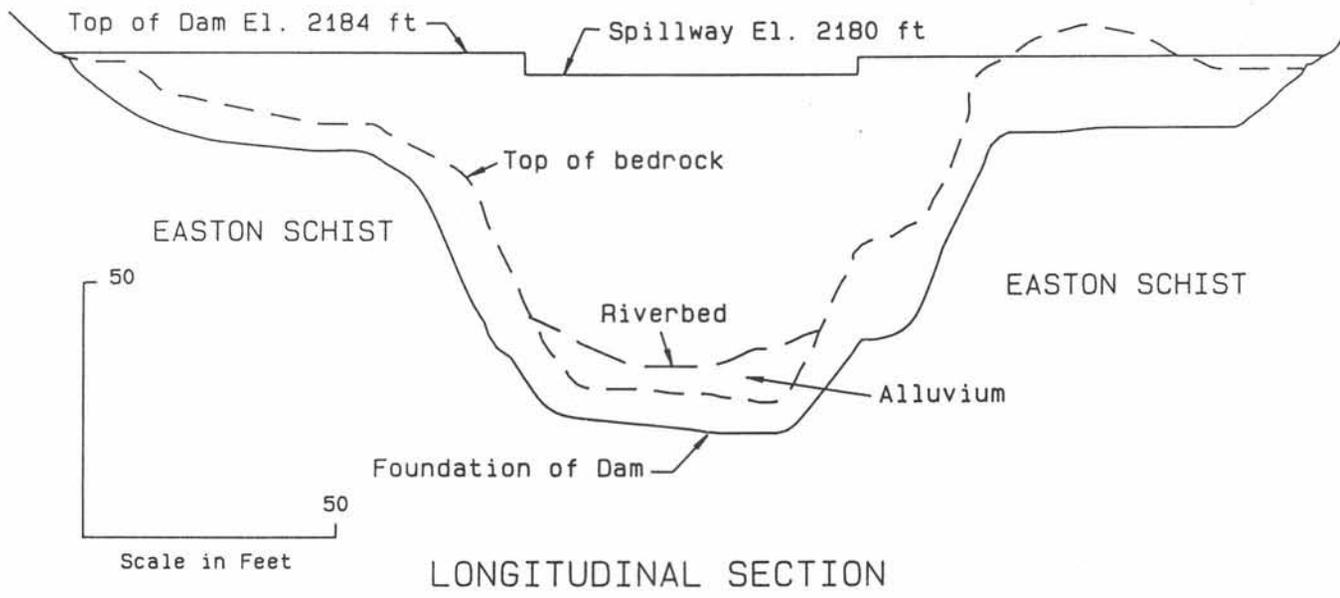
PLAN

LONGITUDINAL SECTION

Figure 2. Plan and longitudinal section of Easton Dam; view downstream. Plan view adapted from U.S. Bureau of Reclamation (1981).

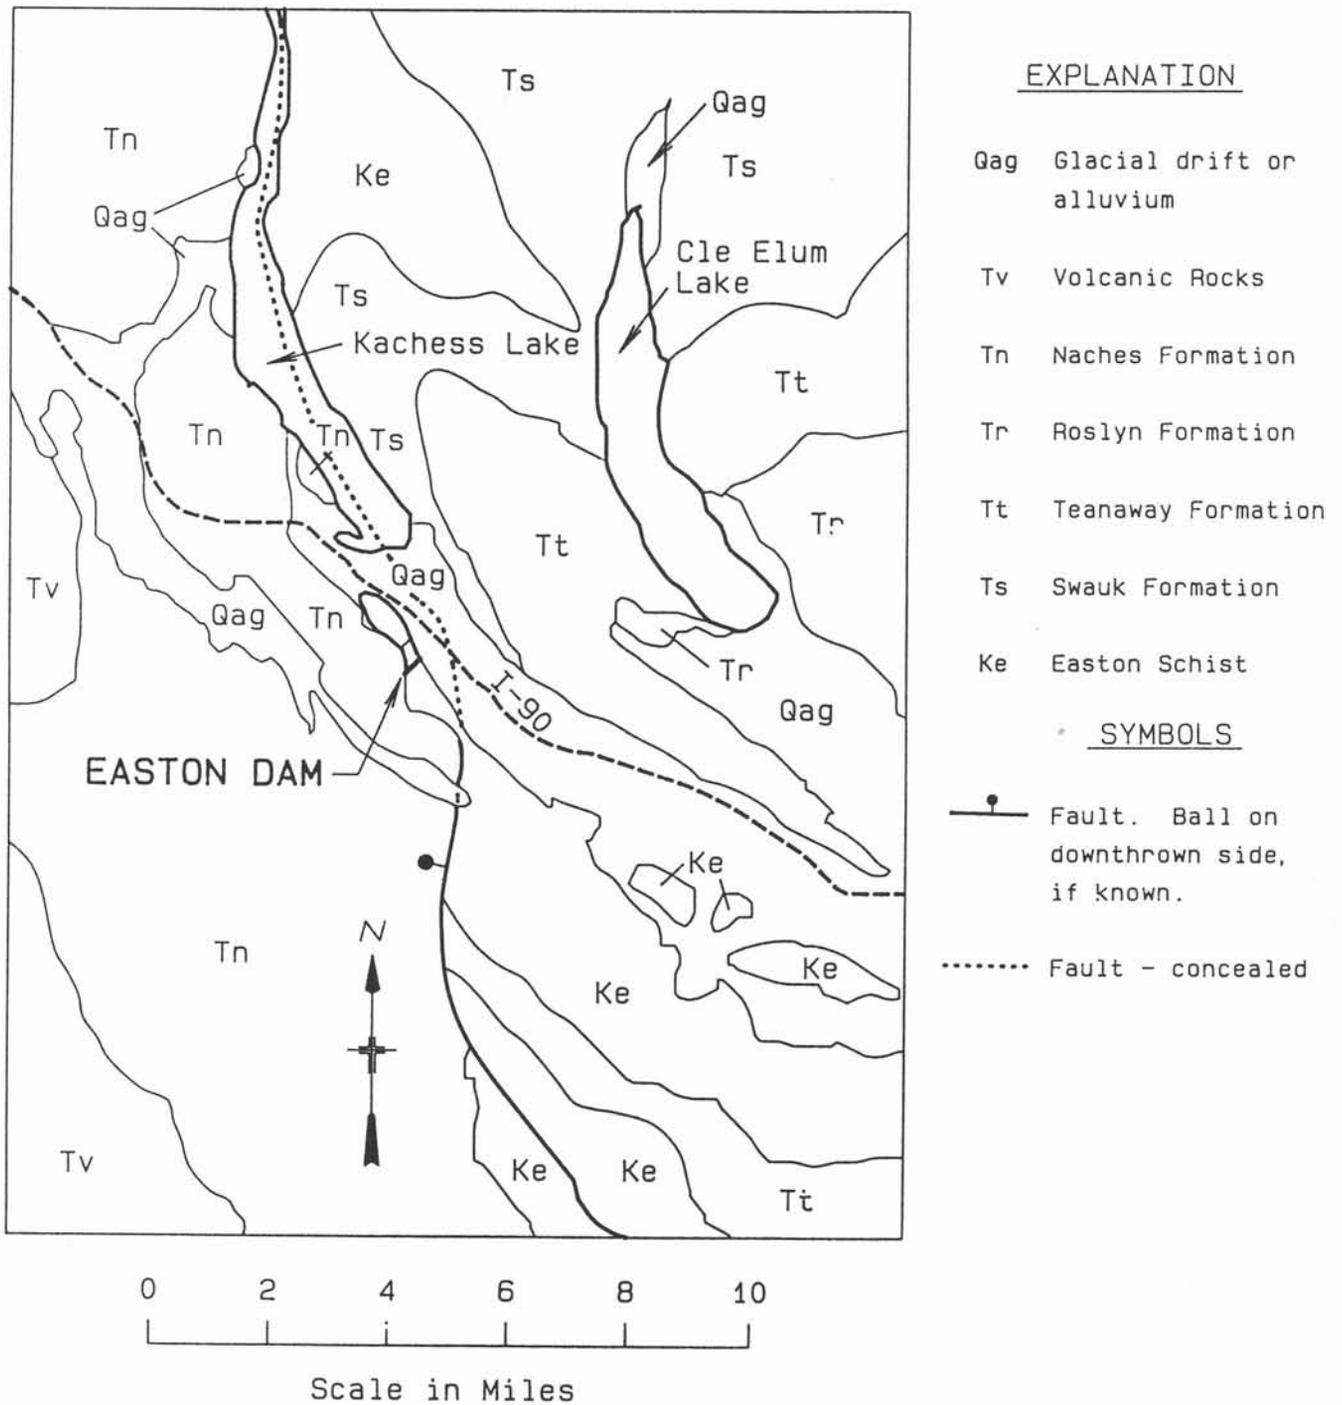
Figure 3. Generalized geologic map of the Easton Dam area. Adapted from Frizzell et al. (1984).

The bedrock for the dam and all the structure sites for the fish passage facilities is the Easton Schist (USBR, 1985a, b). The schist is exposed on both abutments of the dam and along the canyon walls for several hundred feet downstream from the dam.

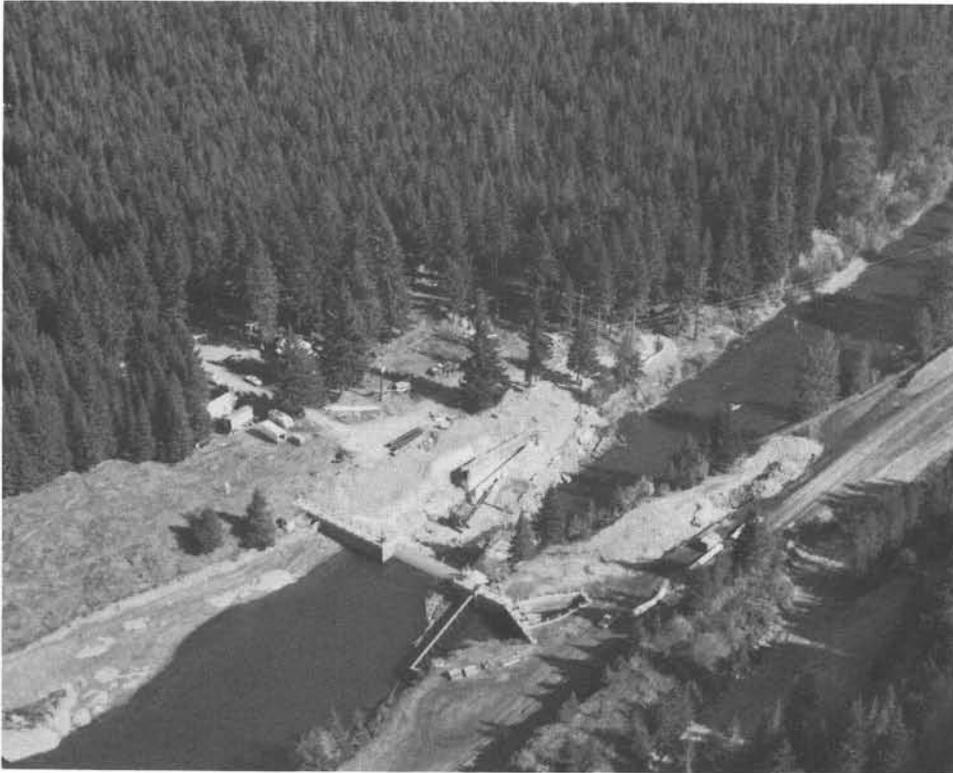
Aerial view downstream showing the construction of a new fish ladder on the left abutment of the Easton Diversion Dam. U.S. Bureau of Reclamation photograph, October 7, 1988.

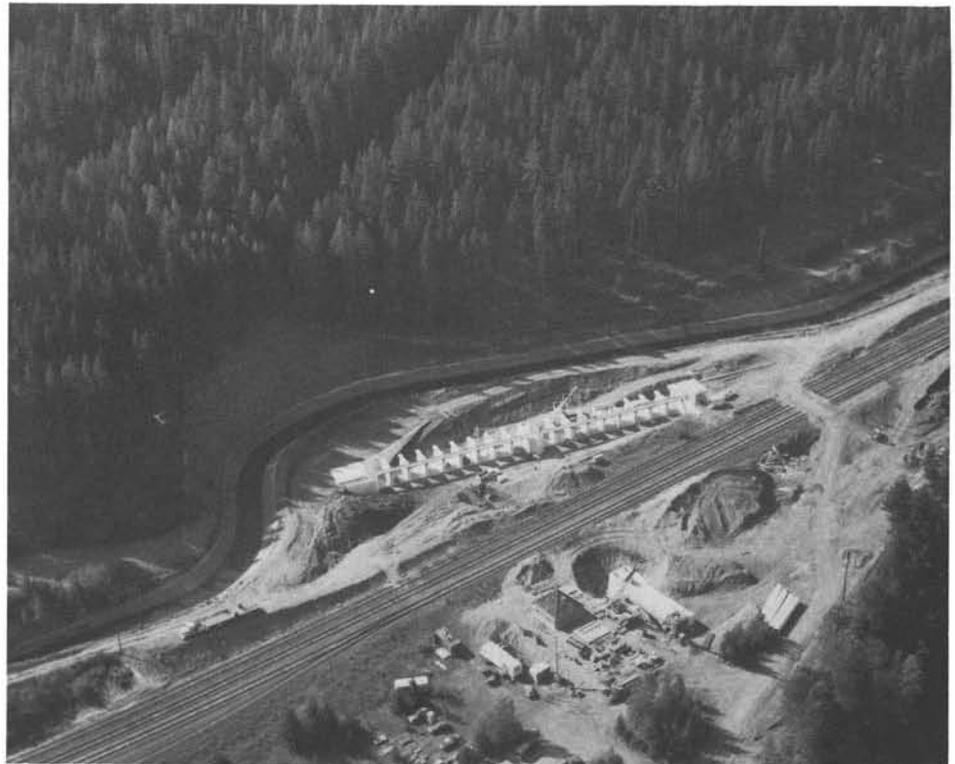
Aerial view showing the construction of the fish screen structure in Kittitas Canal just downstream of the right abutment of the Easton Diversion Dam. U.S. Bureau of Reclamation photograph, October 7, 1988.

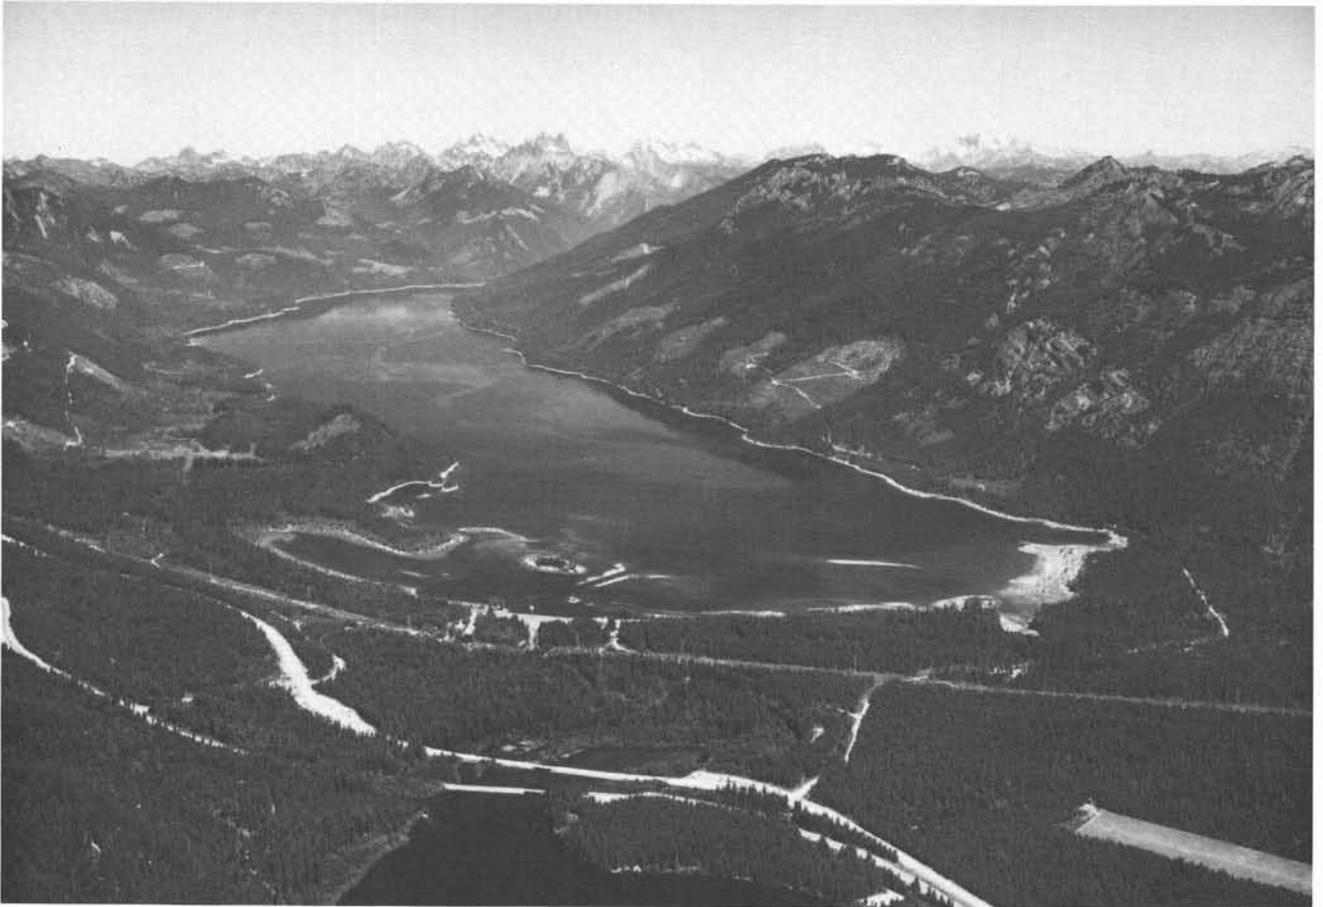
Figure 1. View to the northwest of Kachess Dam and Reservoir. The entire dam is situated on a terminal moraine that extends across the Kachess River valley. The dam restored the water level behind the moraine to near its pre-breach level. Rocks of the Easton Schist are exposed in the upper reservoir area with the Swauk Formation on the east of the reservoir and the Naches Formation along the west side. I-90, Interstate Highway 90. U.S. Bureau of Reclamation photograph, July 1968.

The entire foundation of the dam, including the abutments, is formed by the terminal moraine. Maximum thickness of the moraine at the dam can only be estimated, as most of the early test borings were placed in areas other than along the centerline of the dam on the crest of the moraine. Borings 500 to 700 ft upstream of the dam on the lower portion of the moraine and on both sides of the intake conduit encountered bedrock at depths ranging from 50 to 87 ft. Bedrock was not encountered at either abutment or at any location throughout the length of the dam. Excavations for the cut-off trench and the core wall trench, as well as exploratory test pits, indicated that much of the moraine contains sufficient fine-grained material to be relatively

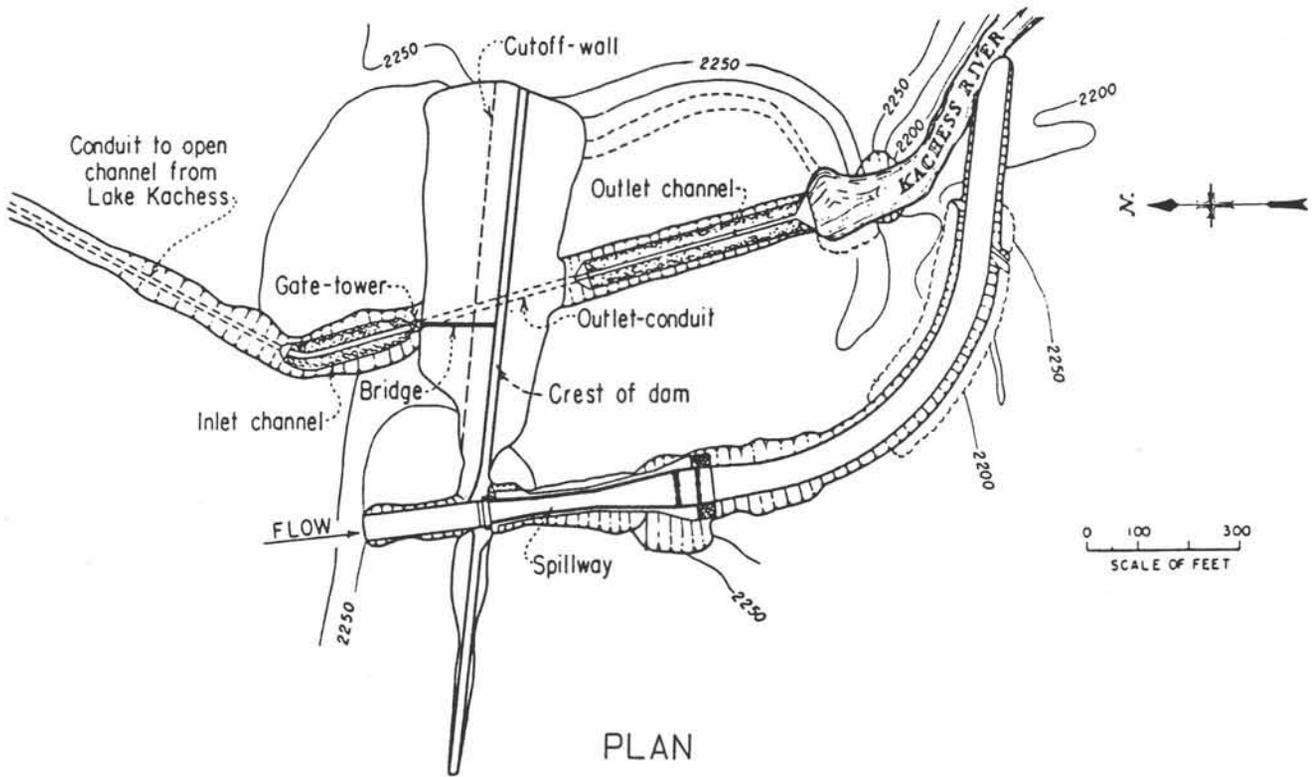
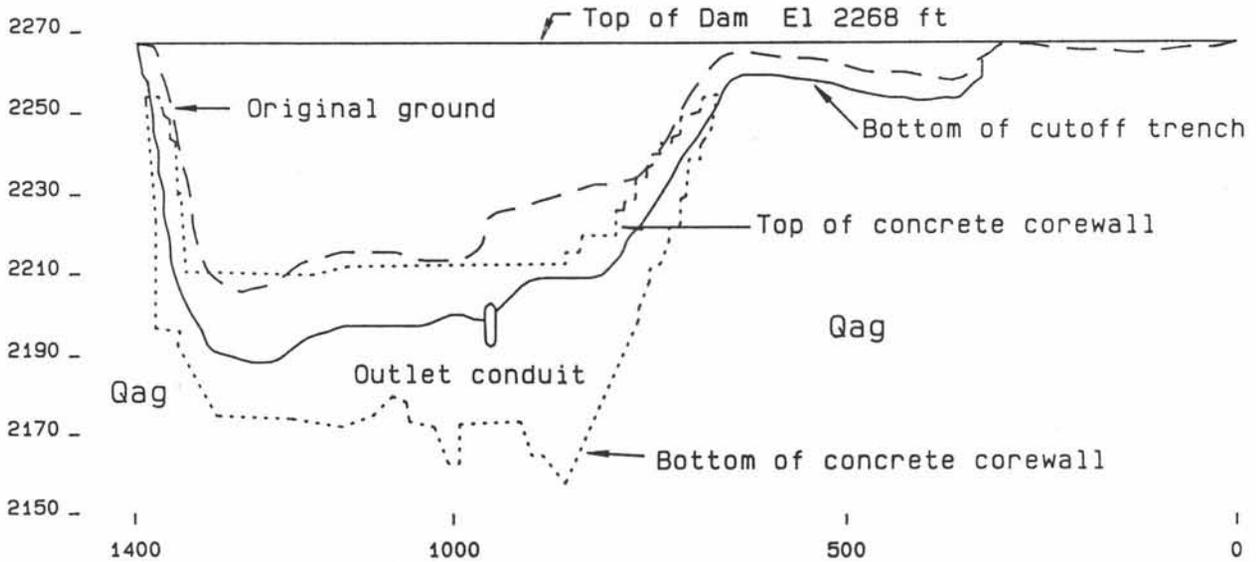
PLAN

LONGITUDINAL SECTION

Figure 2. Plan and longitudinal section, Kachess Dam; plan view adapted from U.S. Bureau of Reclamation (1981). See Figure 3 for explanation of symbols.

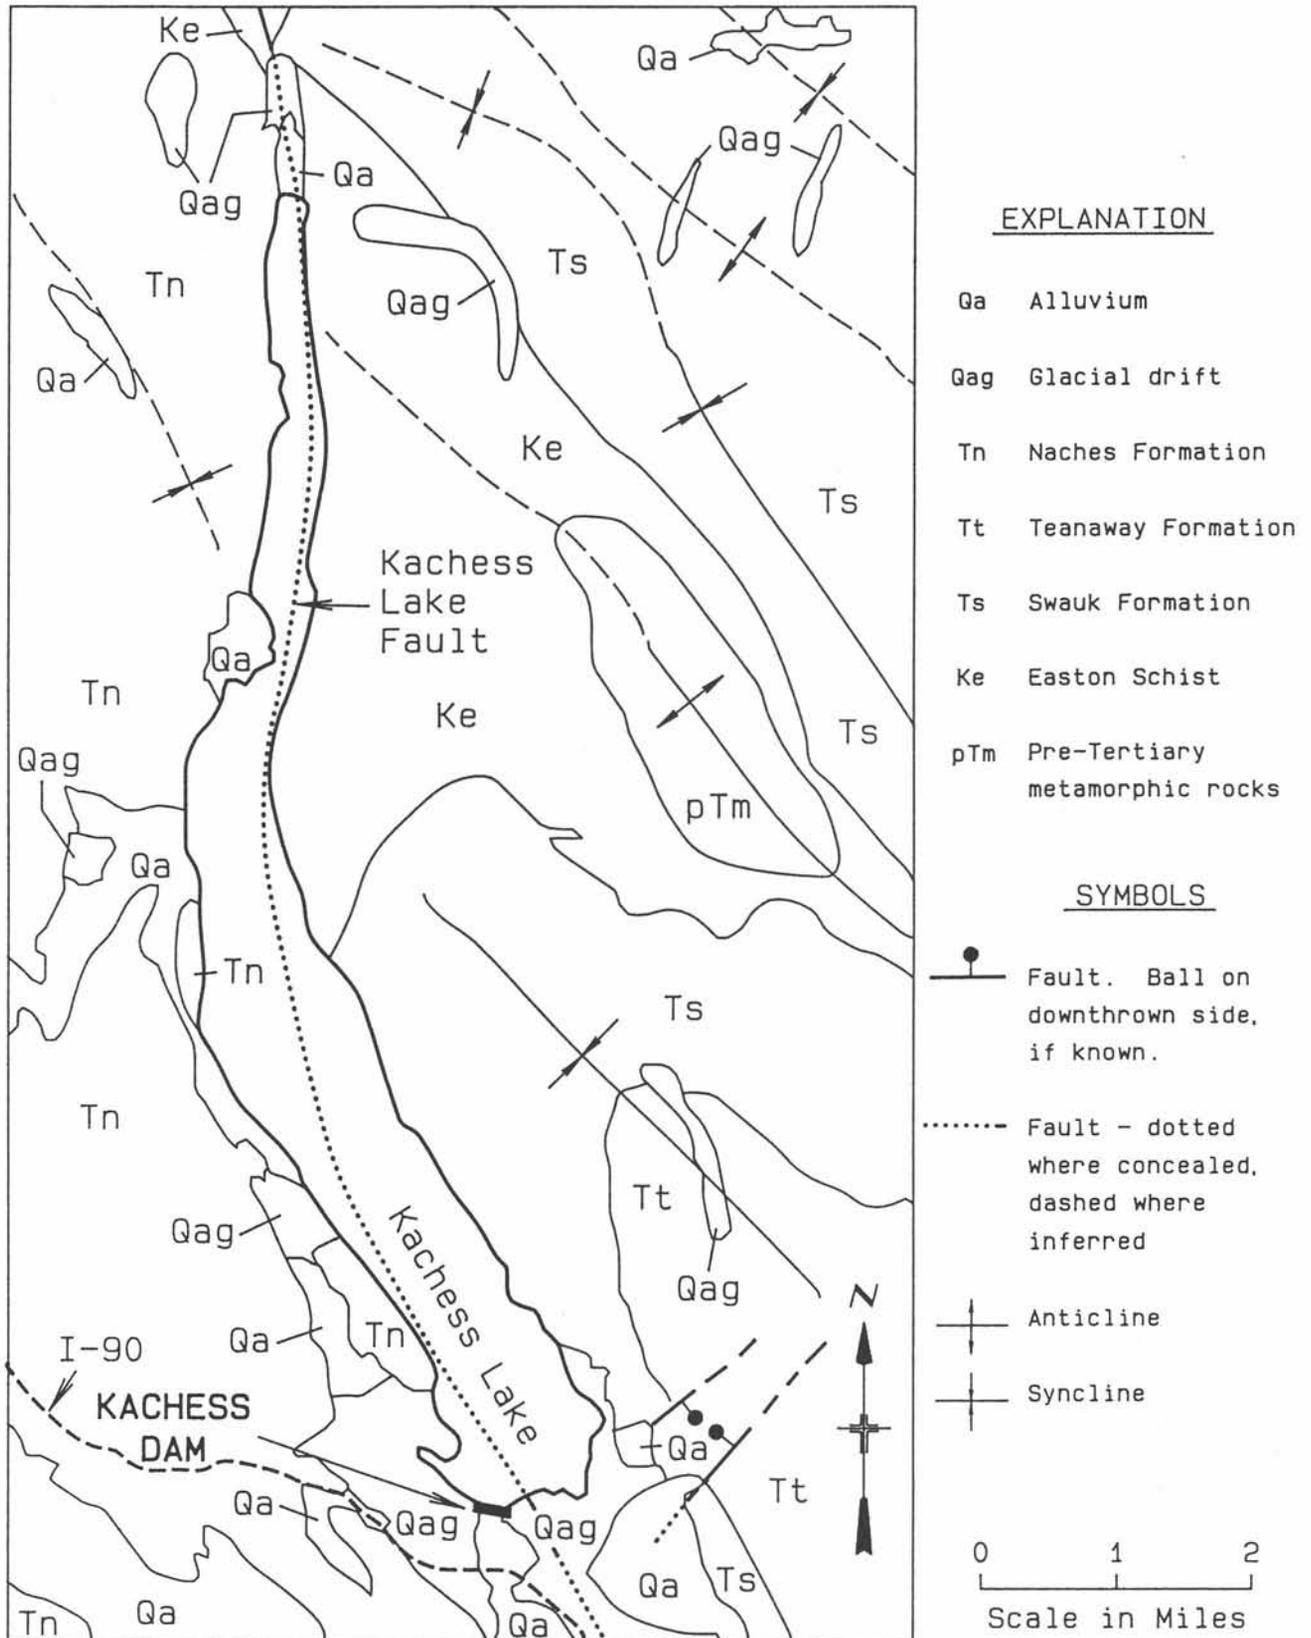
Figure 3. Generalized geologic map of the Kachess Dam area. Adapted from Frizzell et al. (1984).

Several normal faults are known in the immediate area of Kachess Dam and Reservoir. The largest, most significant of these is the Kachess Lake fault, which trends north-northwest through the Kachess River valley (Figure 3). The Kachess Lake fault is thought to be the southernmost segment of the Straight Creek fault zone, a major structure extending south from Canada into Washington State (Piety, 1986). Two northeast-trending faults, the Swan Lake and Lodge Creek, have been mapped on Kachess Ridge east of the reservoir (USBR, 1987). Each is less than 5 mi. long, and both offset the Swauk and Teanaway formations (Figure 3).

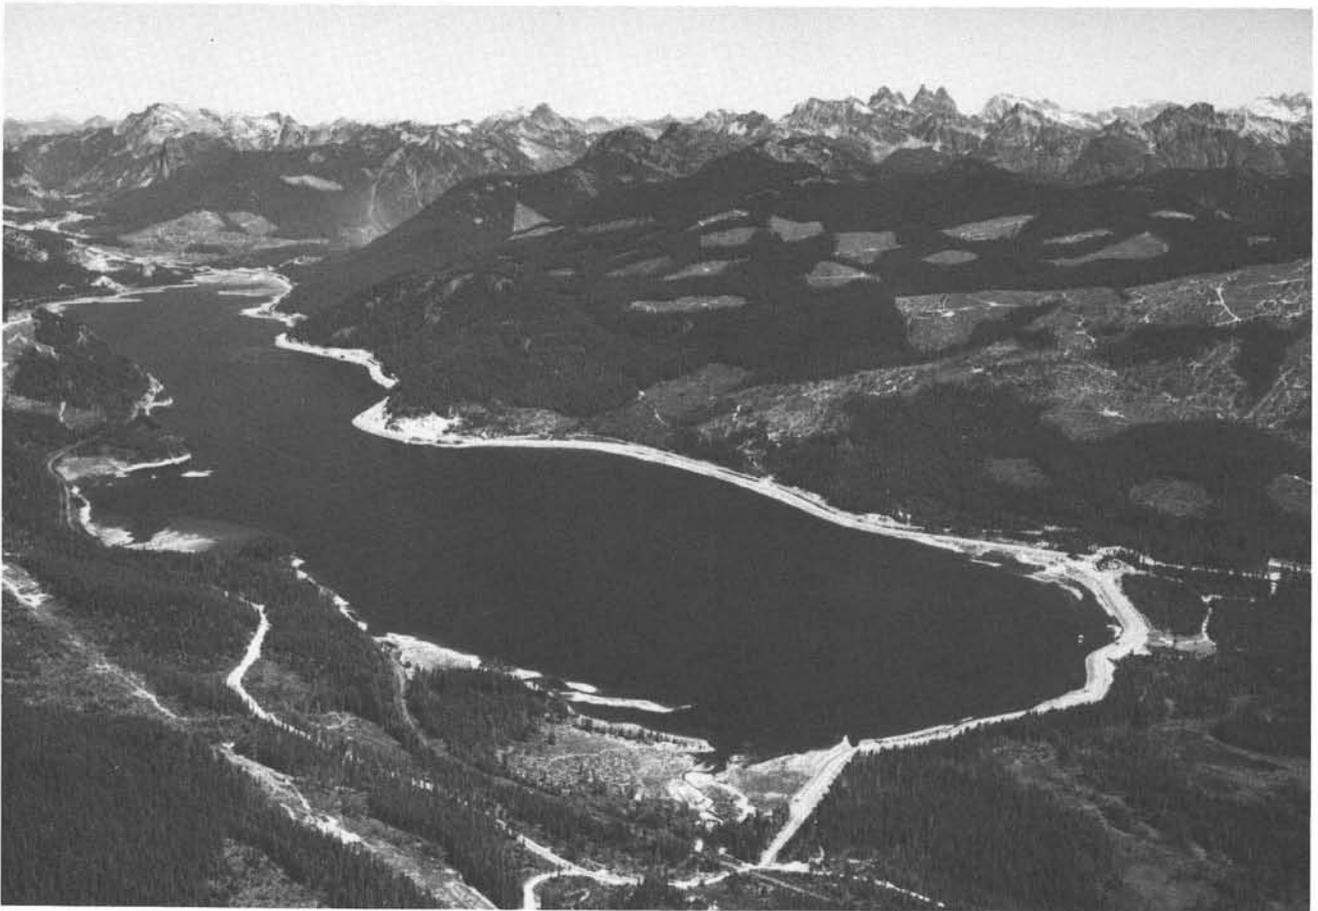
Figure 1. Aerial view to the north of Keechelus Dam and Reservoir. The dam was constructed on a prominent glacial moraine of Lakedale Drift. Much of the embankment was placed as sliver sections mantled against the upstream side of the moraine. Interstate Highway 90 parallels the east rim of Lake Keechelus. U.S. Bureau of Reclamation photograph, July 30, 1968.

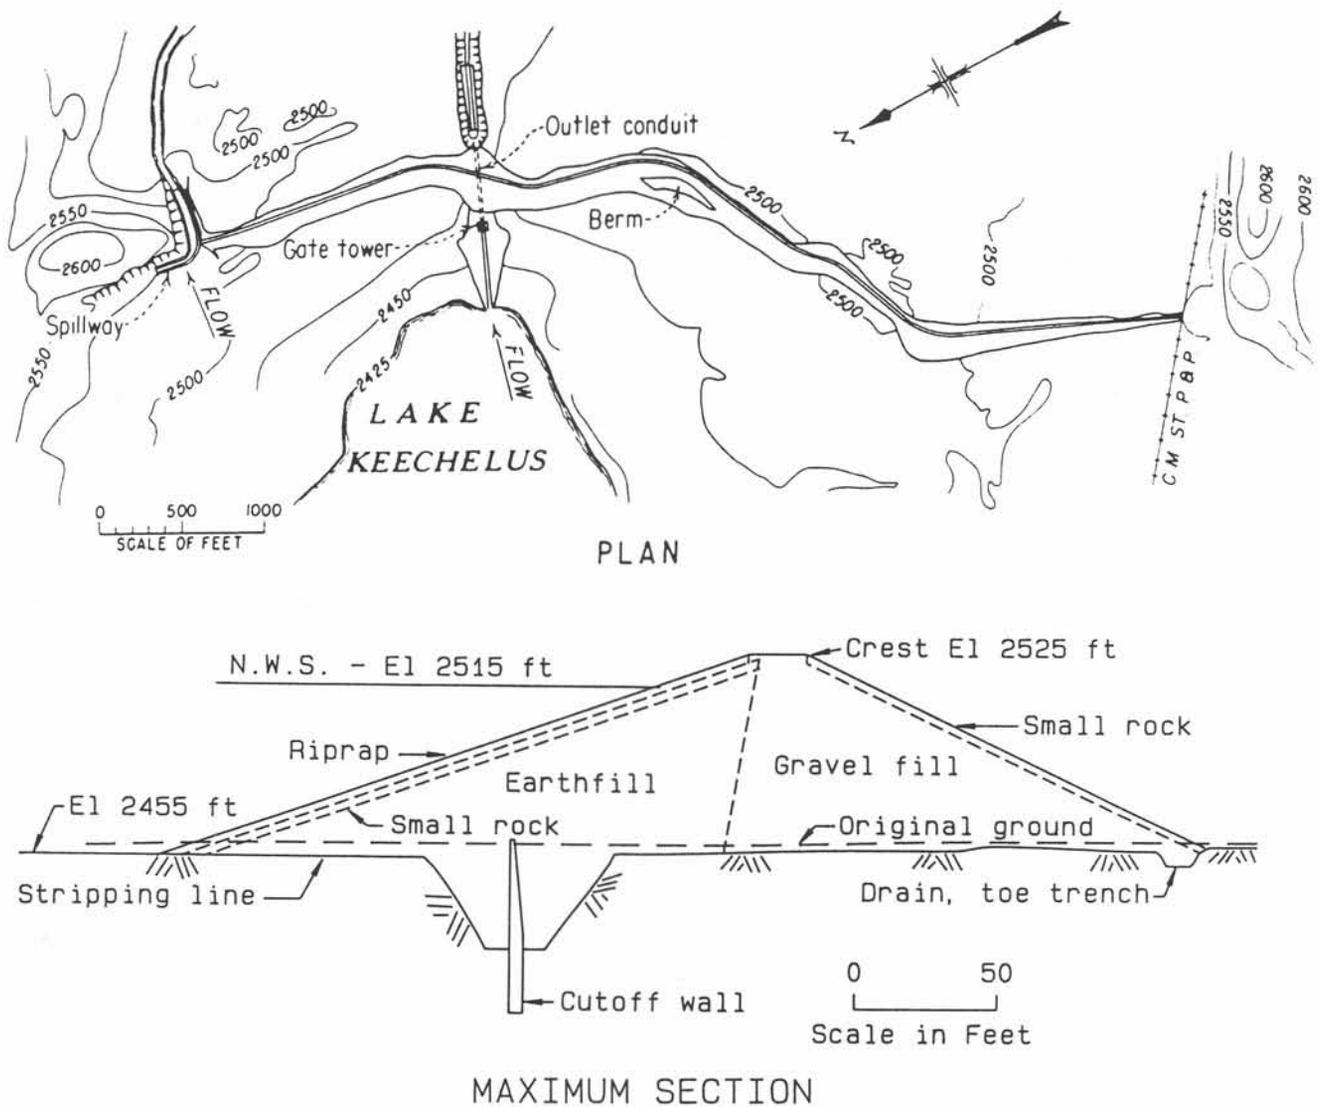
Figure 2. Plan and section of Keechelus Dam. Adapted from U.S. Bureau of Reclamation (1981).

rock/glacial material contact drops rapidly to the south. No attempt was made to determine the depth of bedrock across the valley floor. The results of the explorations showed the moraine to be suitable for the foundation of Keechelus Dam. Apparently, it was determined that the drift was largely impervious, and major, potentially pervious interbeds would be cut off with the cut-off trench and planned core wall (Figure 2).

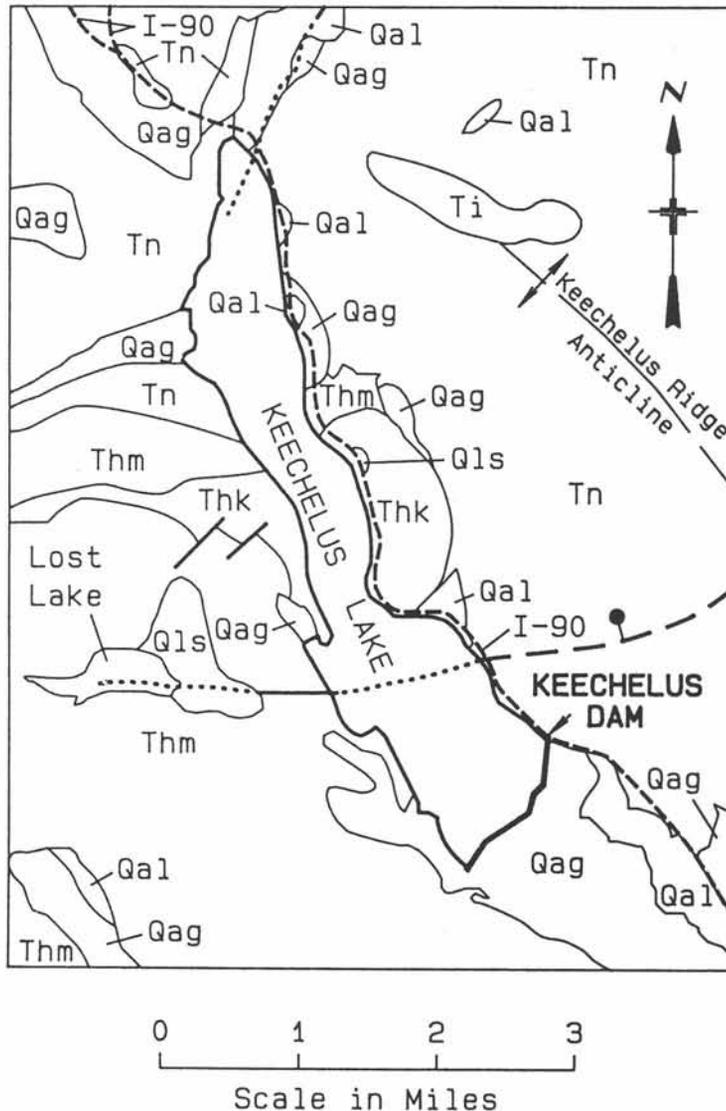
Figure 3. Generalized geologic map of the Keechelus Dam area. Adapted from Frizzell et al. (1984).

Essentially, two major bedrock assemblages bound the reservoir. The oldest is the Naches Formation (Frizell et al., 1984) of Eocene age, consisting predominantly of rhyolite, andesite, and basalt flows, tuffs, and breccias with interbedded sandstone, siltstone, shale, conglomerate, and some coal seams. This unit occurs predominantly along the east and northwest rims of the reservoir (Figure 3). Lightly to moderately jointed vol-

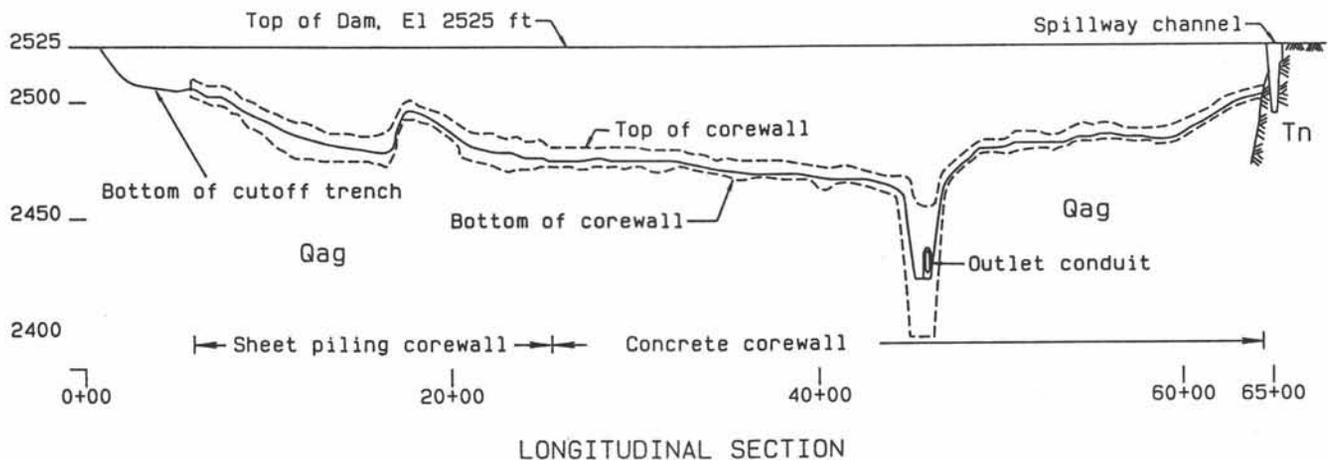
Figure 4. Longitudinal section of Keechelus Dam. Adapted from USRS (1915)

Construction details of the core wall are lacking. Design drawings indicate that, for its entire length, it is founded on practically impervious gravelly clay (Figure 4). Whether the core wall was constructed beneath the total length of the dam is unknown. Also, the record is unclear as to the total depth or lowest elevation to which the core wall was extended (USBR, 1982).

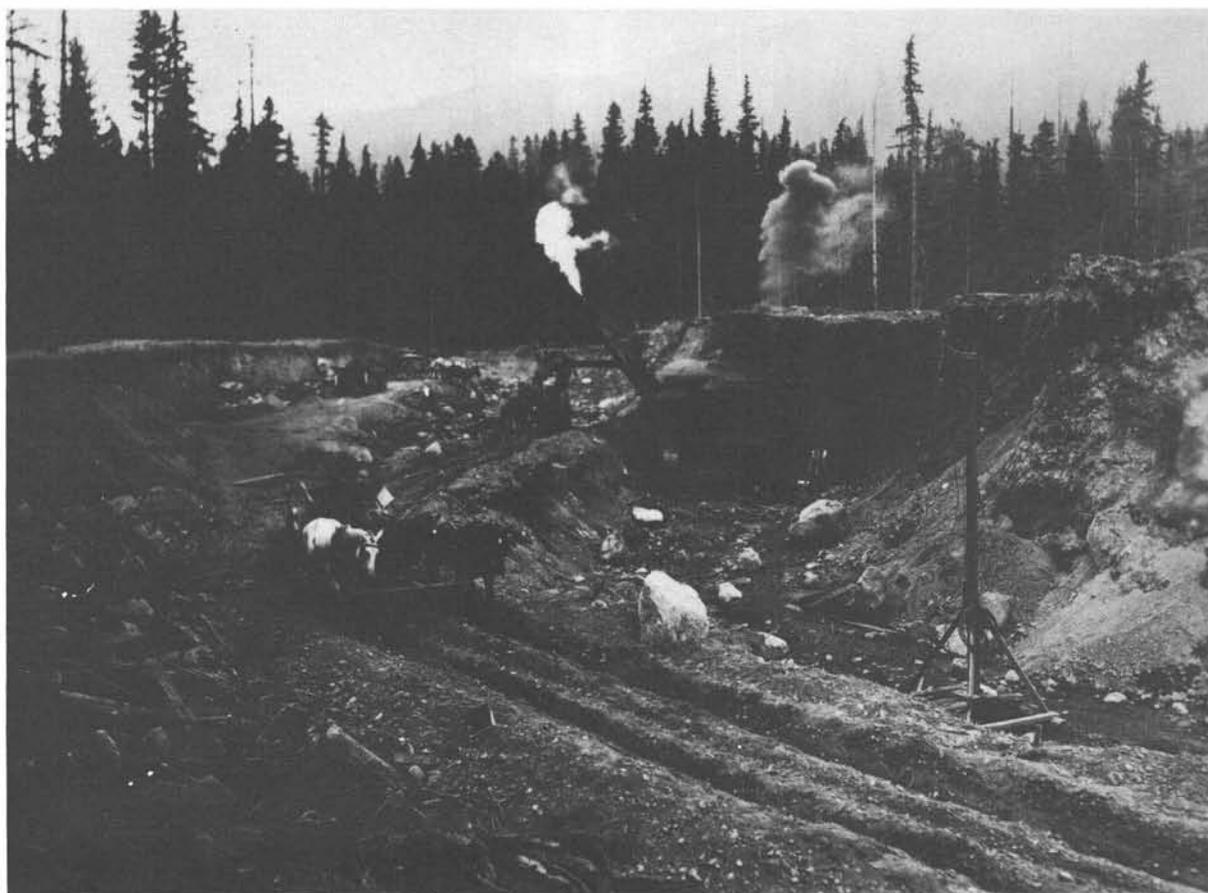
A Marion 35-ton shovel at work excavating the east borrow pit at Keechelus Dam. Materials were loaded on horse-drawn dump wagons. The pit was shot ahead of the shovel because of the presence of boulders. A cyclone well drill was used to put down the holes; later, coyote holes were used. Because most of the material in the area was wet, corduroy or planked roads were commonly used. U.S. Bureau of Reclamation photograph, July 24, 1916.

Test pit records indicate that high water-table conditions occurred within the borrow pits (USRS, 1912, 1916). The high moisture content of the material and the presence of free water required special handling and excavation techniques. For example, at the East borrow pit, the ground was so wet that it was impossible to load the drill holes with black powder, and the low-grade dynamite used was not nearly so efficient. "Coyote" holes were utilized effectively. Irregular holes were

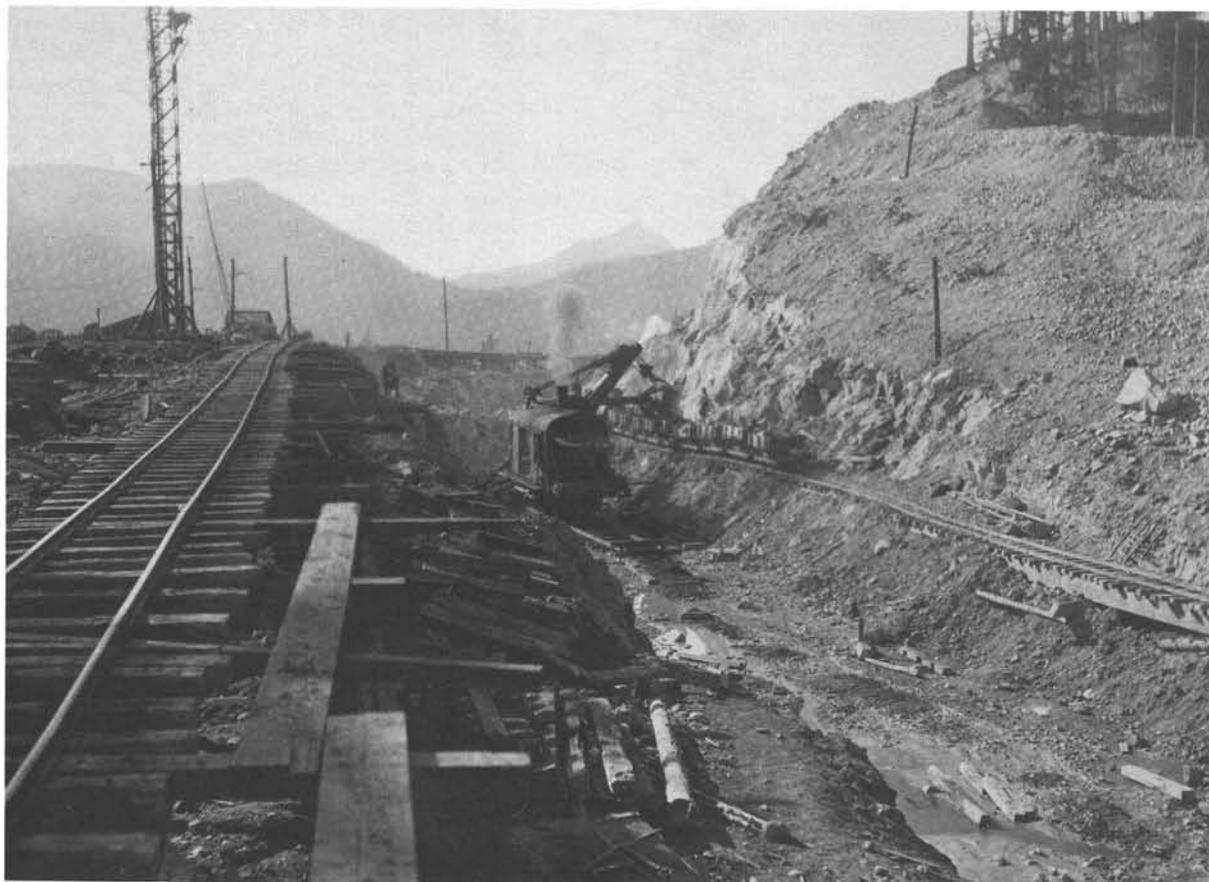
Steam shovel loading riprap-size shot rock into rail cars. This view, to the west, shows the base-level excavation in the spillway channel at Keechelus Dam. U.S. Bureau of Reclamation photograph, September 29, 1916.

Most of the spillway construction required rock excavation. Two 3-in. Woods air drills and two jack-hammer drills were used on two- and three-shift schedules. The more portable jack hammers were used for trimming rock highs and breaking up large, lightly jointed masses of rock. Most of the shot holes were from 8 to 12 ft in depth and were spaced about one-half their depth apart. Usually from 60 to 120 holes were shot at once, as it was found that the more holes were shot the less danger of losing holes near the edges of the blasting areas (USRS, 1916). Most of the small rock facing on the dam and the upstream riprap was obtained from the spillway excavation.
