ENGINEERING GEOLOGY IN WASHINGTON

Volume II

BULLETIN 78

Runoff and Stream-Channel Changes Following Urbanization in King County, Washington

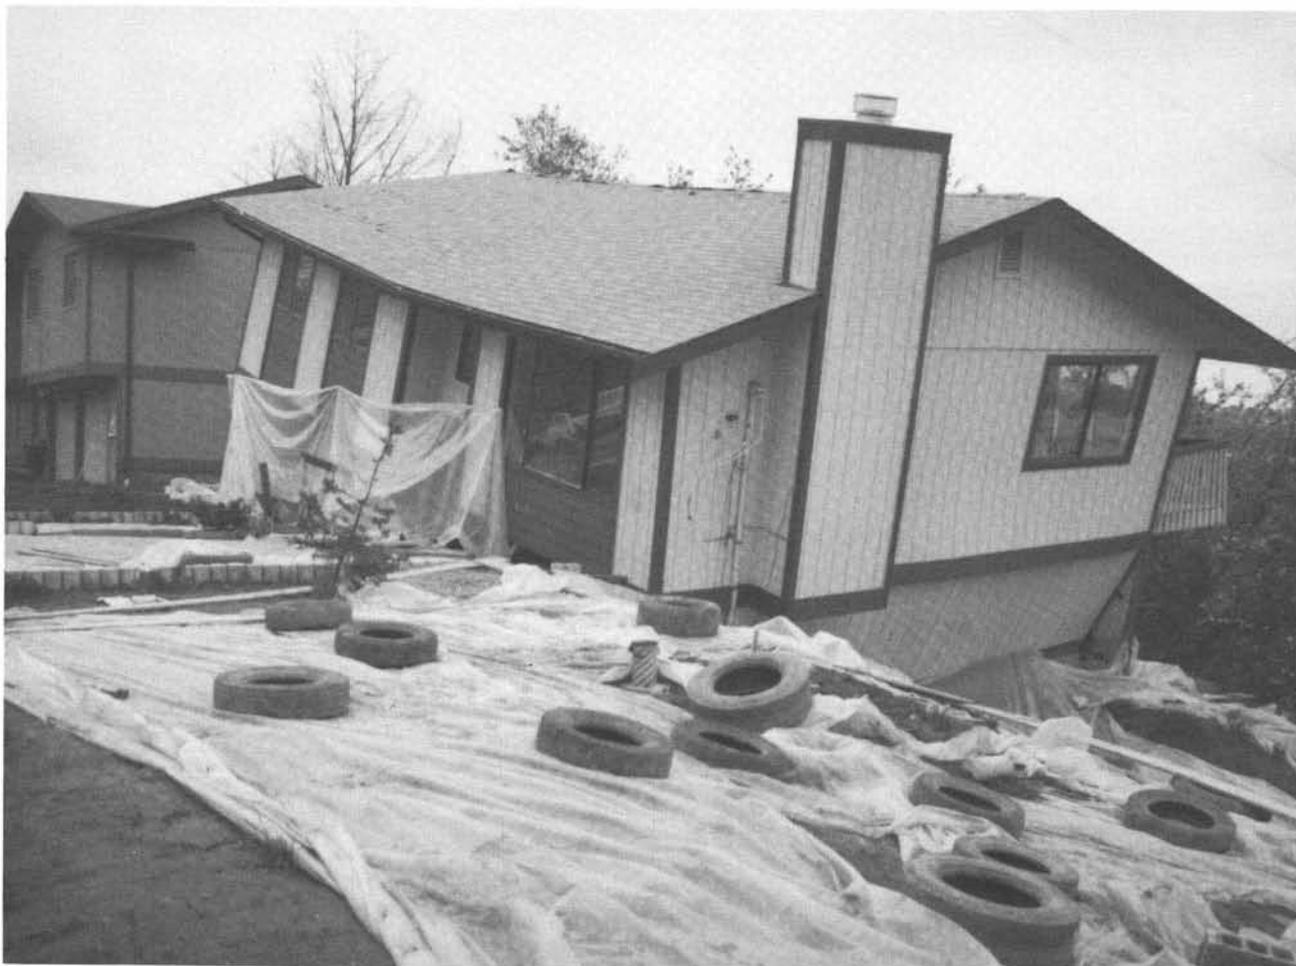
West Seattle residence damaged by a landslide. Photograph by William Evans, 1986.

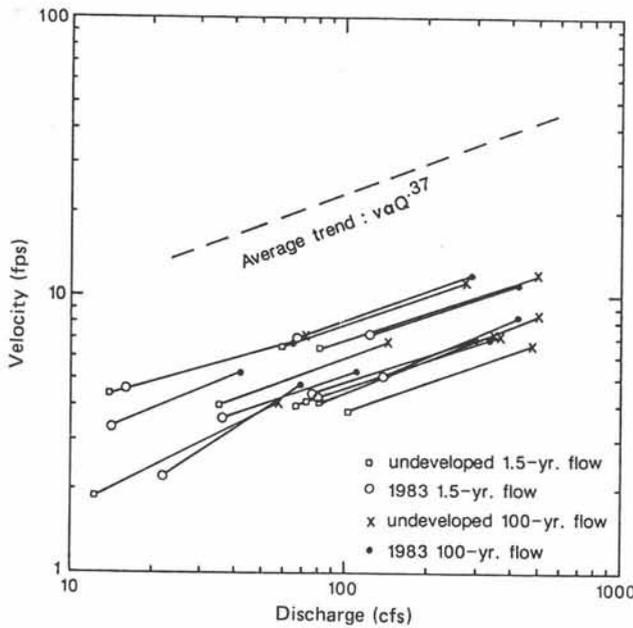
Figure 2. At-a-station changes in discharge and velocity for 1.5-yr and 100-yr flows in 18 subcatchments in Coal Creek (King County, 1987) under both developed and undeveloped conditions. Lines connect flood peaks measured at the same gaging point. Assuming channel width is proportional to $Q^{0.1}$ (Dunne and Leopold, 1978), the channel depth should vary with about $Q^{0.5}$.

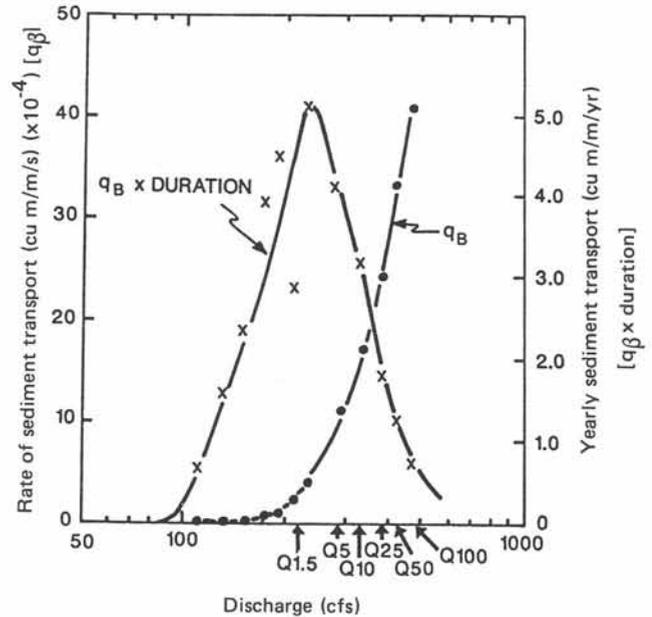
Figure 3. Bedload transport, calculated by the method of Parker and others (1982), for several flood discharges at the Upper Soos Creek gage. Both instantaneous sediment discharges (volume per unit width per unit time) and yearly cumulative sediment discharges are shown. Durations of multi-year flows are scaled proportional to the duration of $Q_{1.5}$, with assumed discharge of 220 cfs.

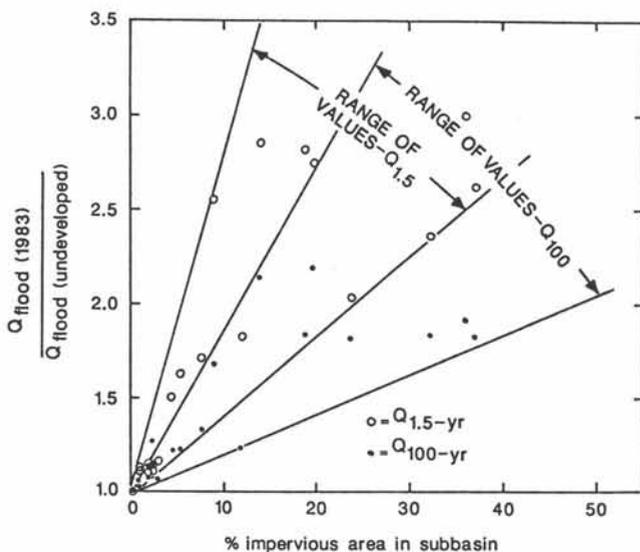
Figure 4. Change in flood peaks with increased impervious area, plotted as the ratio of existing (1983) to undeveloped-basin flood peaks for 1.5-yr and 100-yr flows for 20 subcatchments in the Coal Creek basin.

The third, most widely recognized impact of drainage-basin development is the increase in peak discharge at the basin outlet, commonly expressed by the increase in discharge for floods of a given return frequency. The change is well demonstrated by Coal Creek model output for the (simulated) undeveloped state and the (gaged and simulated) 1983, partly developed basin (King County, 1987). In Figure 4, the 1983 1.5-yr and 100-yr peak discharges from subbasins ranging from 0.3 to 18 sq km (80 to 4,500 acres), expressed as a proportion of their predevelopment peaks, are plotted against the basin area covered by impervious surface area. The correlation between development and increased discharge is irregular but nonetheless obvious.

The progressive effects of development may be partly quantified. Although no discrete threshold is suggested by Figure 4 (in contrast to Morisawa and LaFlure, 1979, figure 11), subbasins where the impervious areas exceed 20 percent experience nearly doubled 100-yr flows, and 1.5-yr flows average perhaps 2 1/2 times greater, than in the predeveloped condition. (Typical suburban development has about 35 percent impervious area.) This 2 1/2-fold discharge increase may transport up to ten times more sediment than in the predeveloped state (refer to Figure 3). The 100-yr flow (and presumably intermediate events) will transport proportionally less sediment over time, so the dominance of the more frequent flood stages on long-term sediment transport will be enhanced. Finally, because 1- to 2-yr floods typically correspond with bankfull stage, the new channel should eventually adjust to accommodate about twice or more the undeveloped discharge.

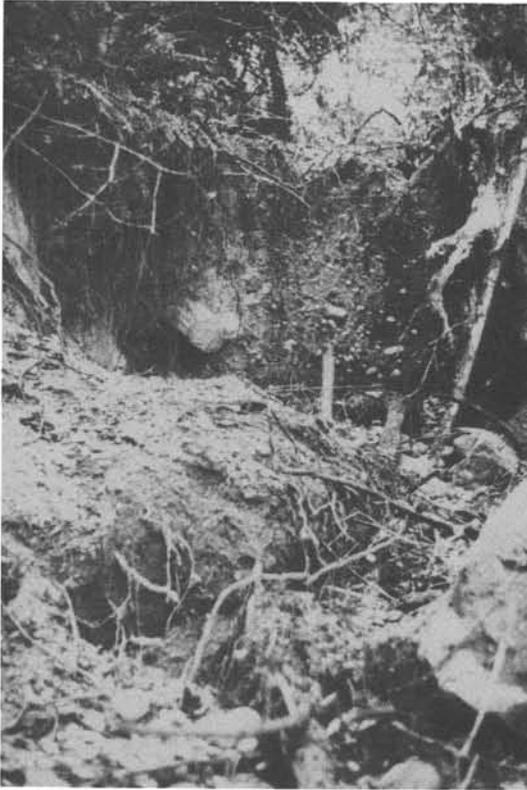
6a

Figure 6. Stream incision in the Snoqualmie River valley sidewalls. 6a, Upper channel. Low-gradient upstream channel terminates abruptly at headwall. Flow is directly towards camera. 6b, Headwall of lower channel reach. Only the upper one-third of the headwall is included in this picture. 6c, View vertically down and downstream from the top of the headwall (viewed from the location of the hat in Figure 6b).

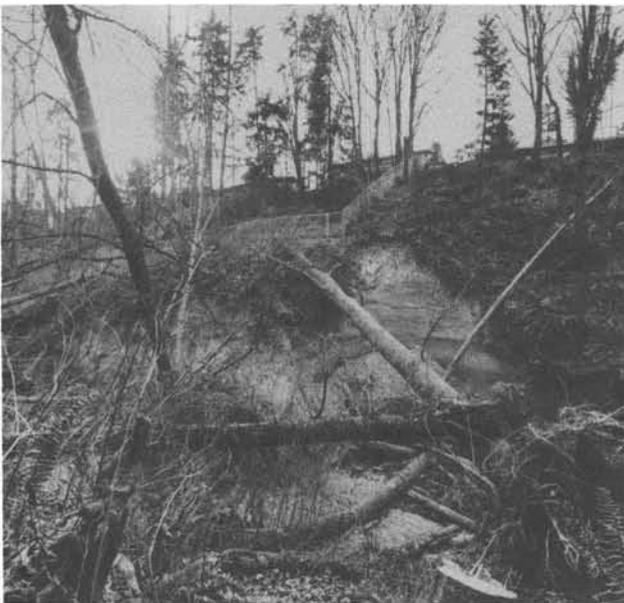
Figure 7. Gully incision along the Newport Hills tributary to Coal Creek.

As the intensity of uncontrolled development increases, the rate and magnitude of stream-channel impacts may also increase. Although nowhere in King County are erosive sand deposits exposed as thickly and steeply as above the Snoqualmie River, elsewhere in the county these deposits are located where more intensive urbanization has already occurred during an era when no drainage controls were required for development. One such locality is the "Newport Hills Tributary" to Coal Creek, a stream that descends from till-covered uplands into the Lake Washington trough (Figure 5). Along this particular tributary, years of uncontrolled discharge eroded a canyon that not only mobilized very large volumes of sediment but also had initiated severe sideslope landslides (Figure 7). Incision of as much as 10 m has occurred over about 20 yr, involving 1,000 m of

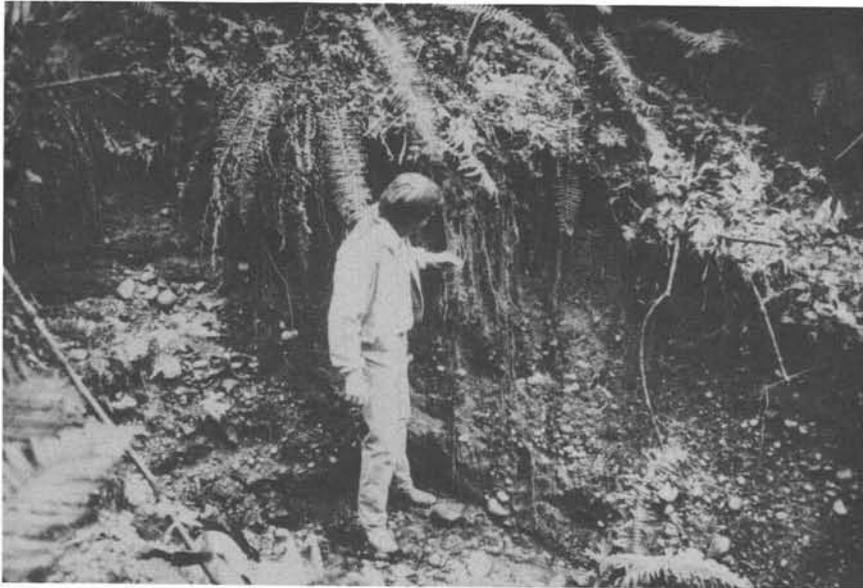
**a**

Figure 8. Stream incision off the East Lake Sammamish plateau.

8a, Recent incision into hillslope colluvium. Flow is from left to right; average stream channel gradient about 15 percent.

Incision on the main stream now averaged 1 m below the junction and locally exceeded 2 m (Figure 8a). An 18-in. culvert clogged and washed out in late 1986 near the base of the slope, where eroded sediment begins to drop out as the slope gradient decreases (Figure 8b). Two additional private culverts and a state highway remain in the path of the runoff and its sediment load.

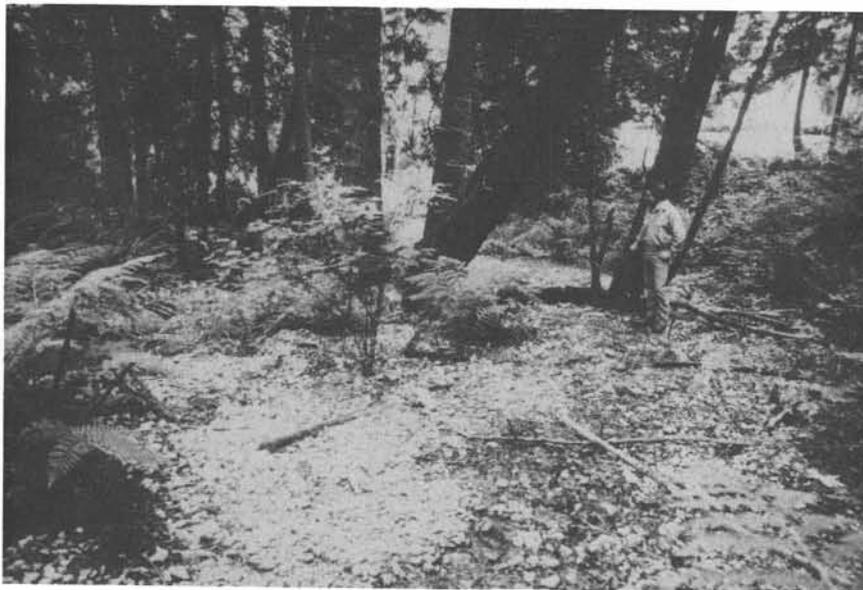
**b**

8b, Depositional fan just upstream of washed-out culvert. Aggradation here is less than 1 yr old.

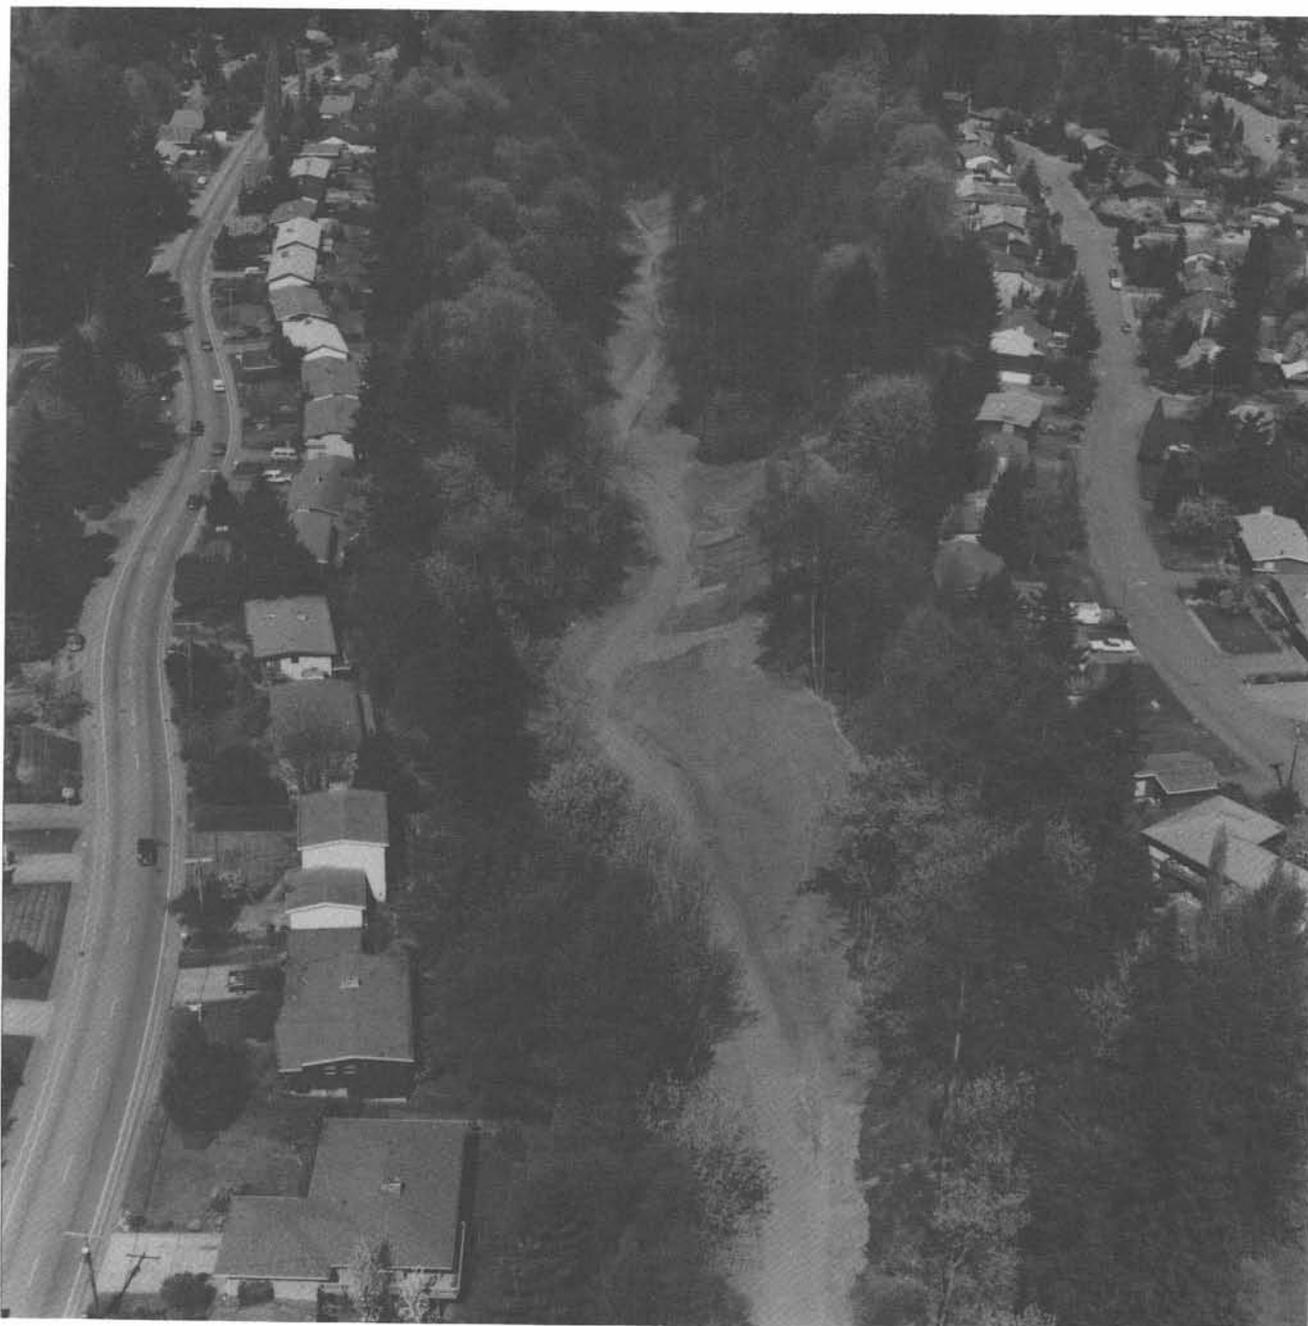
Aerial view of part of the Newport Hills tributary to Coal Creek (also illustrated in Figure 7 of this paper) following pipe installation and infilling of the canyon. Although an effective resolution to the consequences of incision, this "solution" engenders such cost and environmental damage itself that early recognition and mitigation represent the only rational long-term approach to these problems.

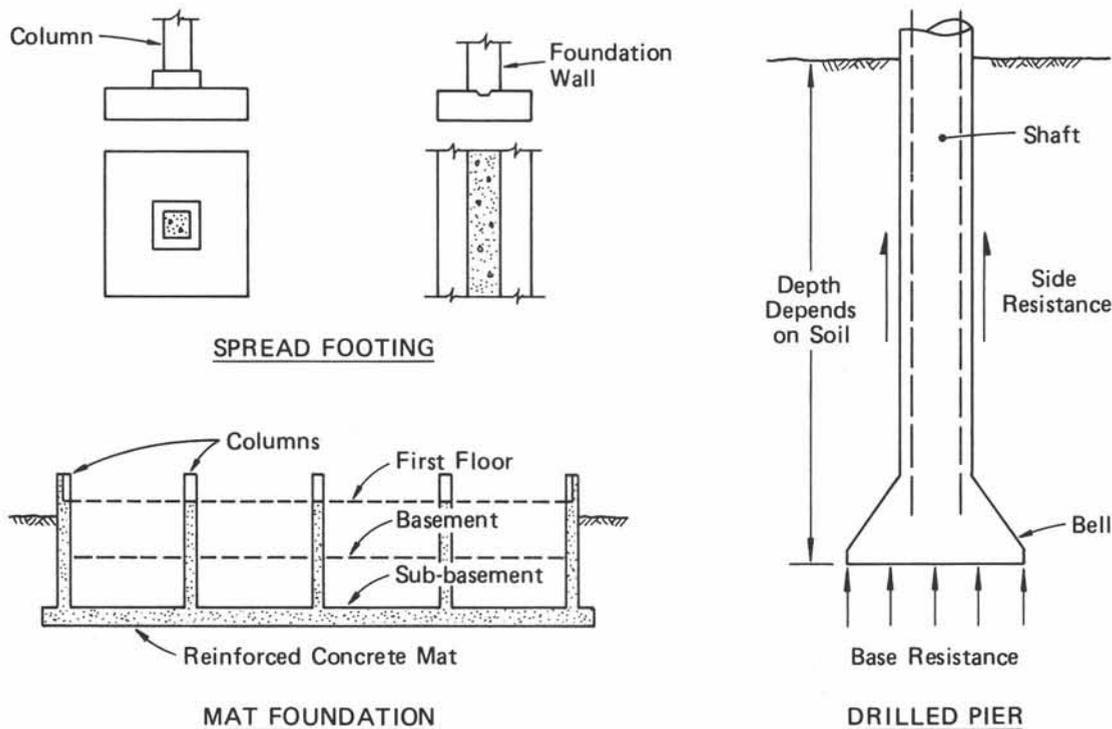
Figure 2. Building foundation types.

The foundation data presented in Table 1 are divided into four main categories: spread footings, mats, drilled piers, and combinations thereof. Buildings 1 through 5 in Table 1 are supported on spread footings. Buildings

6 through 18 are supported on mat foundations, and structures 19 through 35 are supported on drilled piers, while buildings 36 and 37 are supported by a combination of foundation types. Also included in Table 1 are design values for spread footings supporting low-rise portions of buildings, such as plaza and concourse areas, elevators, and entrances.

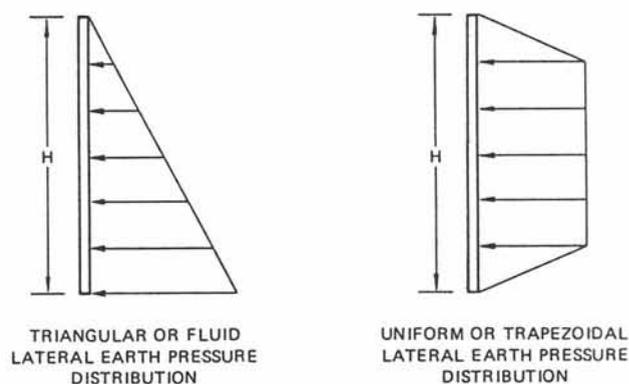
Figure 3. Typical distributions of lateral earth pressures, downtown Seattle foundations.

either uniform lateral pressures or triangular (fluid) lateral earth pressures. Uniform pressures may be truncated at the top and/or bottom and are the same pressures as those used for temporary shoring. Triangular lateral pressures may be either in the active or at-rest conditions. Typical earth pressure distributions are shown in Figure 3.

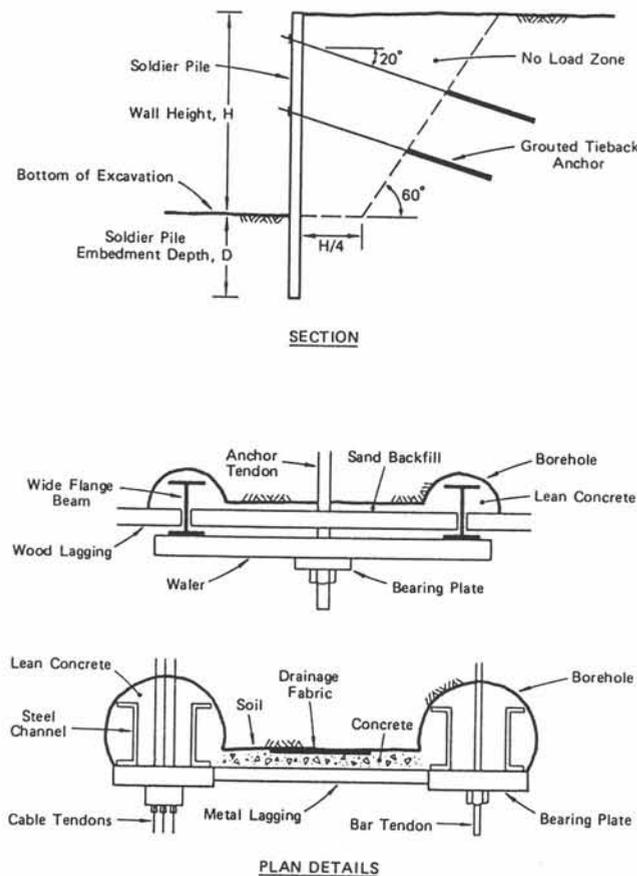
Figure 4. Detailed view of soldier pile-tieback anchor shoring walls as used in downtown Seattle high-rise building foundations.

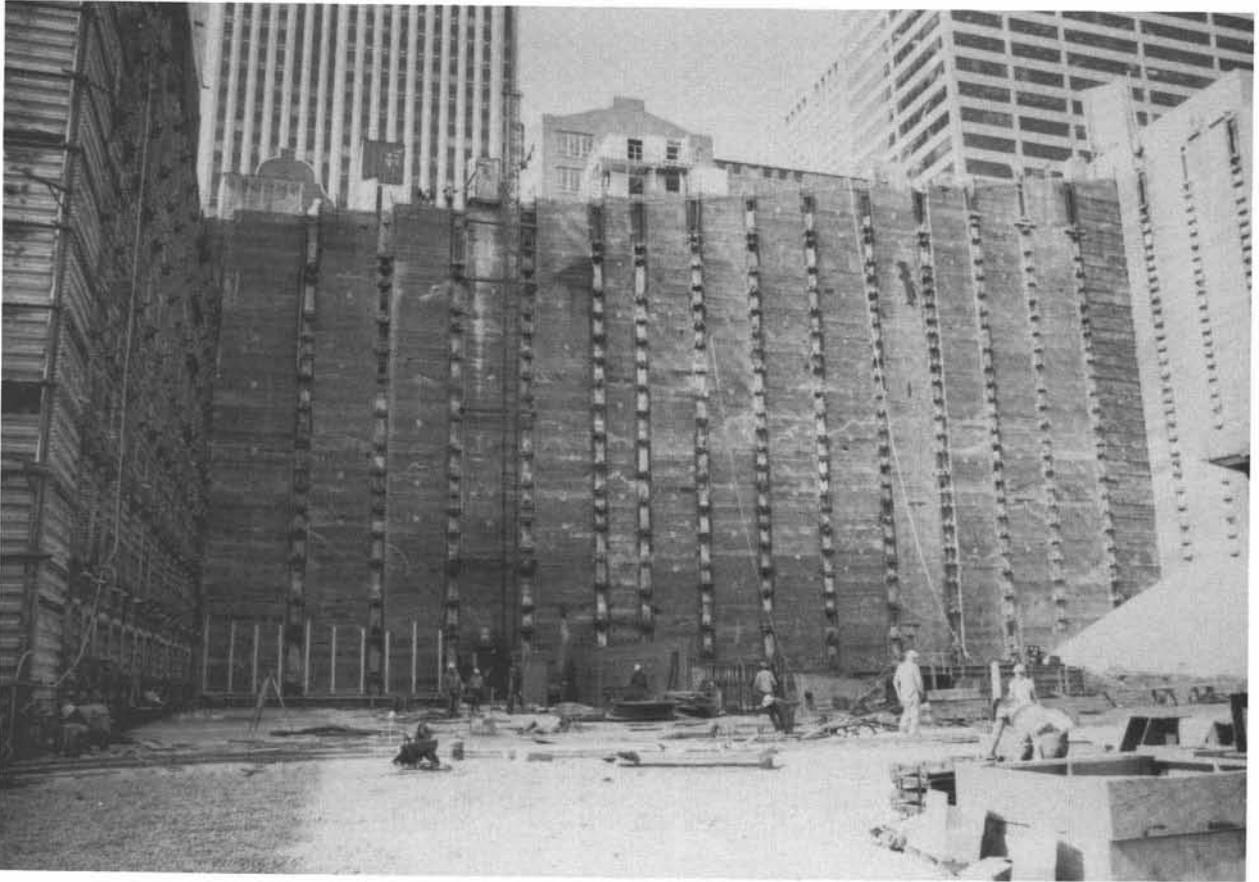
Completed excavation for the Columbia/Sea First Center, downtown Seattle, in 1983. This is the deepest shored excavation on the West Coast. Photograph courtesy of Shannon & Wilson, Inc.

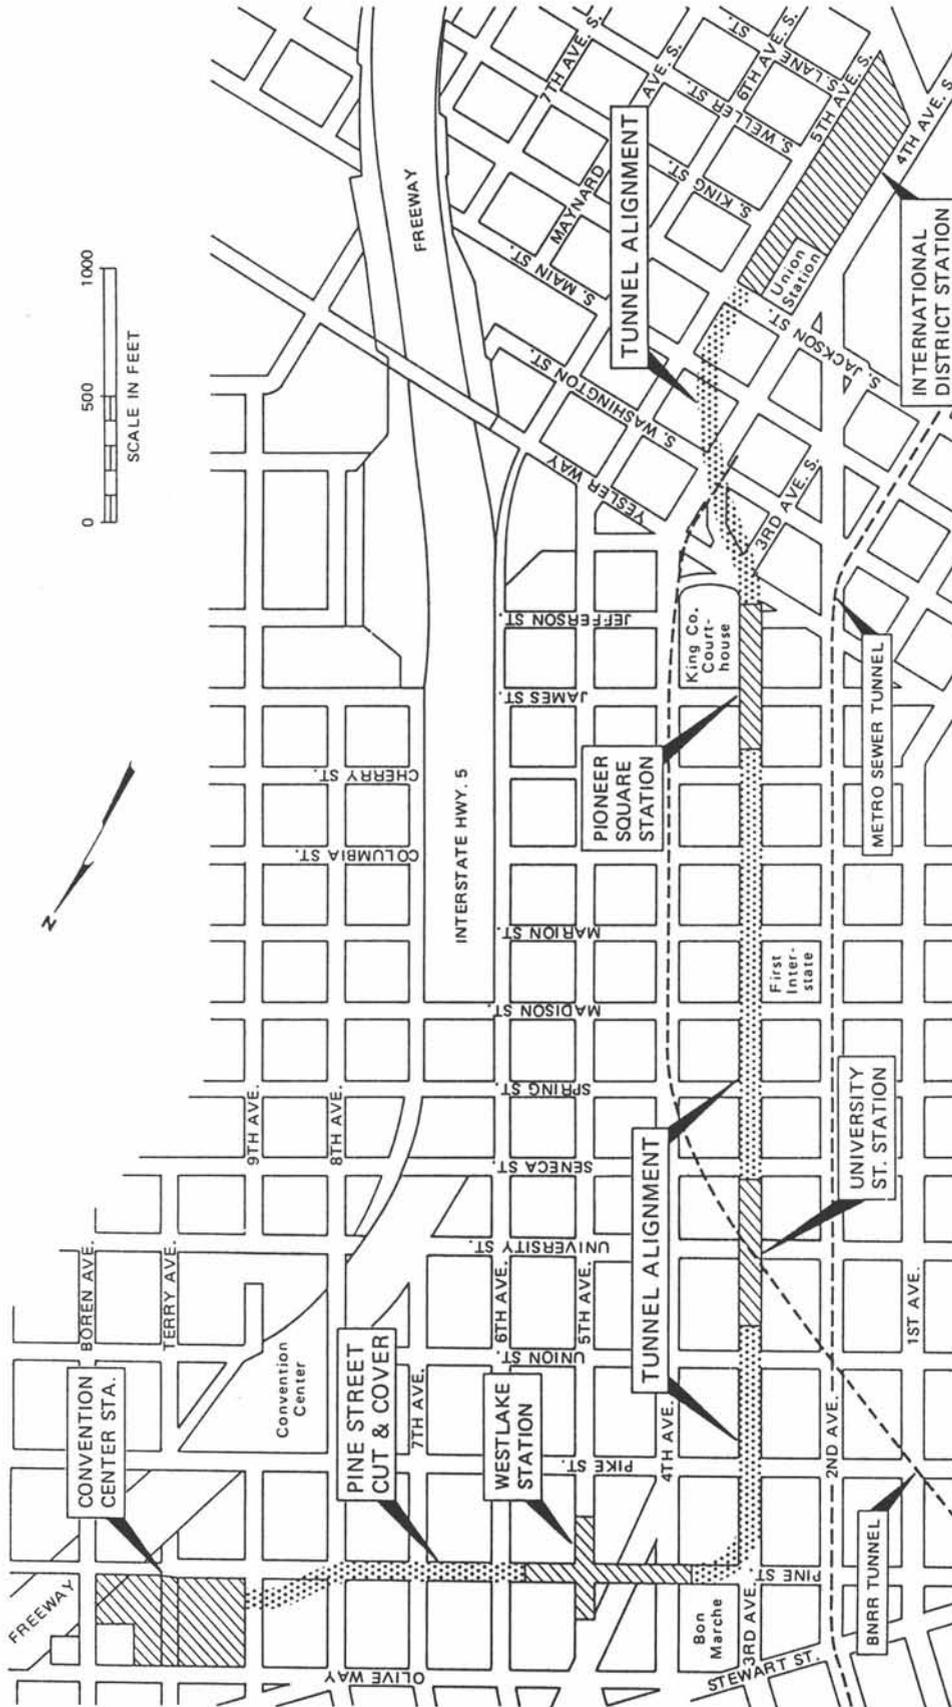
Figure 1. Plan of the Downtown Seattle Transit Project showing major structures in the area.

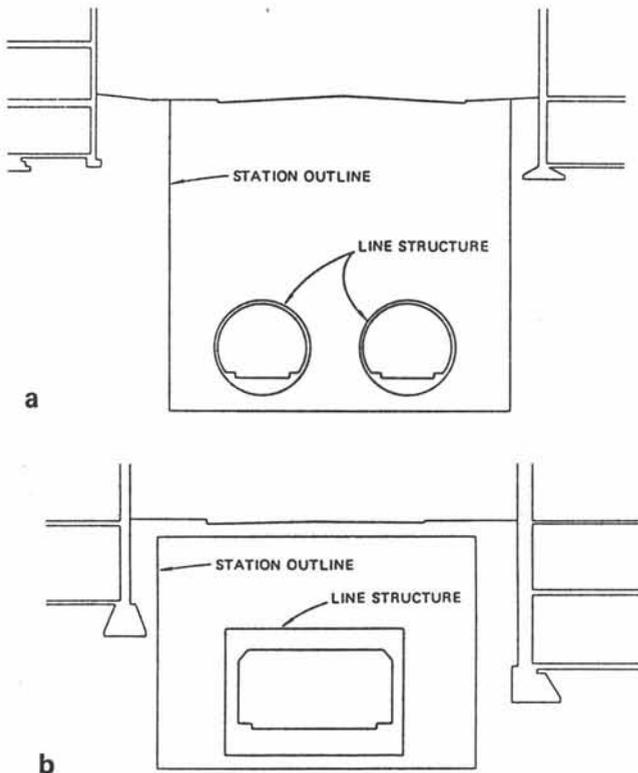
Figure 2. Typical sections of tunneled (a) and cut-and-cover (b) sections. Tunneled section is on Third Avenue; cut-and-cover section on Pine Street.

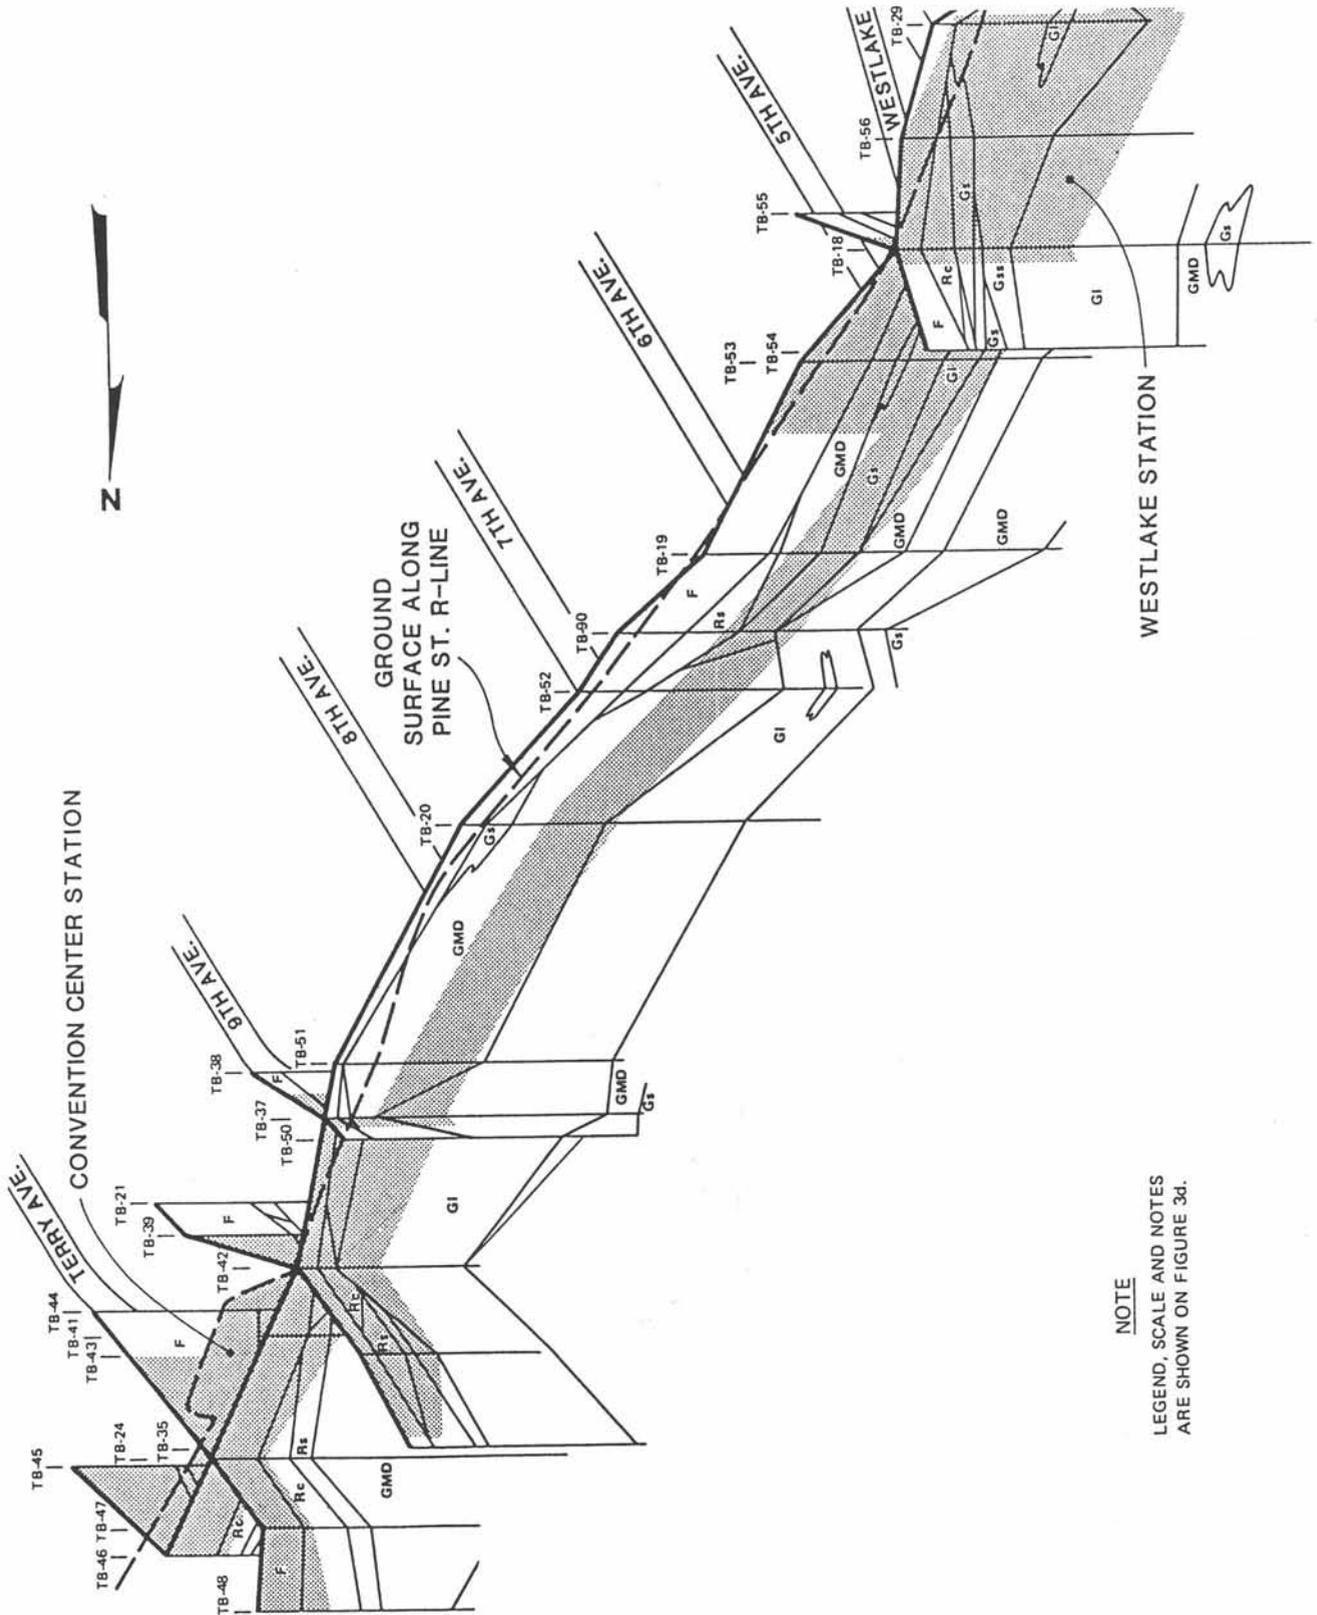
Figure 3a. Generalized geologic conditions in downtown Seattle.

An interpretation of the geologic history of the downtown Seattle area and specifically along the project corridor is presented on Figure 3. This was prepared on the basis of the information recovered from the borings for the transit tunnel along Third Avenue and Pine Street and additional boring logs from nearby projects. The interpretation is also related to the general glacial history of the Puget Lowland. The soil strata encountered in the subsurface explorations have been geologically grouped into lithogenetic units. A

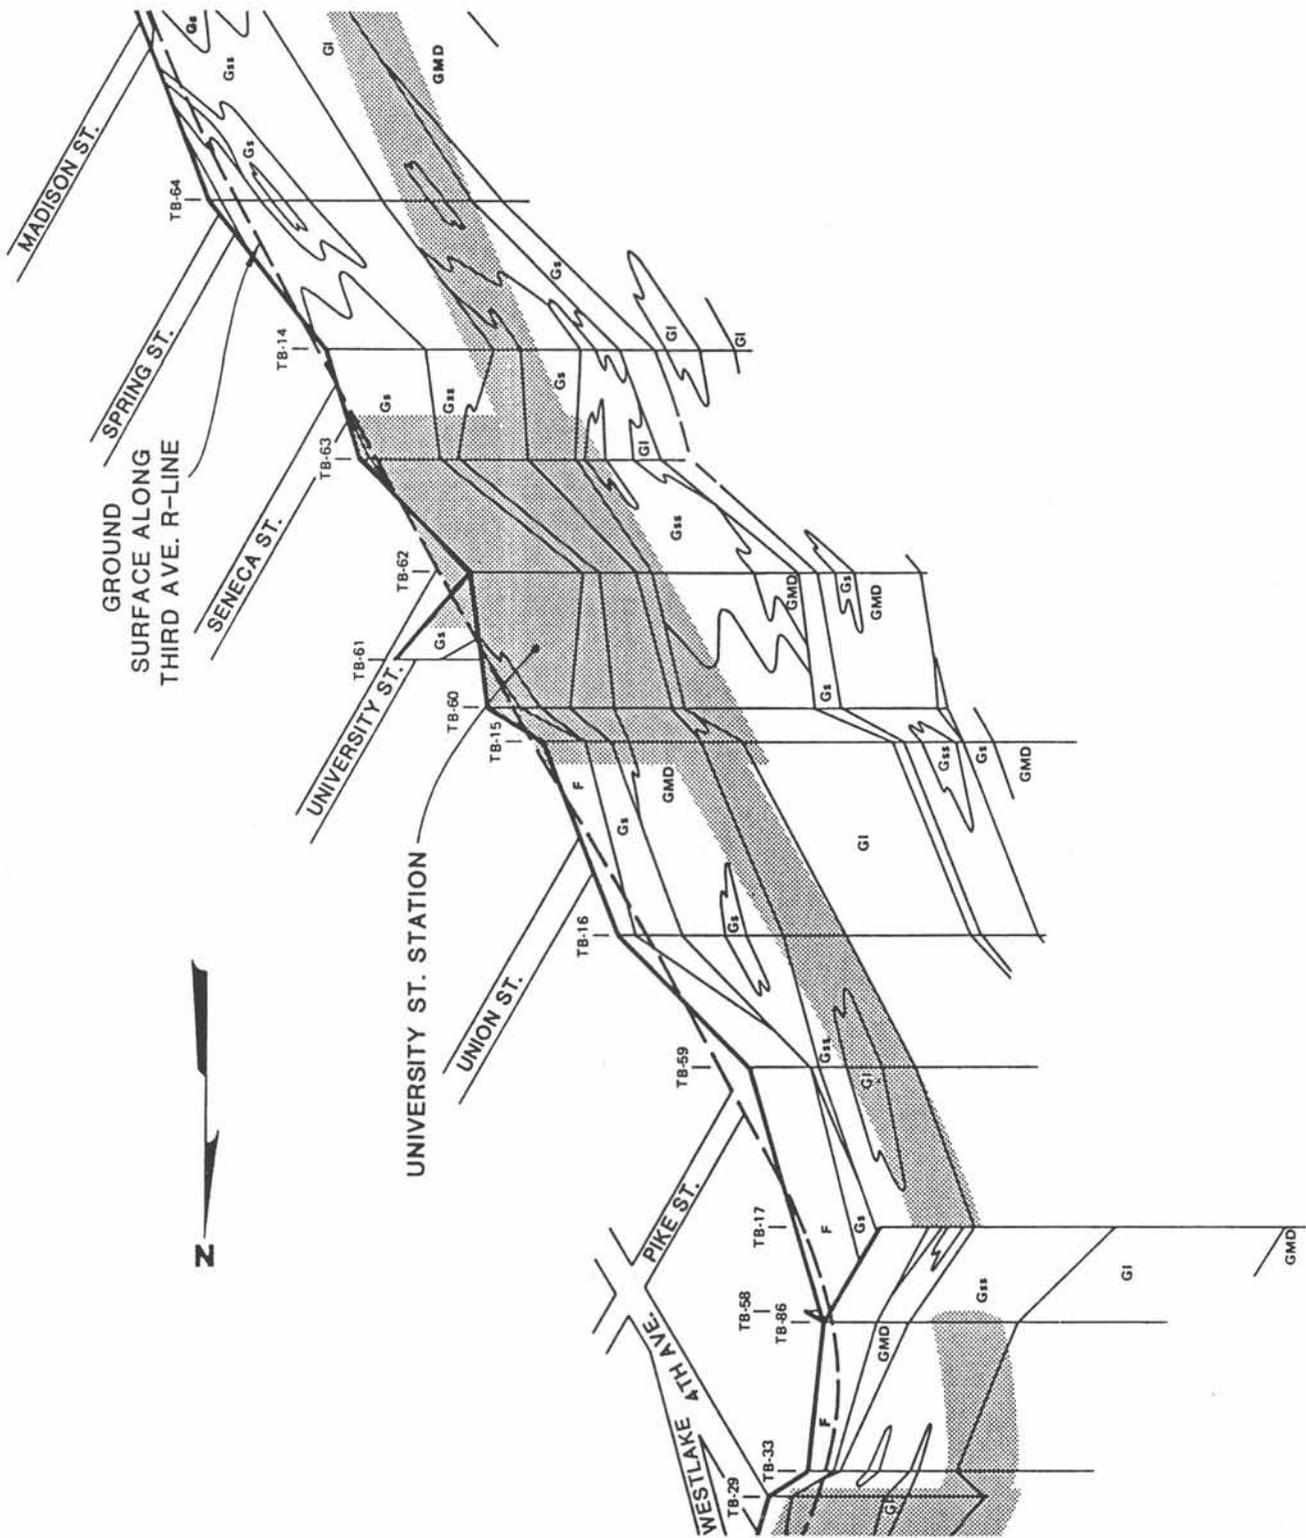
Figure 3b. Generalized geologic conditions in downtown Seattle.

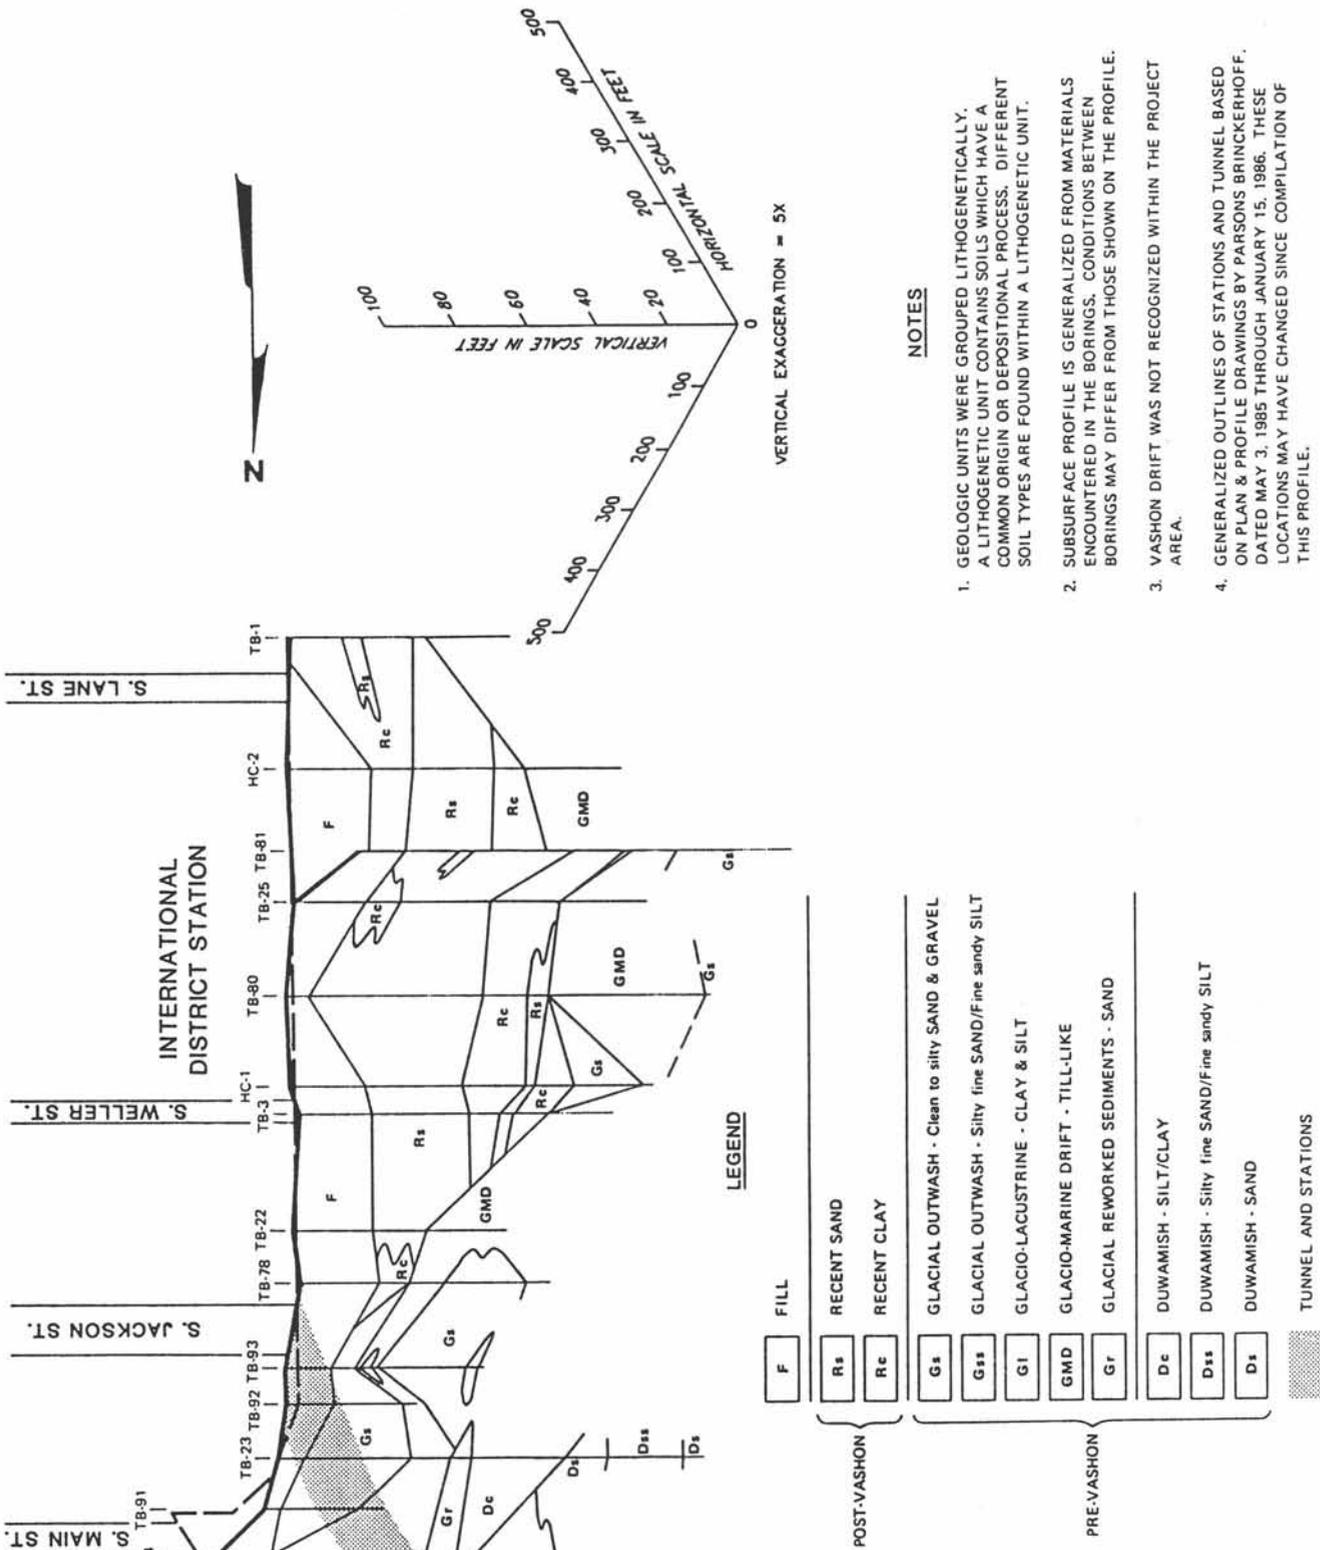
Figure 3d. Generalized geologic conditions in downtown Seattle. (Note: post-Vashon sediments are of Holocene age.)

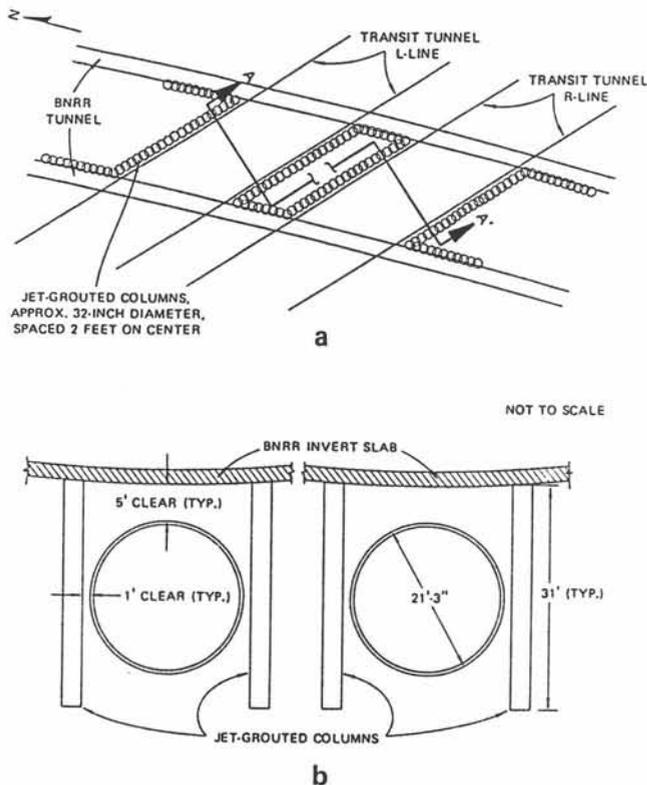
Figure 4. Construction details for Burlington Northern Railroad tunnel undercrossing. a, plan view; b, cross section at A-A'.

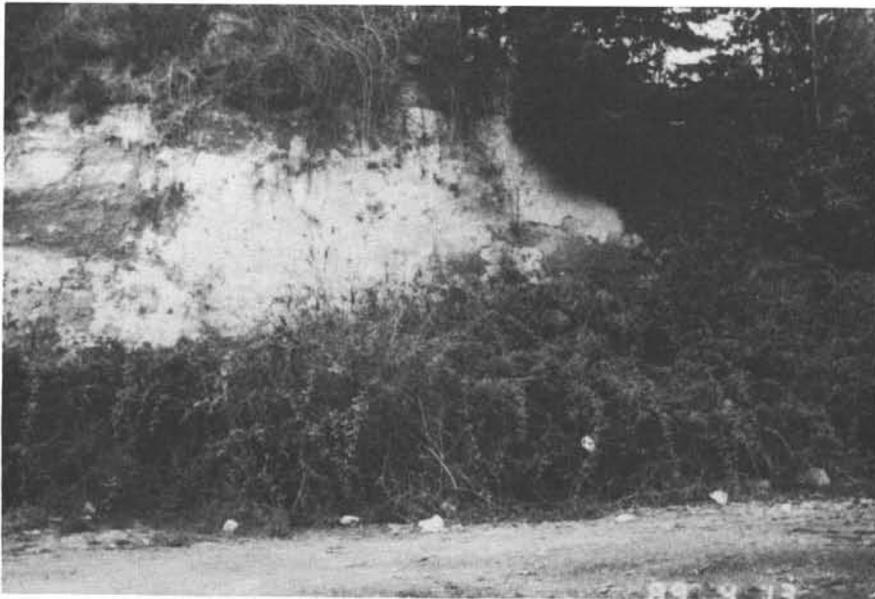
Exposure of Vashon Till in the Fremont District of Seattle. Photograph by W. T. Laprade.

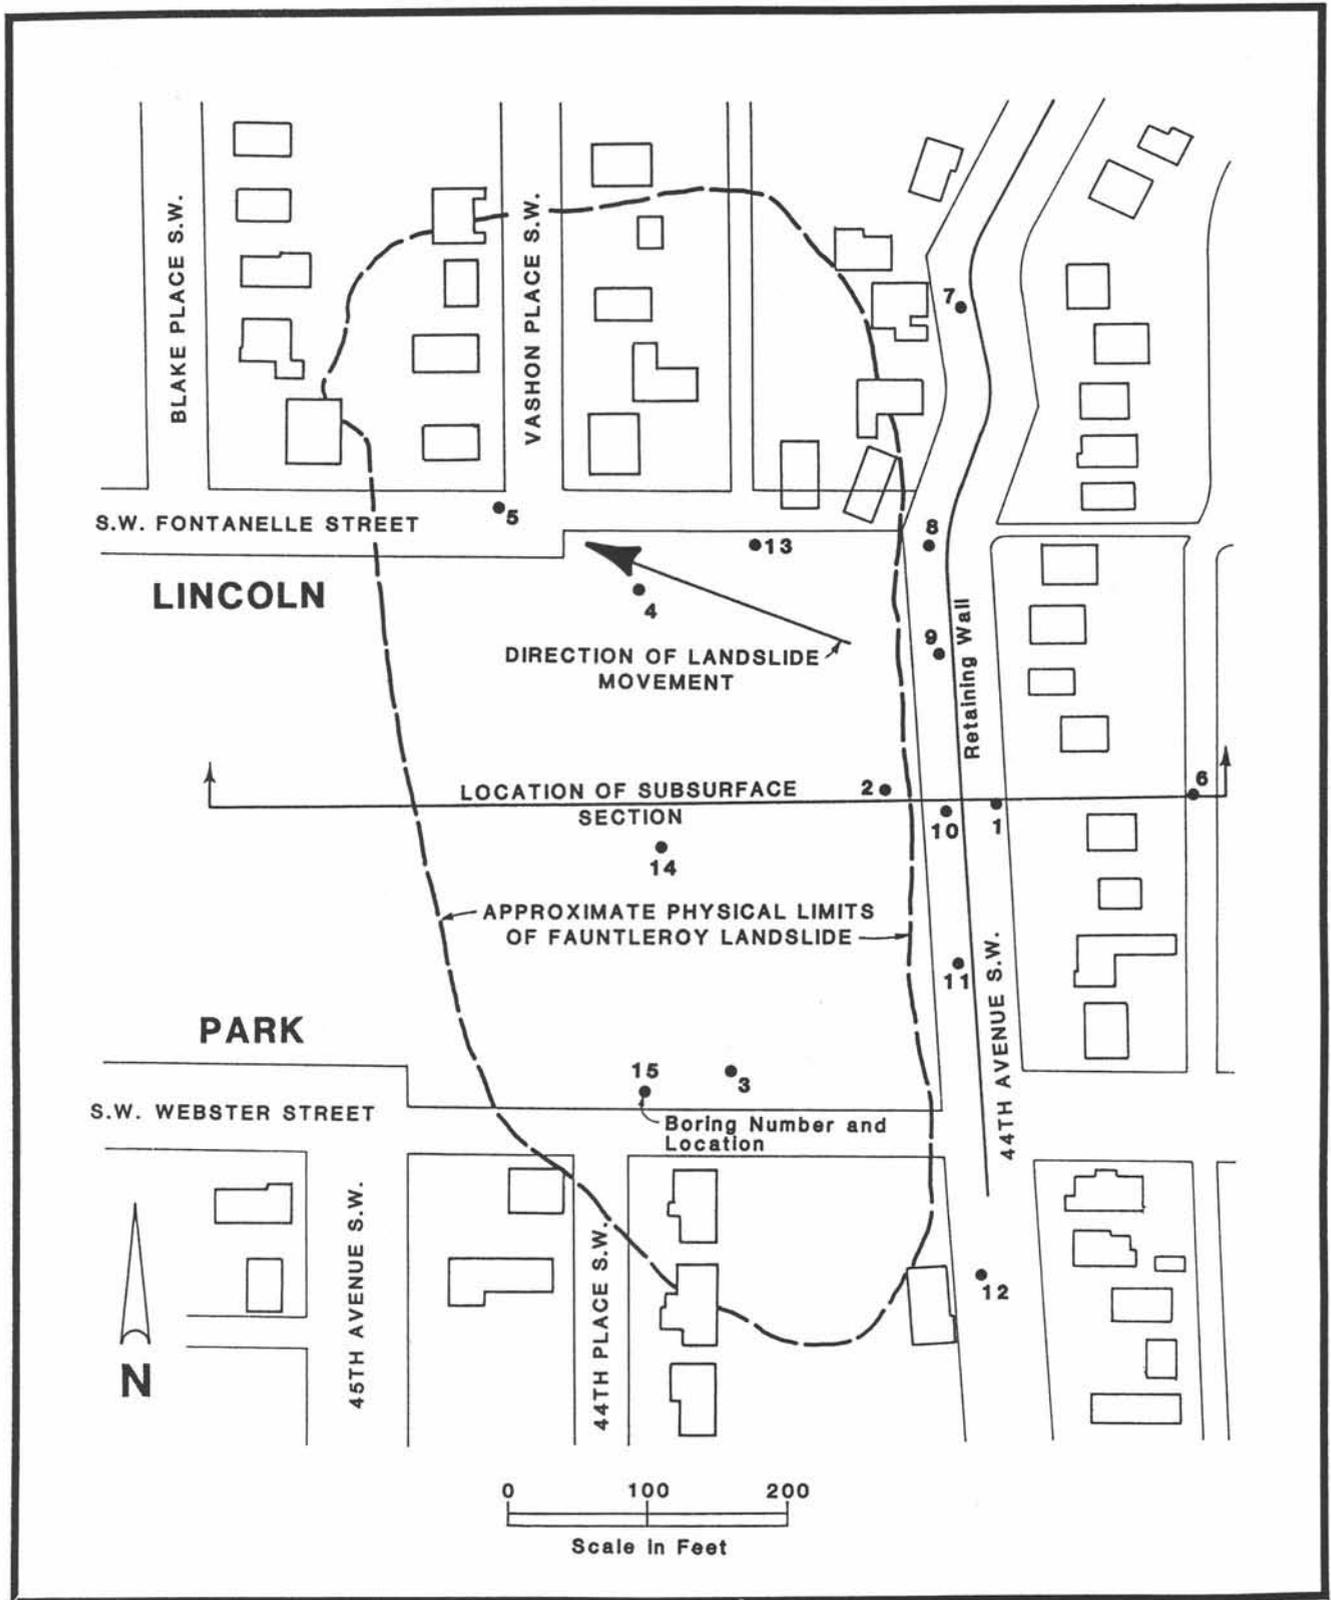
Figure 2. Limits of the Fautleroy landslide. Section is shown in Figure 3.
