ENGINEERING GEOLOGY IN WASHINGTON

Volume II

BULLETIN 78

Runoff and Stream-Channel Changes Following Urbanization in King County, Washington

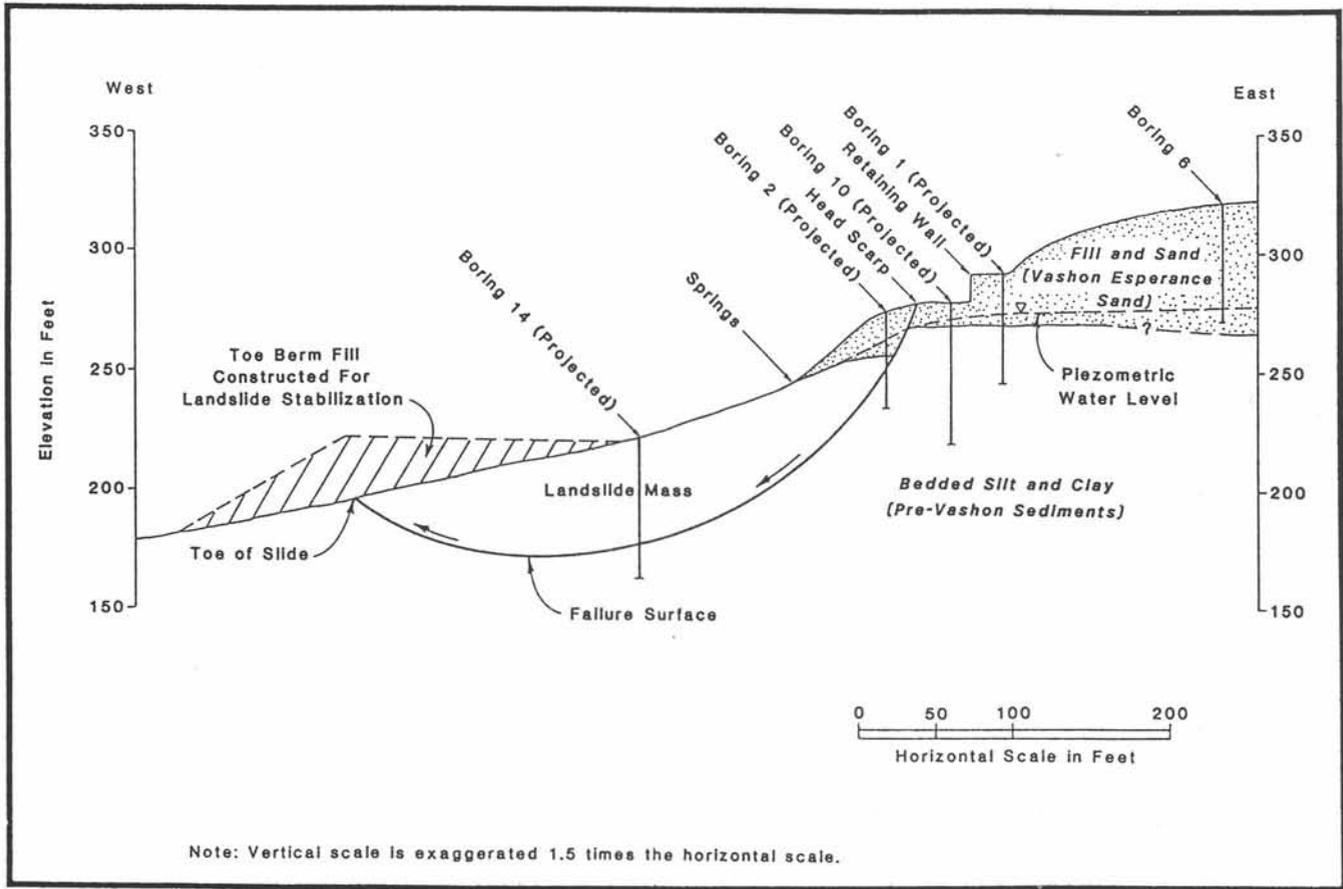
Figure 3. Generalized geologic section of the Fauntleroy landslide.

The landslide failure surface shown in Figure 3 was developed from surface evidence as well as subsurface measurements. For example, the piezometer that was installed in boring 2 in late April 1983 became kinked at a depth of 24 ft in January 1984. The depth of piezometer deflection in boring 2 coincided with a zone of intense fracturing noted in soil core samples obtained from that boring, leading to the conclusion that the zone of landslide movement was 24 ft deep at that location.

The slope profile, soil conditions, and failure-surface geometry used in stability analyses were basically as shown in Figure 3. The first step in the analyses was to

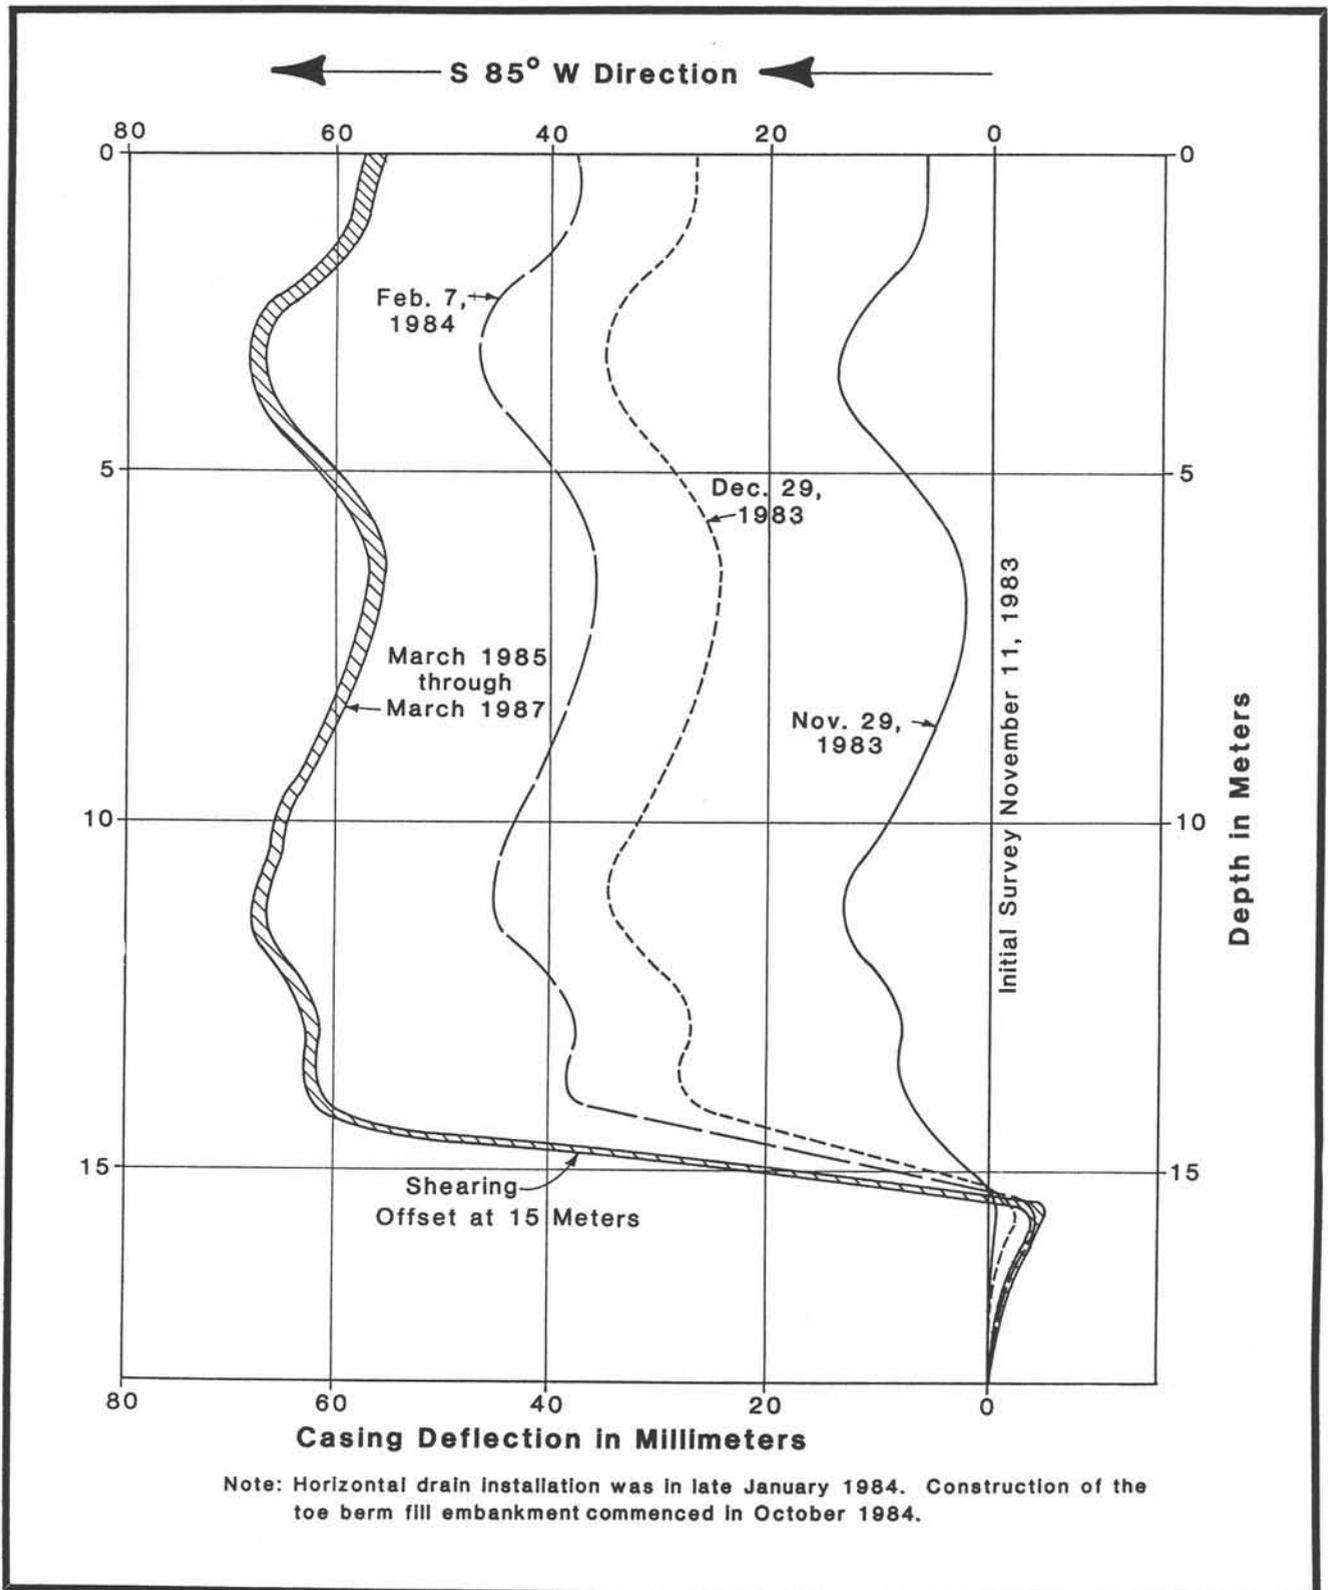
Figure 4. Plots of inclinometer data from boring 13 in the Fauntleroy landslide.

A slope indicator casing was installed in boring 14 in early November 1983. Subsequent inclinometer readings documented a shearing offset in the slope indicator casing at a depth of 45 ft. Numerous slickensided fractures were found in soil core samples obtained between the depths of 34 ft and the base of the drillhole (59 ft) for boring 14. The inclinometer casing for boring 13 indicated shearing at a depth of 49 ft. This zone also coincided with observations of shearing in soil core samples. Plots of the inclinometer surveys in boring 13 are shown in Figure 4. These plots indicate progressive creep of the slide mass between November 1983 and March 1985.

Analysis of the inclinometer measurements in borings 10, 13, 14, and 15 resulted in the following conclusions regarding the Fauntleroy landslide:

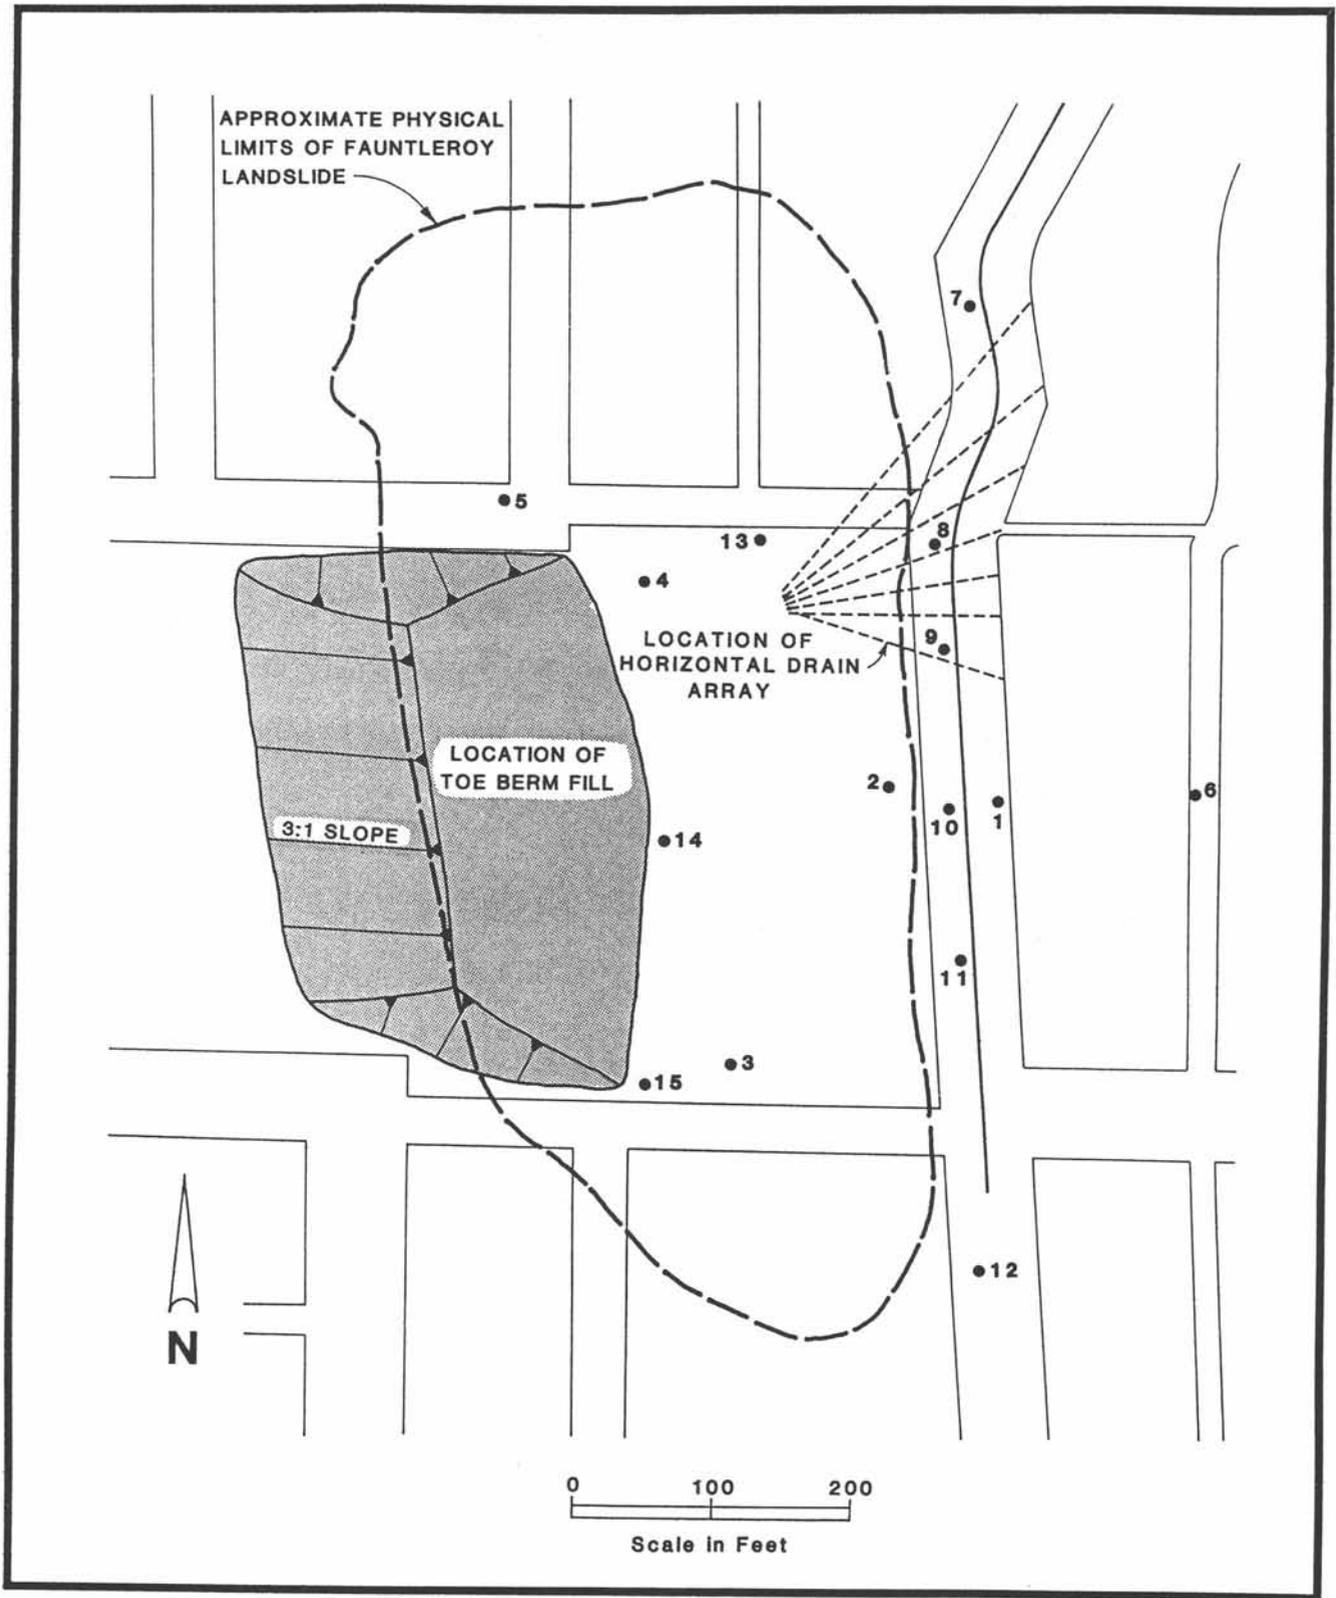
Figure 5. Locations of corrective measures for the Fauntleroy landslide.

The drainpipes consisted of Schedule 80 PVC pipe with an inside diameter of 1.5 in. The lowermost (westernmost) 30 to 50 ft of pipe was not slotted. The remainder of each drain was perforated with three rows of machined slots having a slot width of 0.010 in. Discharge from the drains was routed to a special catch basin near the western ends of the drains, where the flow from each drain could be measured independently.

Permanent water-level reductions of approximately 5, 12, 9, and 7 ft were documented for the piezometers in borings 7, 8, 9, and 10, respectively. These piezometers are in the immediate area of the drain array. Permanent water-level lowerings of lesser magnitudes were also indicated by the ground-water monitoring data for the piezometers in borings 1, 5, and 6.

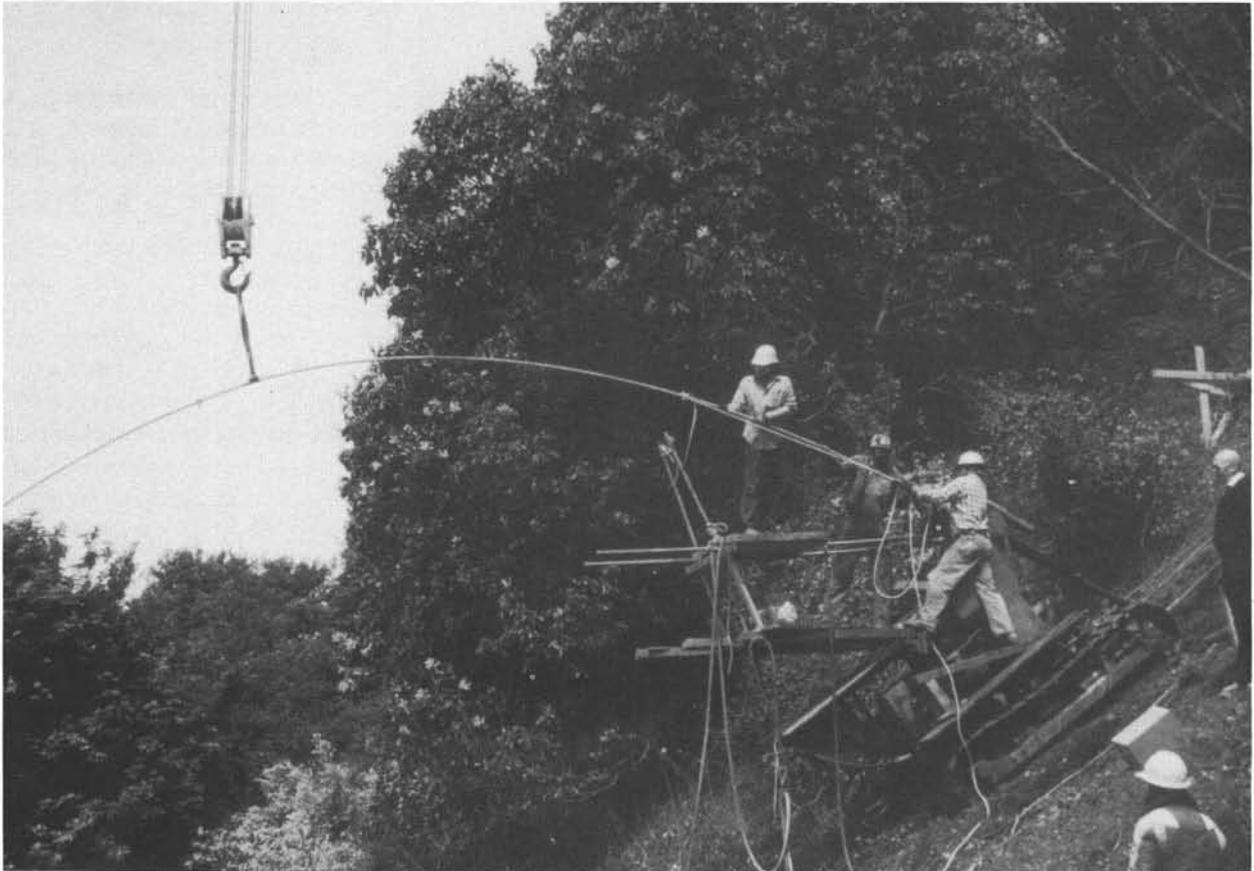
Tie-back anchors being installed for a residence on a steep hillside, 1982. Photograph courtesy of Shannon & Wilson, Inc.

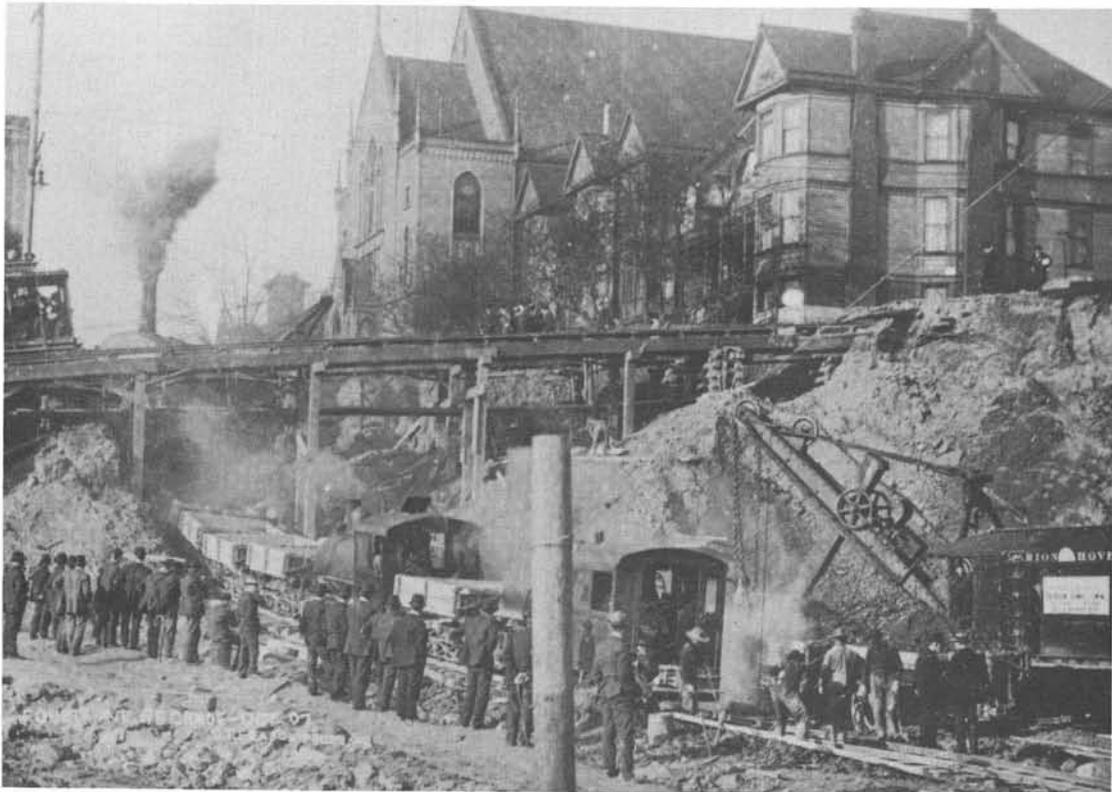
Figure 2. 3rd Avenue excavation, 1905. Photo courtesy of the Museum of History and Industry, Seattle.

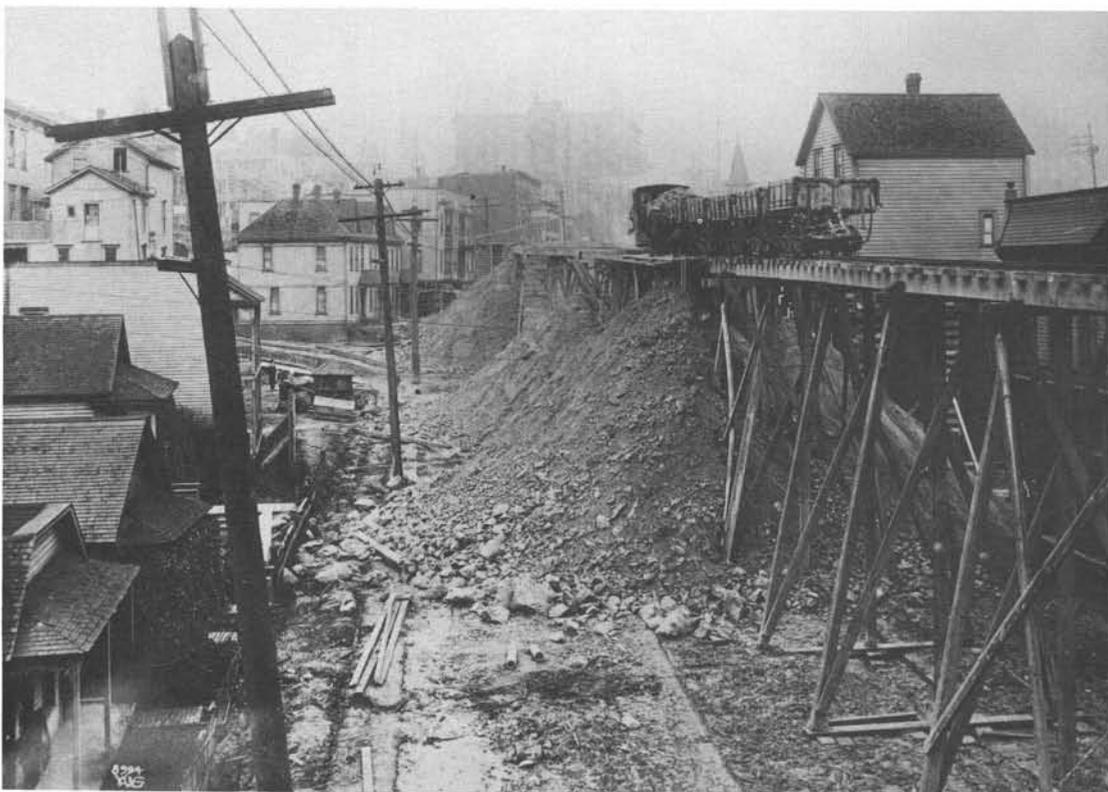
Figure 3. 7th Avenue fill, 1906, view to the south from Stewart Street. Photo courtesy of the Museum of History and Industry, Seattle.

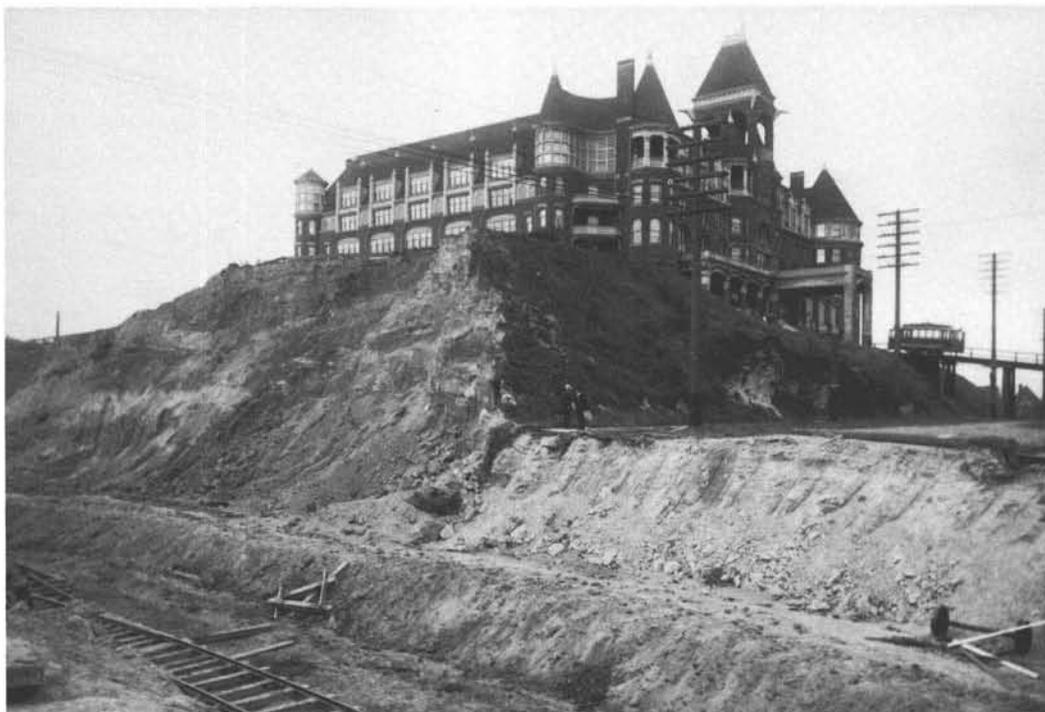
Figure 5. Washington Hotel with counterbalanced trolley. Photo courtesy of Museum of History and Industry.

trolley line was built to connect the entrance with level ground at Pike Street. Built mostly on trestle, the line had a steady grade of 20 percent. Seattle Electric Co. car No. 139 shuttled back and forth on the three-block route for its 12-yr life span (Figure 5). As the years passed, Moore became increasingly unhappy with the problems of his hotel-on-a-mesa location. He finally decided to capitulate, and on April 18, 1906, the Council granted Moore's request to excavate, at his own expense, the streets in the block occupied by the hotel. In addition to the loss of a hotel, this change of mind cost him \$133,079.22.

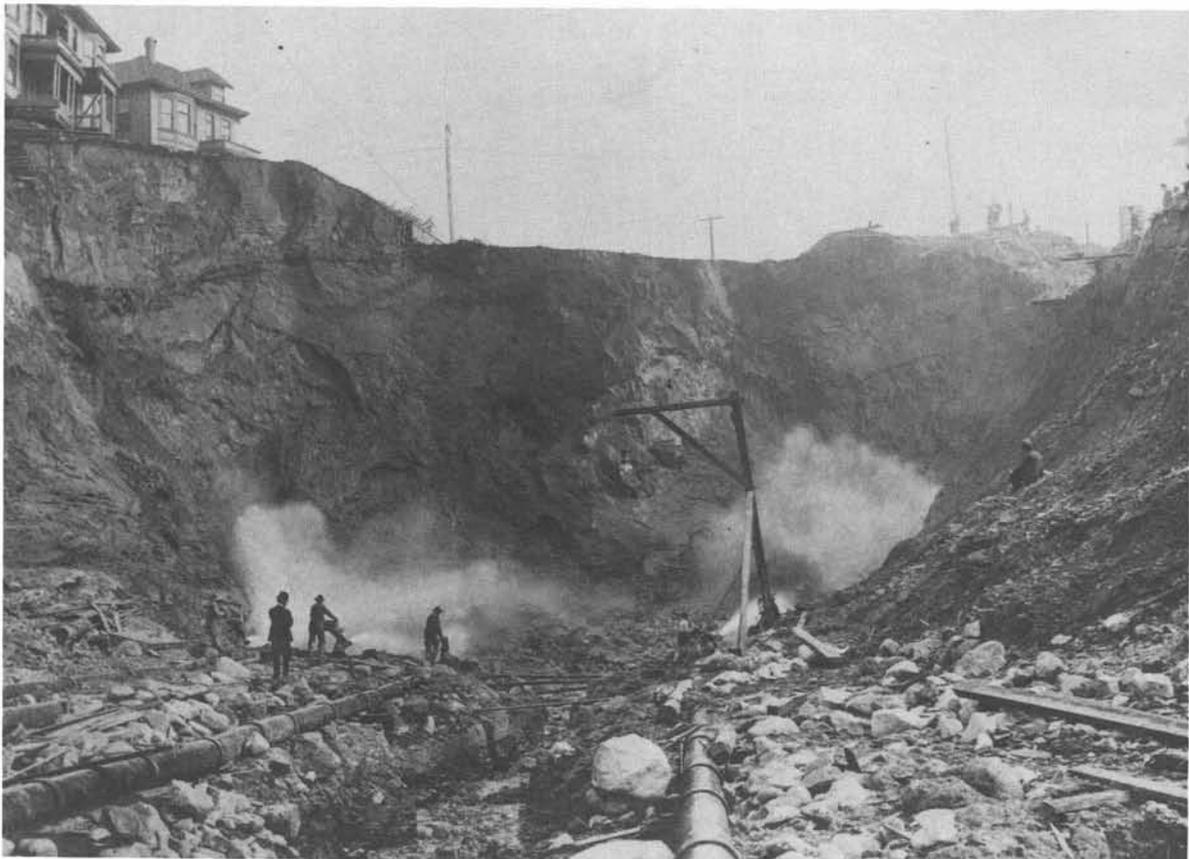
Figure 6. Hydraulic boring into Denny Hill at Blanchard Street. Photo courtesy of Special Collections Division, University of Washington Libraries (negative no. 5021).

using surplus water from the city water system. This method is illustrated in Figures 6 and 7. That water supply proved inadequate, however, and "the largest pump in the northwest" was installed on Elliott Avenue at Stewart and Virginia, drawing its water from the limitless source of salt water in Elliott Bay. It was powered by an 800-hp motor connected by belt to a four-stage turbine and was guaranteed to deliver 3,500 gal/min against 180 psi at the pump. This was about 5 million gal each 24 hr. Being a relatively new method of excavation, difficulties were experienced, but the sluicing demonstrated the feasibility of the hydraulic method of moving the glacial deposits of clays, silts, sands, and gravel in the hills. Undercutting the embankments caused controlled slides to occur, breaking the deposits down so that the solids represented as much as 16 percent of the water flowing into the flumes or conduits. Cemented tills proved the most difficult to break down, but even these were handled successfully.

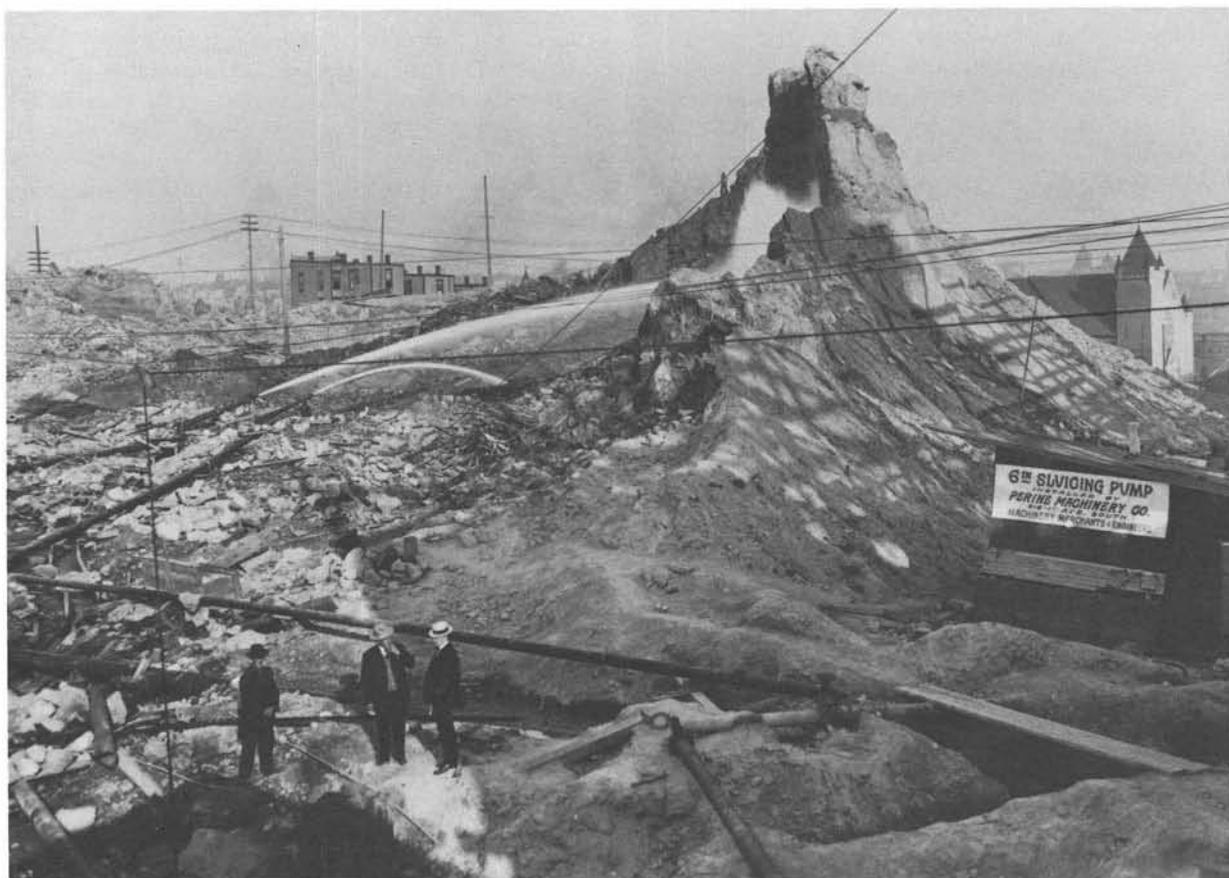
Figure 7. Denny Hill Regrade, 1906-1907. Photo courtesy of Museum of History and Industry, Seattle.

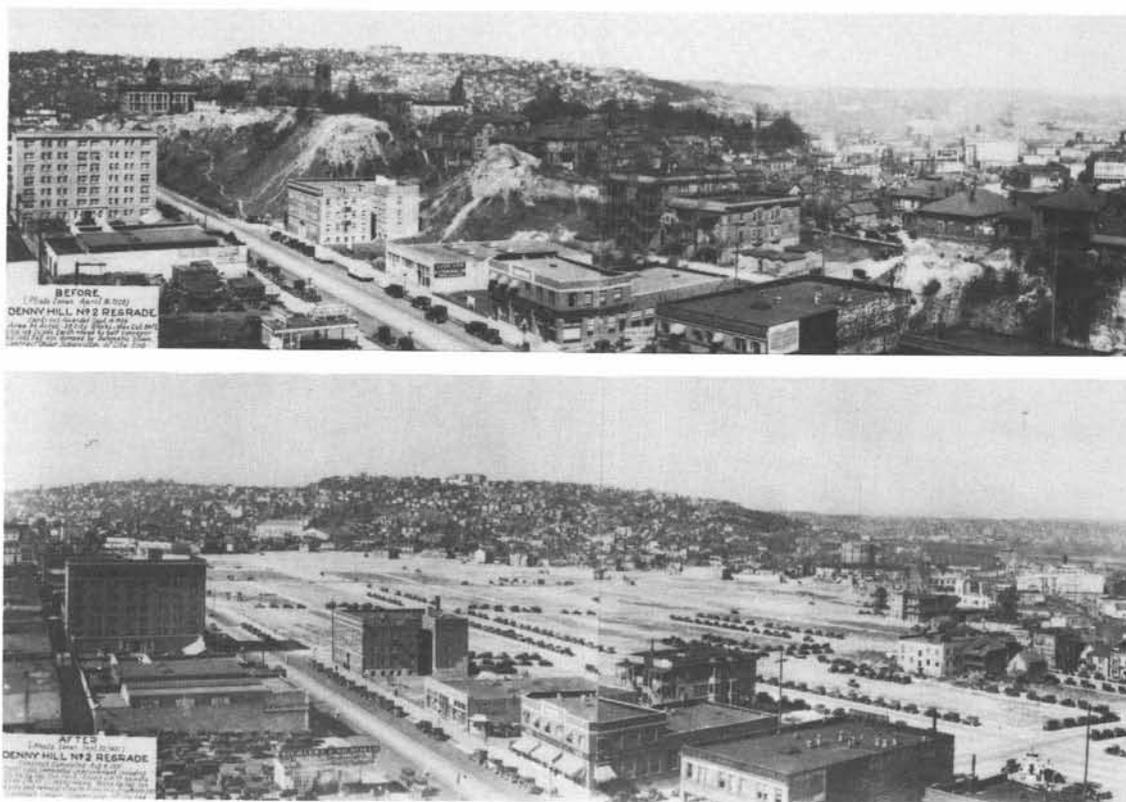
Figure 8. Denny Hill Regrade No. 2: before (April 16, 1928) and after (August 3, 1931). Photo courtesy Special Collections Division, University of Washington Libraries (negative no. 20046).

horse-drawn drays. Roadways and streets around Lake Union, to the north and to the northwest, were opened for much easier travel. Lots near the base of Queen Anne Hill, which prior to the regrades were valued at \$2,500, were, upon completion of the work, quoted at \$15,000. Figure 8 shows conditions before and after the final regrading of Denny Hill.

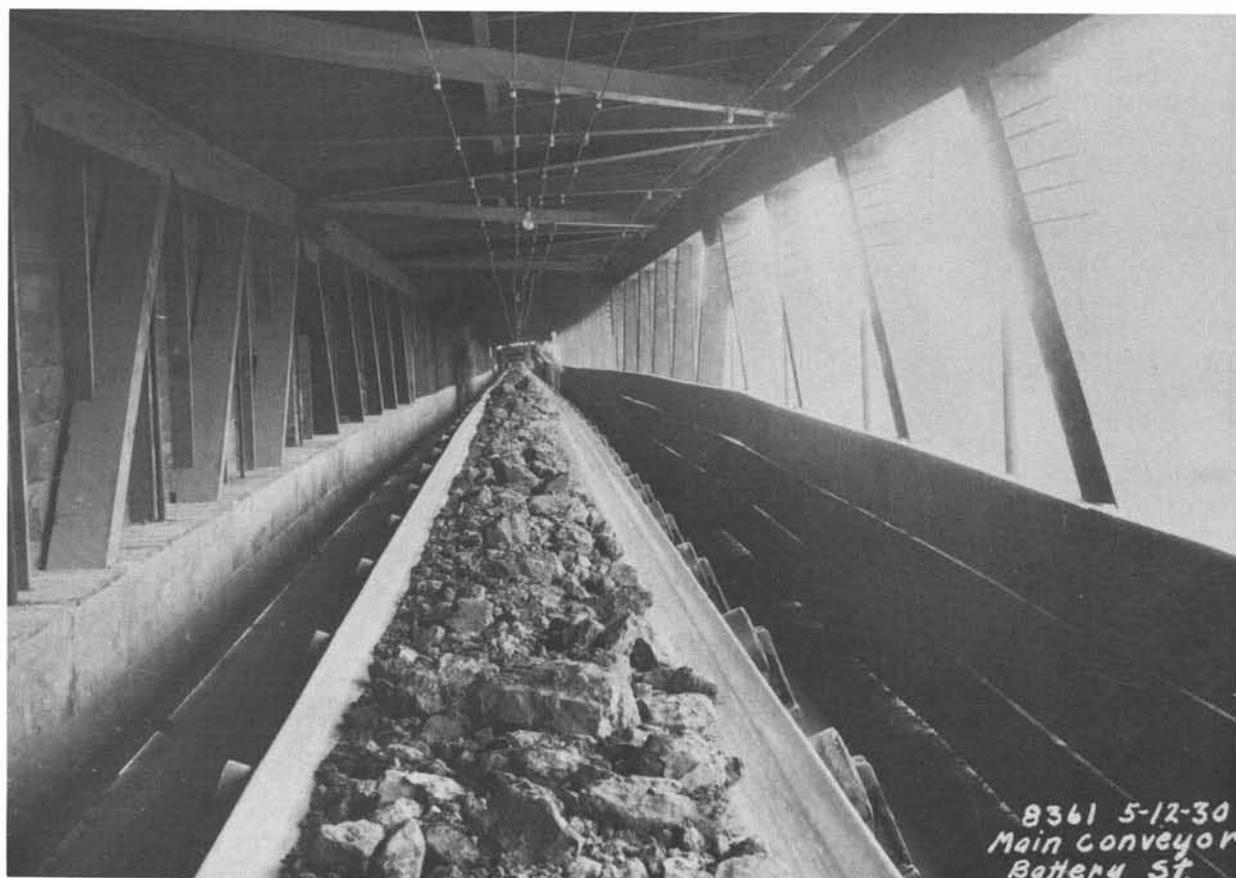
Figure 9. Denny Hill Regrade #2, 1930, main conveyor belt. Photo courtesy of Museum of History and Industry, Seattle.

The contractors chose to use mostly electrically powered shovels, loading excavated soils onto moving belts, for the regrade work. Shovels worked on benches, or layers, thus lowering the hill in stages. Each of the three fixed belts was 35 in. wide. Figure 9 shows one built on Battery Street from Sixth Avenue to Third Avenue; this connected with a second continuing from Third Avenue to Railroad Avenue and a third extending from Railroad Avenue to the discharge point on the dock where self-dumping scows were loaded. The elevated timber support structure for the conveyor belts was lined on both sides to protect pedestrians and traffic and to minimize the dust problem. The 500-cy scows

The three main belts totaled about a half mile in length and were moved at 600 ft/min by large electric motors. Six shorter belts, 30 in. wide and 250 ft long, were used to carry the dirt from the shovels to the main conveyor belts at a speed of 400 ft/min. An ingenious system of movable hoppers straddling the belts allowed the shovels to work along the belt route for some time before it was necessary to swing the belt into a new location. An automatic braking system was arranged so that stoppage of any belt would stop the others. This proved to be a good arrangement, as it prevented damage to the entire system on these occasions.

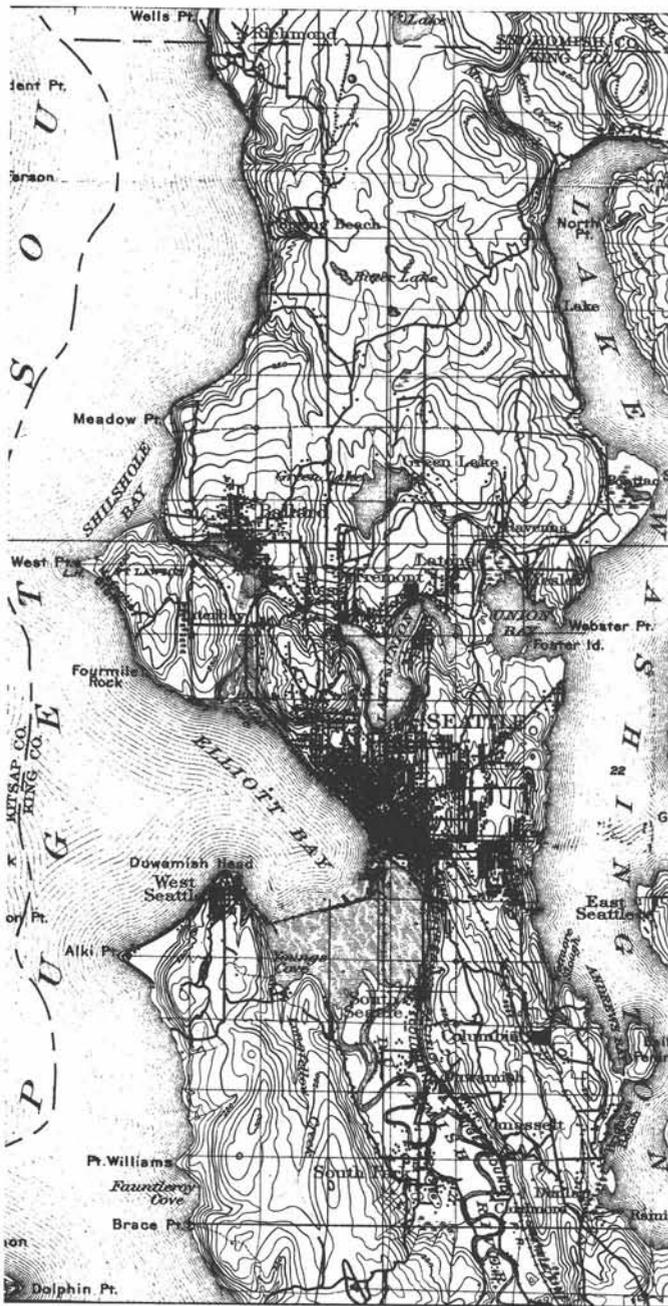
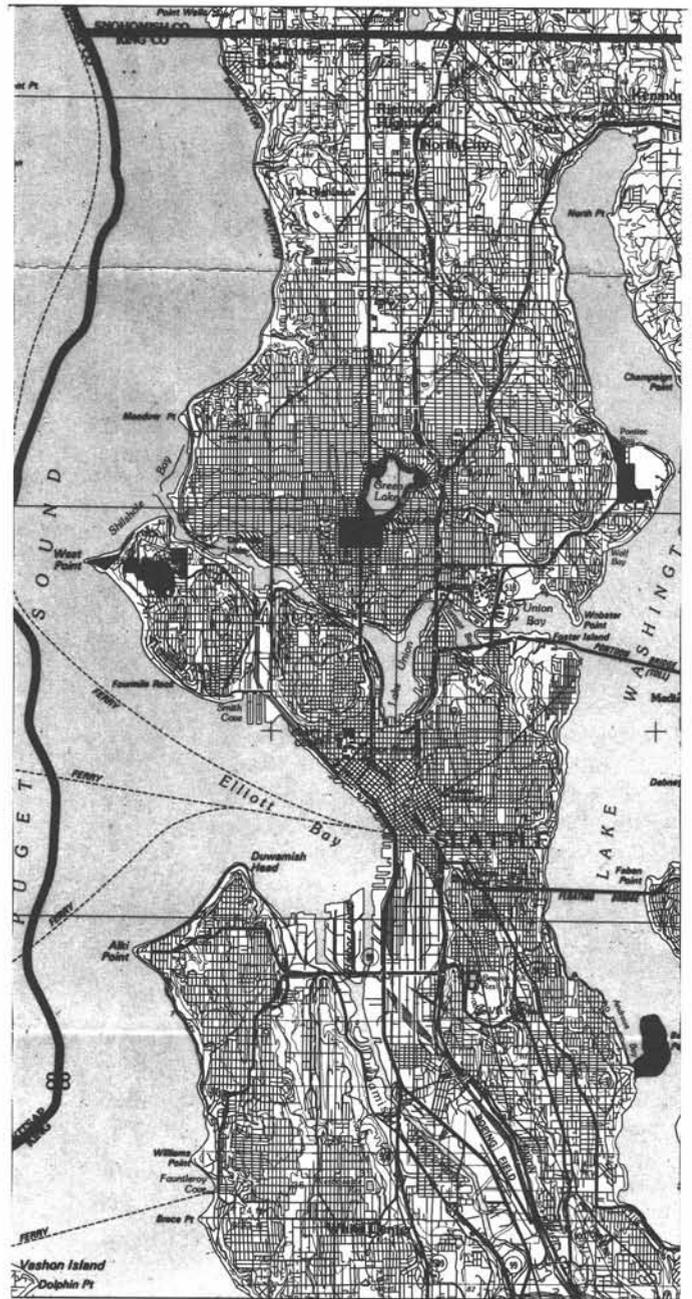
Maps of Seattle for 1897 (left) and 1975 (right) showing changes in shoreline configuration and urban development. From U.S. Geological Survey topographic maps, Snohomish quadrangle, scale 1:125,000 (1897) and Seattle quadrangle, scale 1:100,000 (1975).

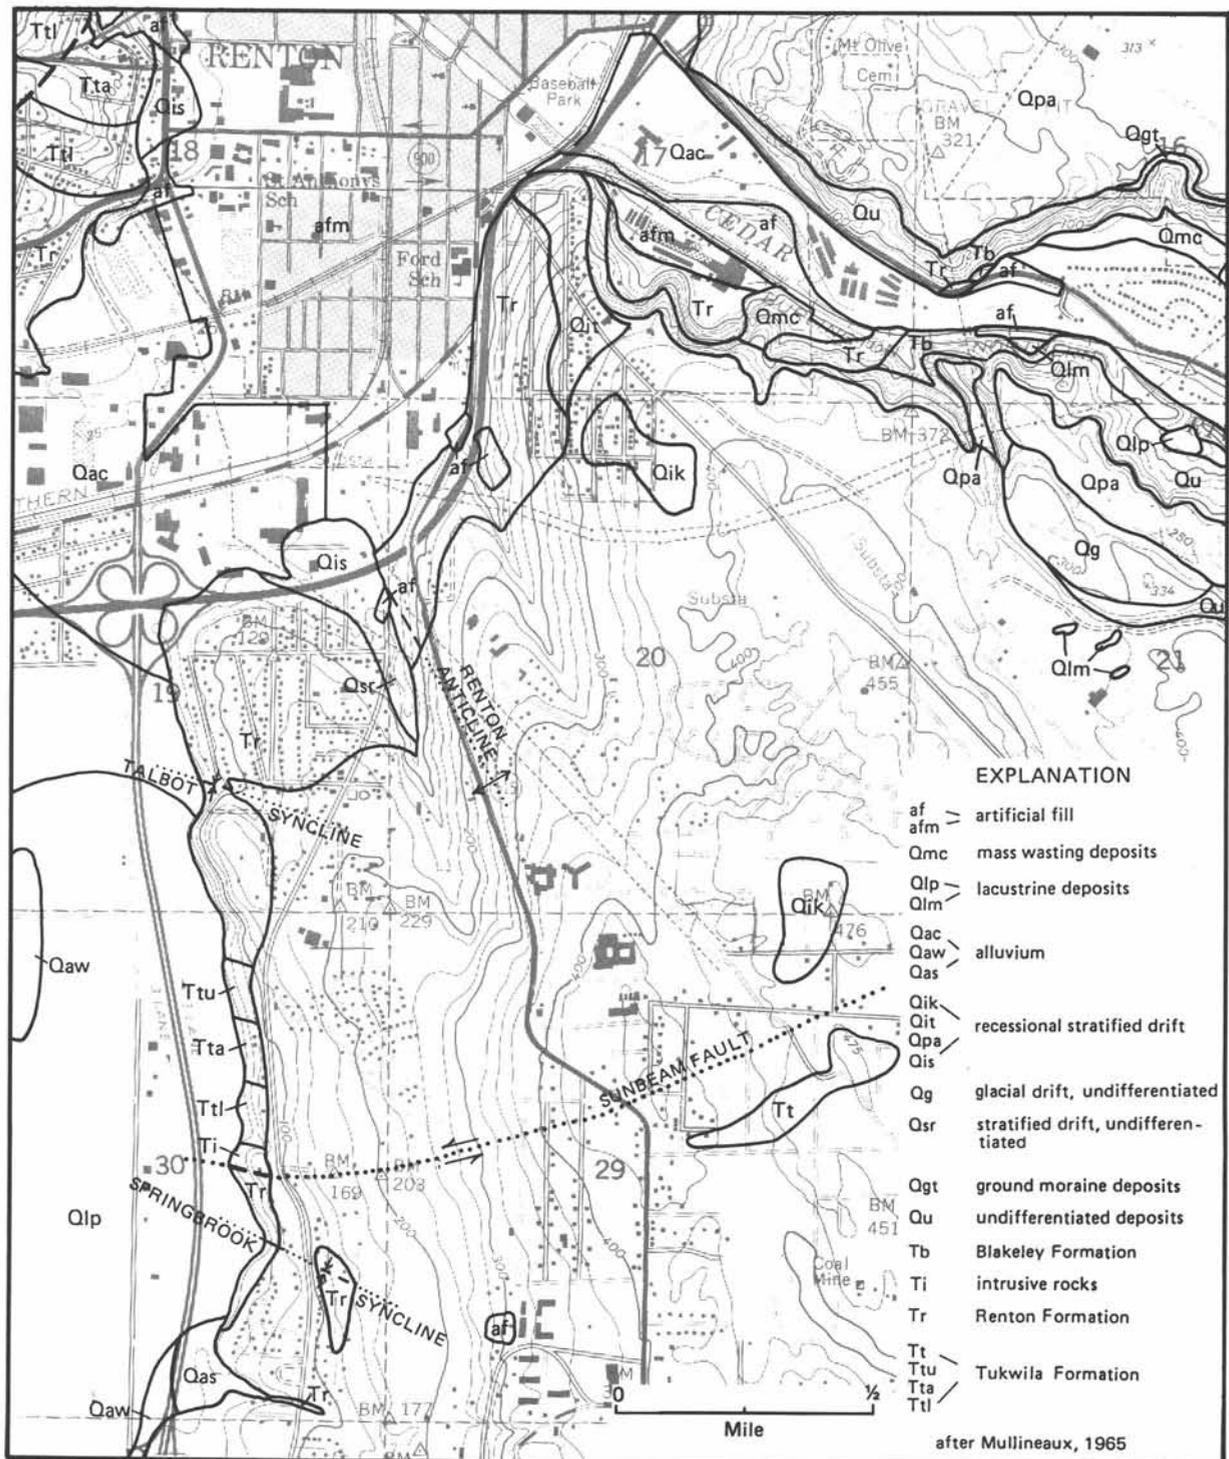
Figure 1. Geologic map of Renton area. Scale 1:24,000.

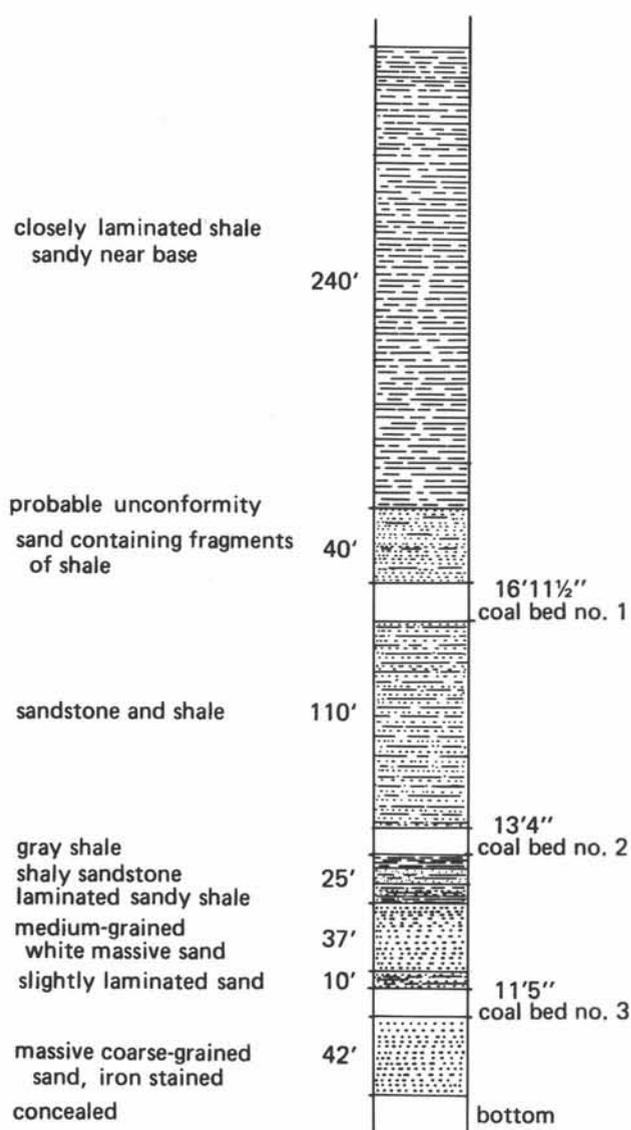
Figure 2. Stratigraphic column of the coal measures exposed in the Renton mines, measured by G. W. Evans (Evans, 1912).

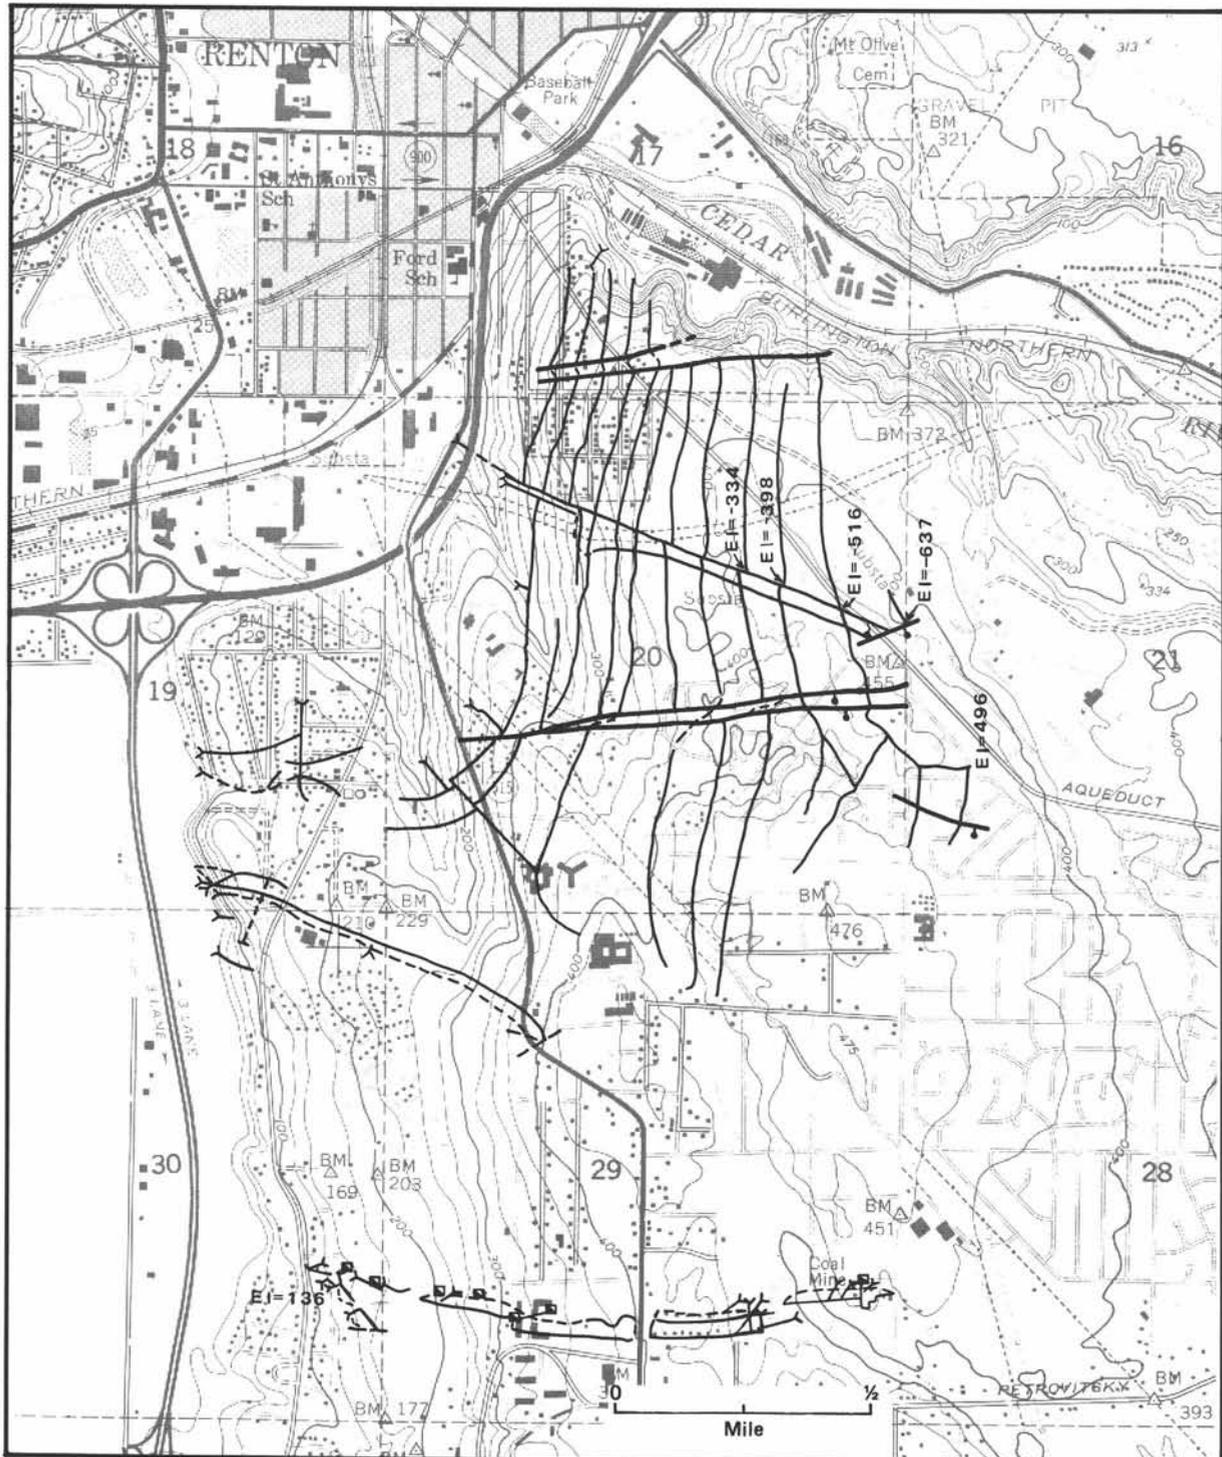
Figure 3. Mine workings on the Renton Number 3 seam. Solid lines are coal slopes and gangways; dashed lines are rock tunnels; heavy lines are faults, with bar and ball on the downthrown side. Elevations are relative to sea level. Compiled from mine maps on file at the Washington Division of Geology and Earth Resources. Scale 1:24,000; base from USGS Renton 7.5' quadrangle.

No maps are available detailing Strain's activities, but the configuration of the mine workings on all three seams as of 1922 is recorded in Figures 3 and 4.

The location of the subsidence was projected relative to the known coal mine workings and found to lie an estimated 290 ft above the third level north on the Number 3 seam and about 205 ft above the Number 2 seam. The top of the Number 1 seam projects to a depth of about 65 ft below the subsidence (Figures 3 and 4).
