ENGINEERING GEOLOGY IN WASHINGTON

Volume II

BULLETIN 78

Runoff and Stream-Channel Changes Following Urbanization in King County, Washington

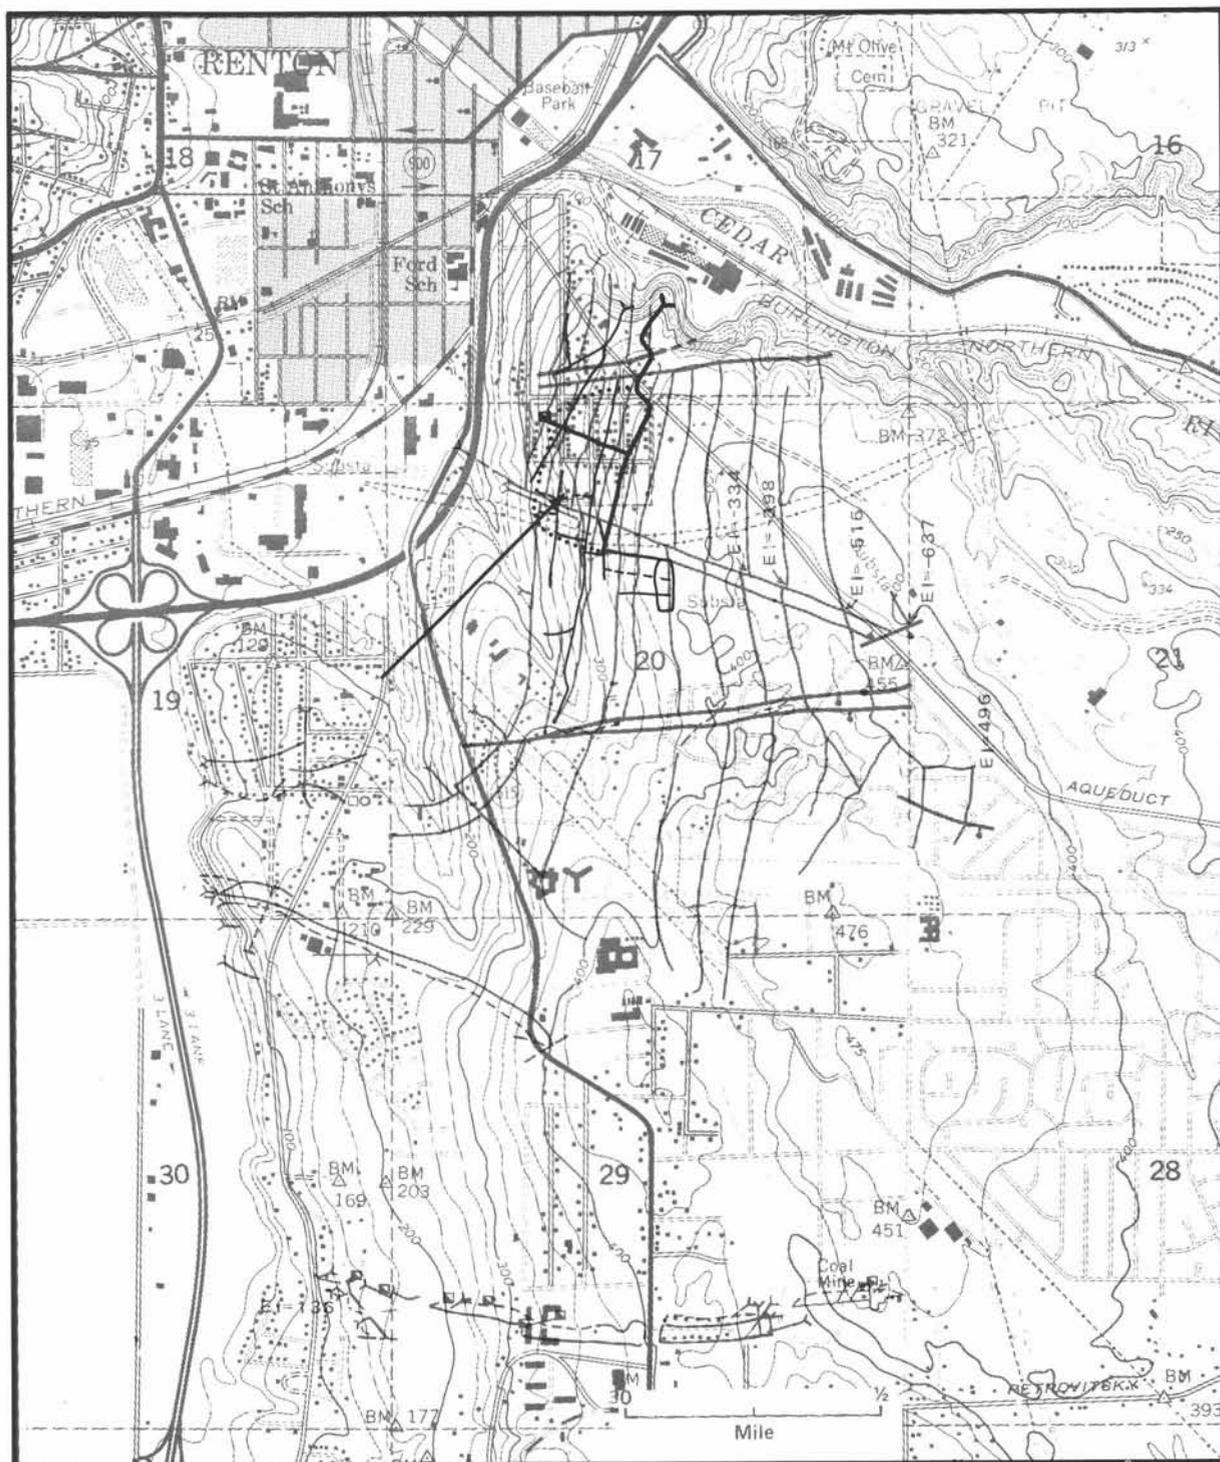
Figure 4. Mine workings on the Renton Number 2 and Renton Number 3 seams, located relative to Figure 3. Dotted line shows maximum extent of workings on the Number 1 seam. The subsidence discussed herein marked with arrow. Scale 1:24,000; base from USGS Renton 7.5' quadrangle.

No maps are available detailing Strain's activities, but the configuration of the mine workings on all three seams as of 1922 is recorded in Figures 3 and 4.

The location of the subsidence was projected relative to the known coal mine workings and found to lie an estimated 290 ft above the third level north on the Number 3 seam and about 205 ft above the Number 2 seam. The top of the Number 1 seam projects to a depth of about 65 ft below the subsidence (Figures 3 and 4).

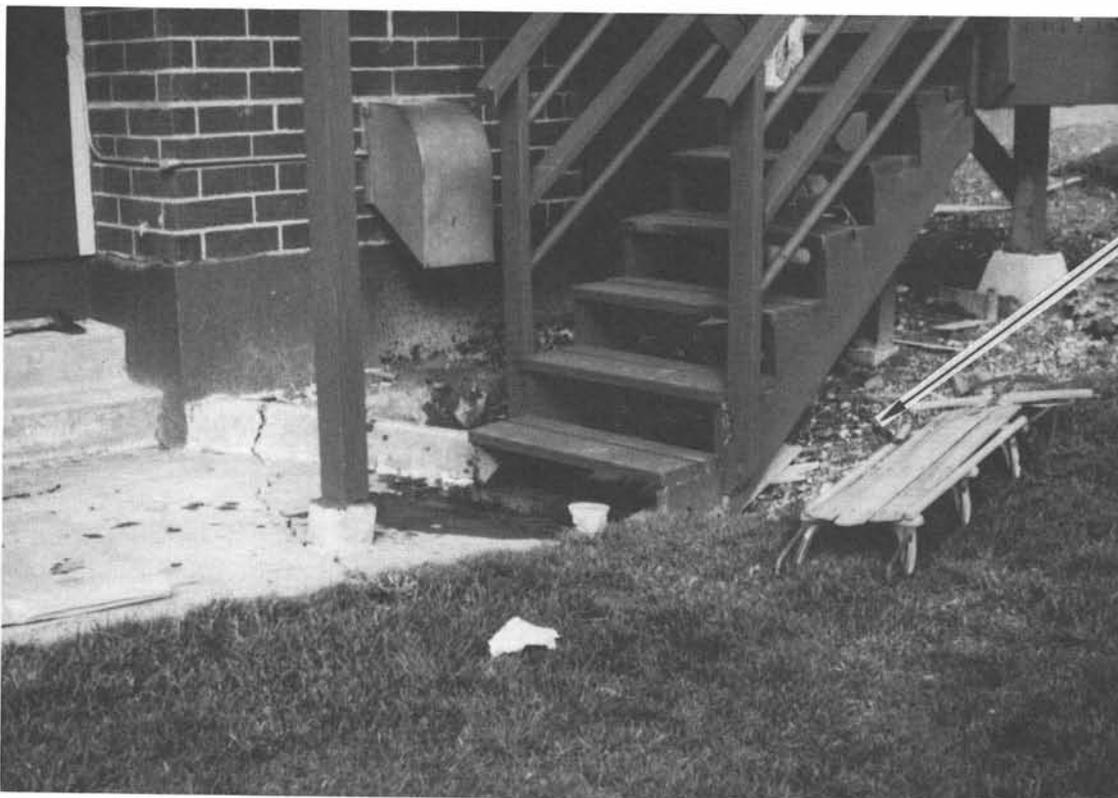
Figure 5. Subsidence on Renton Hill. Tension cracks are visible under staircase (arrow) and patio concrete is cracked. Diameter of the depression is about 6 ft.

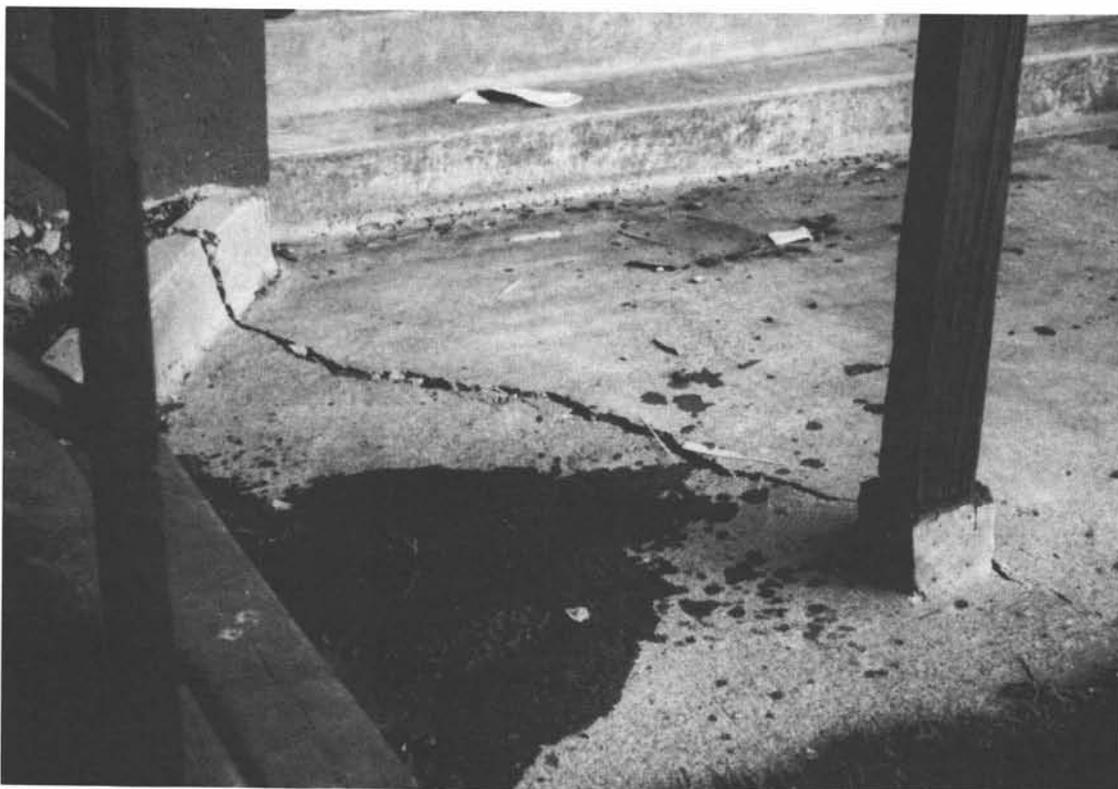
Figure 6. Close-up of damage to patio. Surface slopes about 10° to the right. Note tilt of footing for deck support.

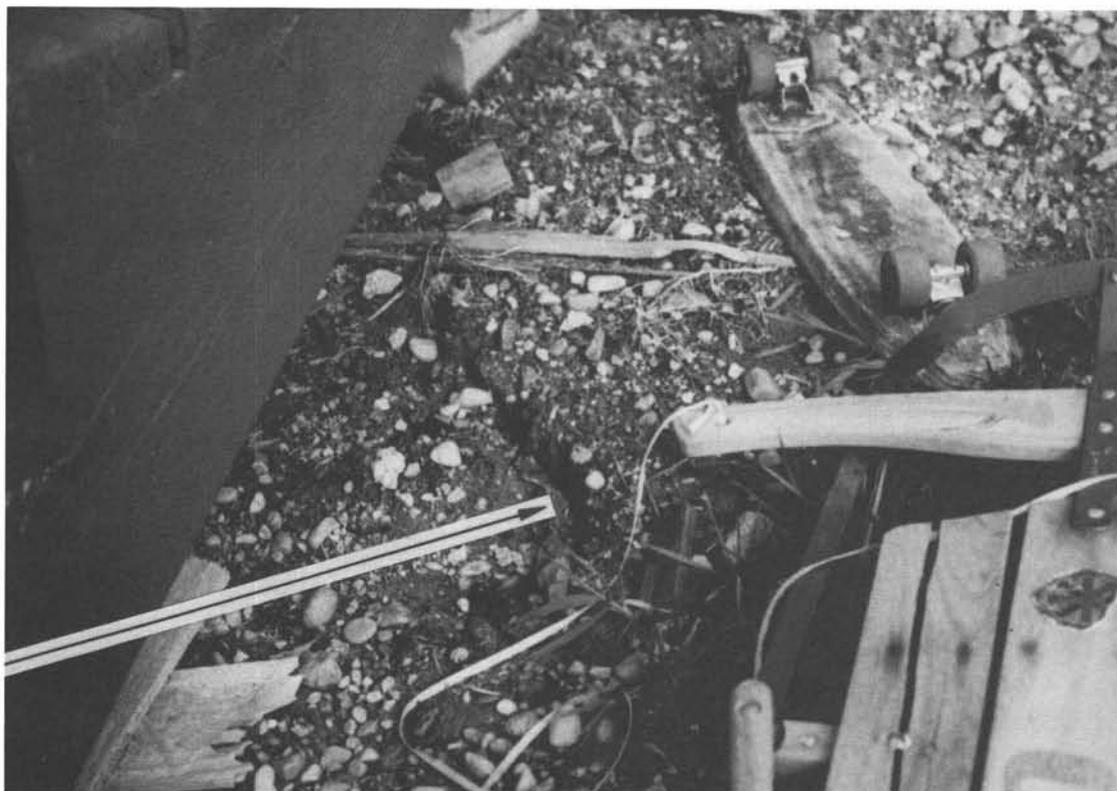
Figure 7. Close-up of tension crack (arrow) under staircase.

In March 1986, another subsidence was noticed by a homeowner who lived about 600 ft south of the subsidence on the Denny-Renton mine that has been reclaimed by OSMRE. The Washington Division of Geology and Earth Resources was notified and one of us (Walsh) investigated the site. A roughly circular area approximately 6 ft in diameter had subsided as much as 10 in., apparently during the preceding night (Figure 5). The most obvious damage had occurred on the concrete patio; subsidence had tilted the footing for the second-story deck 10° to the east (Figure 6). The ground immediately to the east of the patio had also subsided, endangering the stairway, and a tension crack 2 in. wide had opened (Figure 7). Cracking was also visible along the chimney.

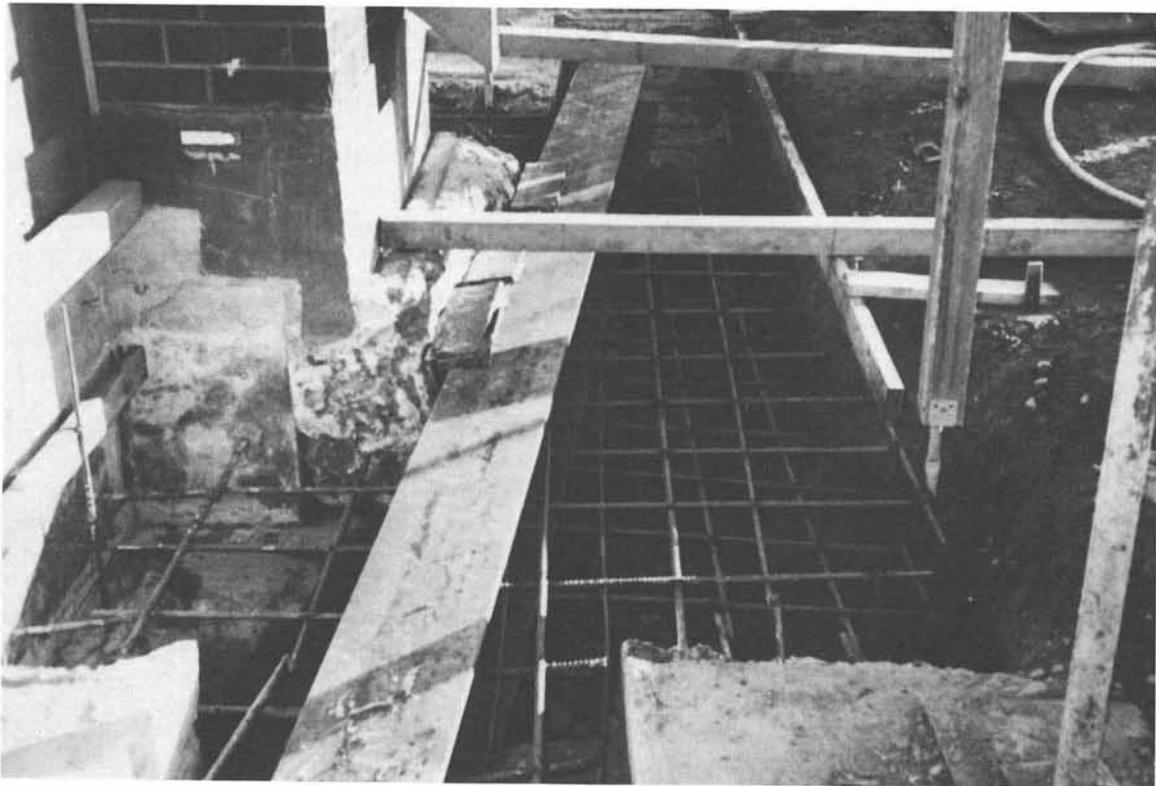
Figure 8. Grade beam during construction.

Based on construction cost, risk of further damage during construction, and potential for successfully preventing further settlement damages, the grade beam method was selected. Design was completed in a matter of a few weeks, and the necessary building permit was obtained on behalf of the owner. OSMRE determined that selection of a construction contractor would be accomplished on a competitive bid basis that was administered by OSMRE. The project was not formally advertised; instead, bids were solicited from contractors experienced in foundation construction and repair. A number of local contractors were contacted and informed of the project. Five indicated interest, but only one attended the initial pre-bid meeting, and no bids were subsequently received. Telephone follow-up indicated the contractors were hesitant to bid because of (1) uncertainty about conditions that would be encountered in the excavation, (2) the amount of paperwork required to meet OSMRE contract requirements, and (3) high risk of owner dissatisfaction compared to anticipated construction cost if the problem were not solved. A second round of contacting perspective contractors was initiated, and two bids were received. The contract was awarded in mid-November 1986, and work was completed within about 3 weeks (Figure 8).

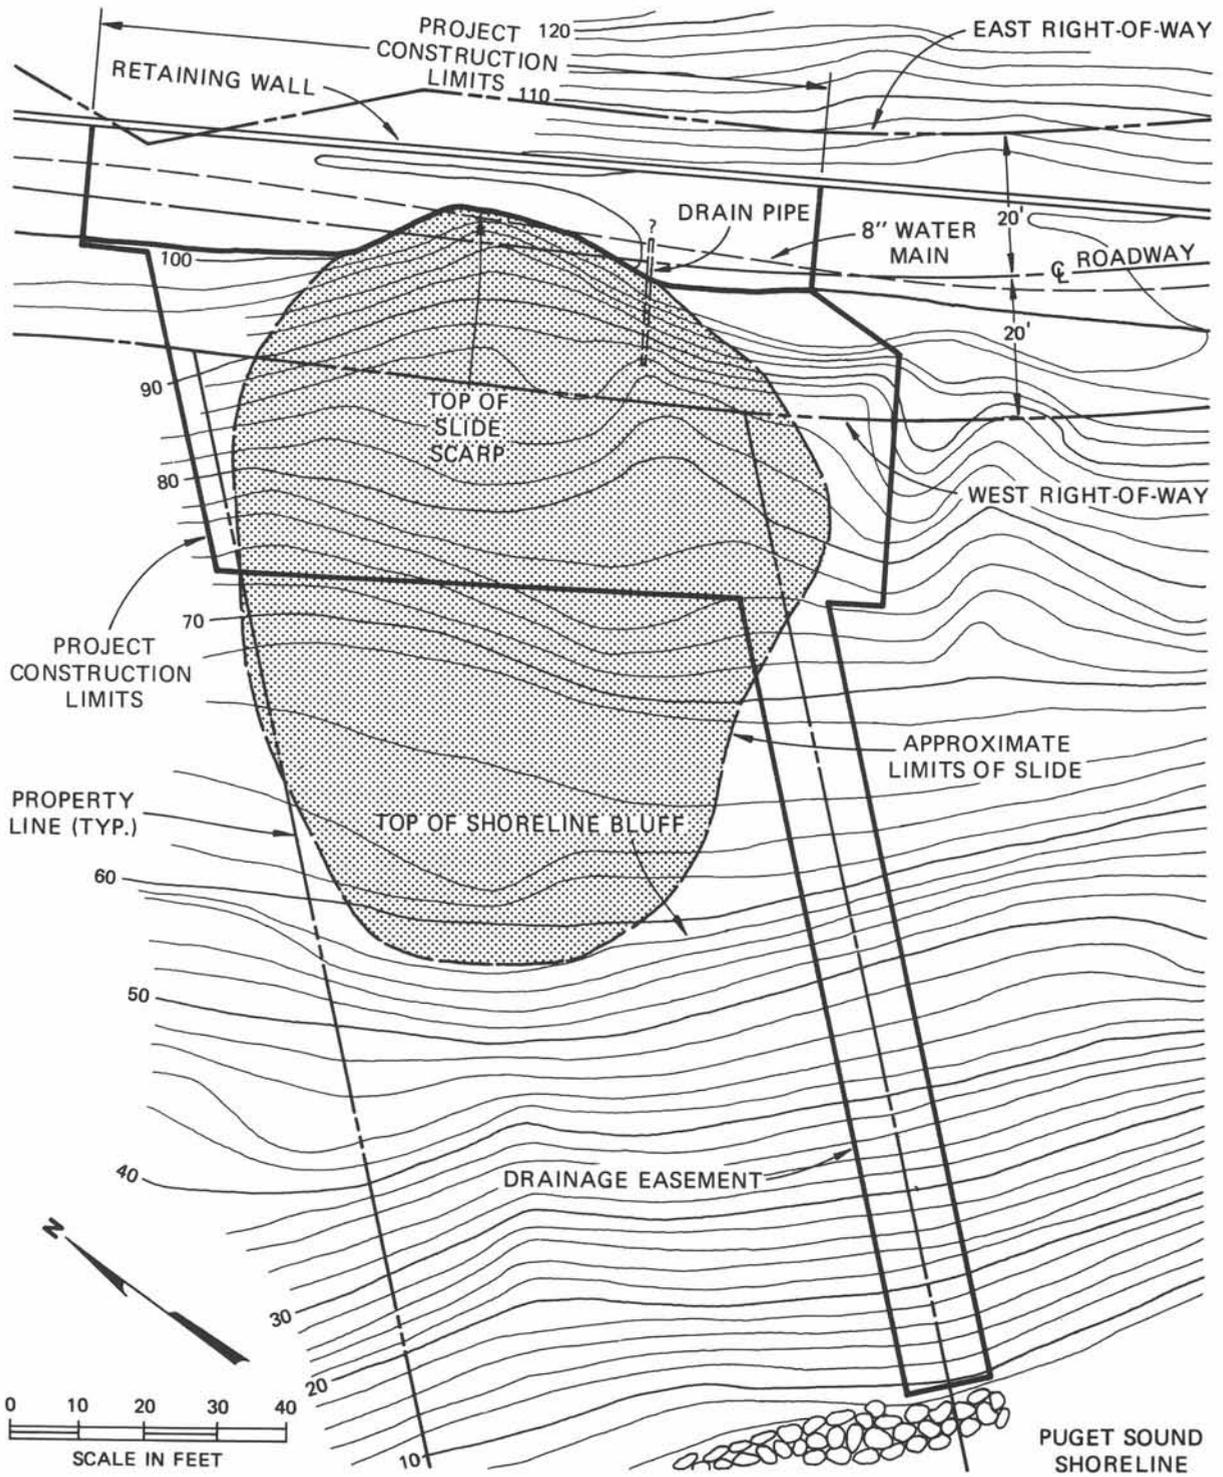
Figure 1. Site plan, including project construction limits and the top of the slide scarp.

appeared to be limited to the previously disturbed surficial soils overlying the undisturbed Lawton clay and silt. The approximate limits of the 1980 slide are shown on Figure 1.

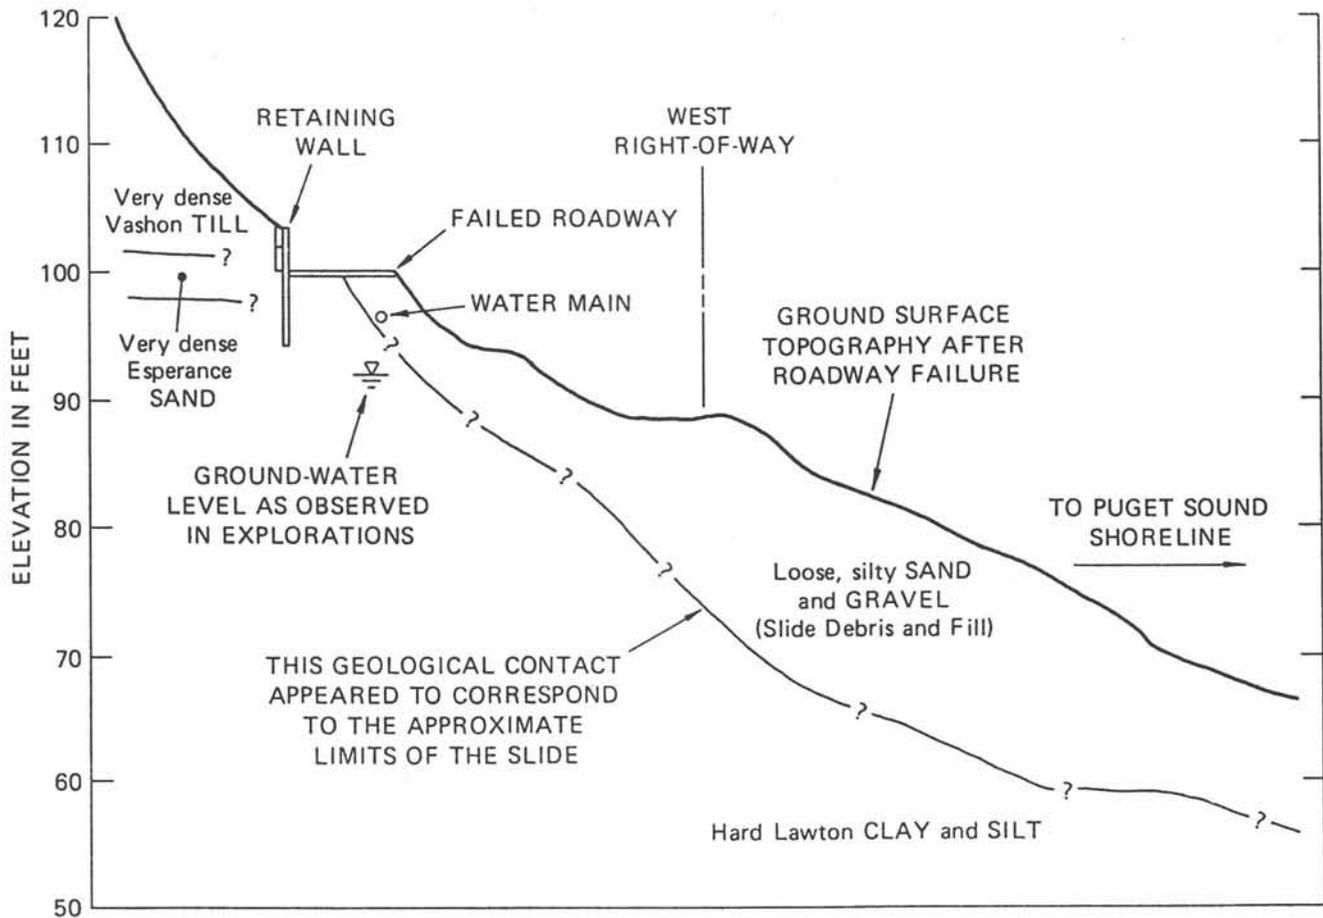
Figure 2. Typical subsurface profile after roadway failure.

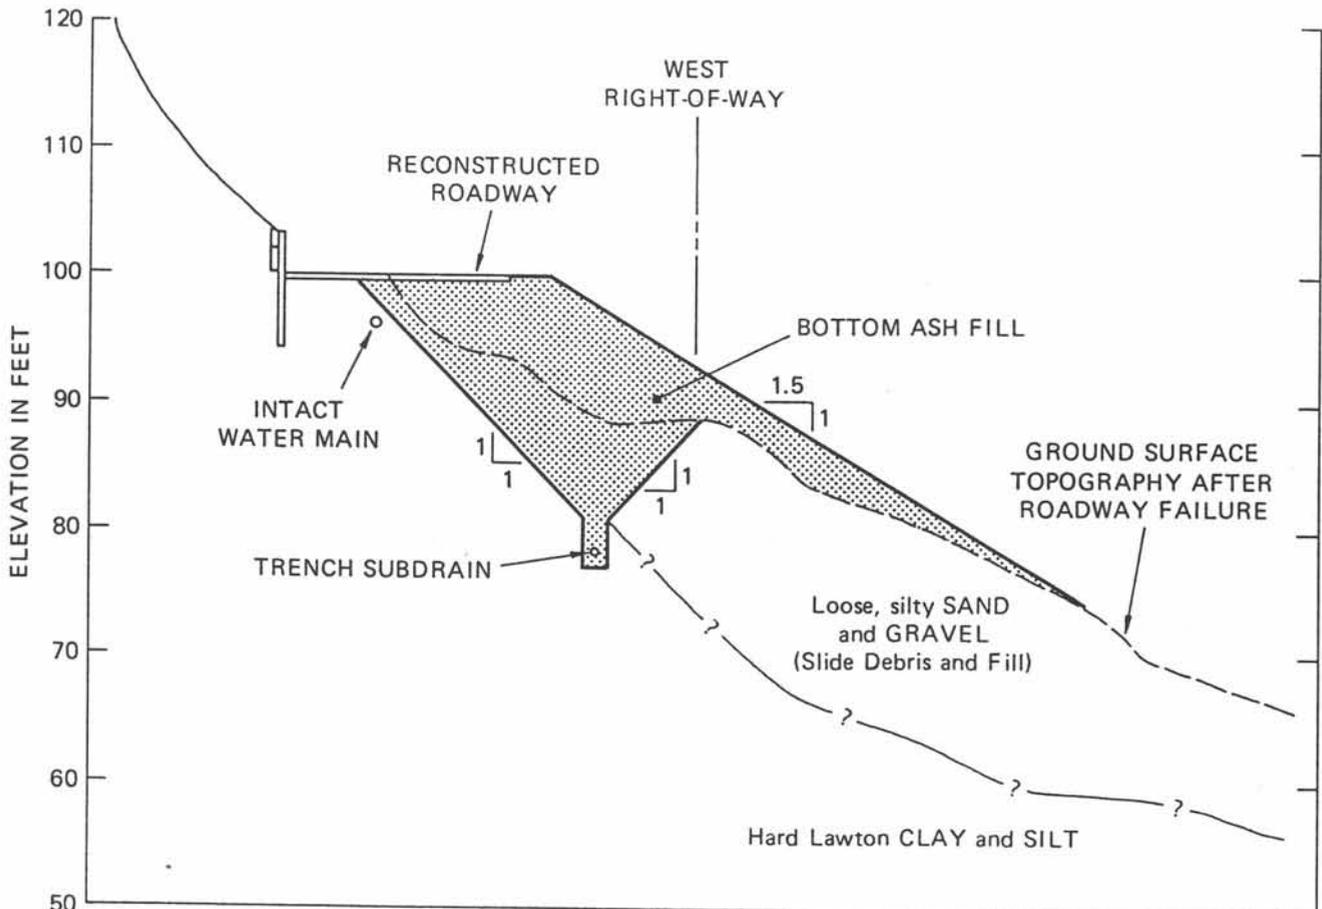
Figure 3. Typical subsurface profile after roadway reconstruction.

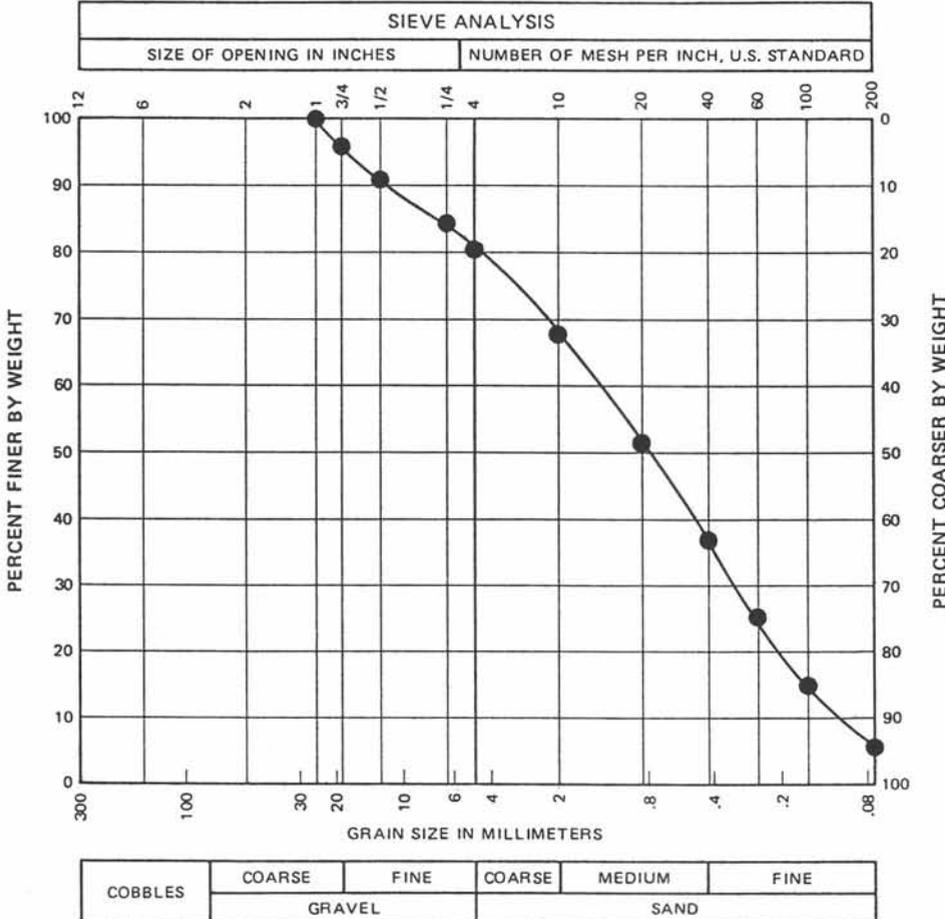
Figure 4. Grain-size distribution for bottom ash.

The bottom ash was selected for its light weight, excellent frictional properties, and good drainage characteristics. A supply of the bottom ash material was readily available at a coal-fired steam generating plant in Centralia, Washington, approximately 100 mi south of the project site. The grain-size distribution curve of typical bottom ash material used in the project (Figure 4) shows that the material is a poorly graded, slightly silty, gravelly sand. Its maximum dry unit weight (Figure 5) is approximately 50 to 60 percent of that determined for a similar naturally occurring sand and gravel deposit. Its light weight is derived from the porous texture that results from intense burning (Seals, et al., 1972).

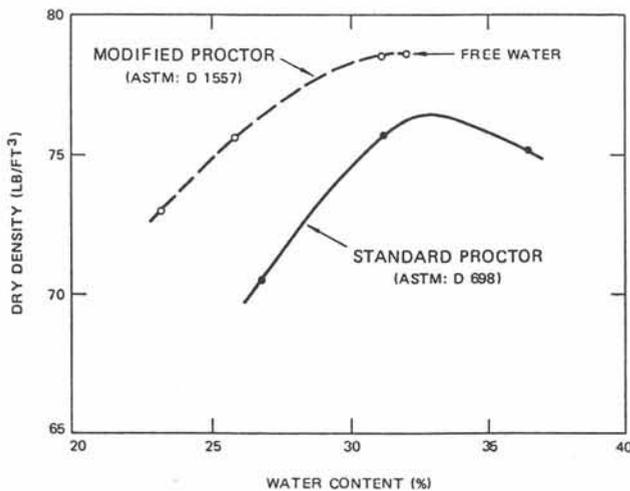
Figure 5. Compaction curves for bottom ash.

The permeability of the ash when compacted to a dry unit weight of about 70 pcf (90 percent of its maximum dry density based on the Modified Proctor test) was determined by laboratory testing to be about 10^{-1} cm/sec. This value is approximately equivalent to that

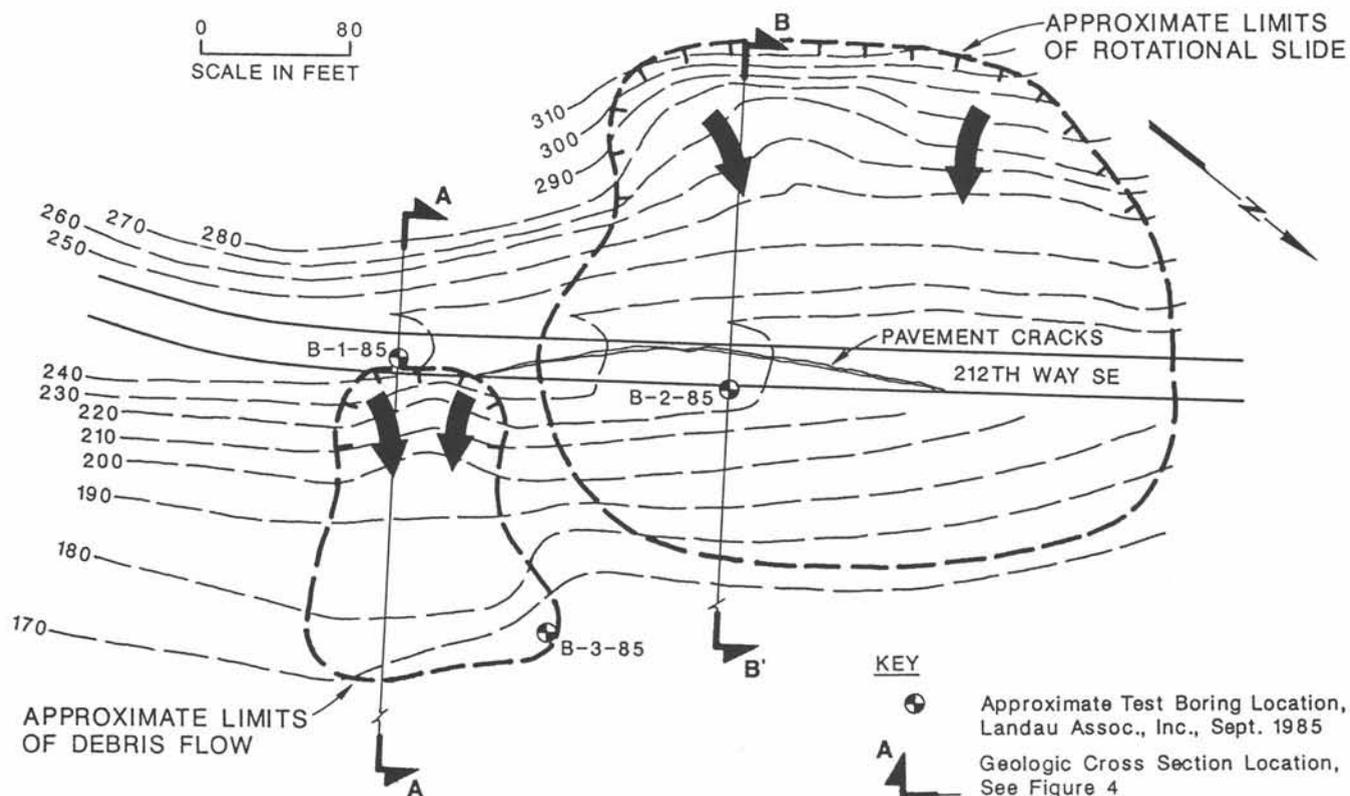
Figure 2. Site plan showing debris flow, rotational slide, and location of test borings and cross-sections.

This study addresses two landslides that occurred within a 450-ft-long segment of 212th Way S.E. in King County, Washington (Figure 1). One of the landslides was a debris flow, the other a rotational landslide. A site plan showing the configuration of the two landslides is presented on Figure 2. Figure 3 is an aerial view of part of the two landslides prior to construction of remedial measures.

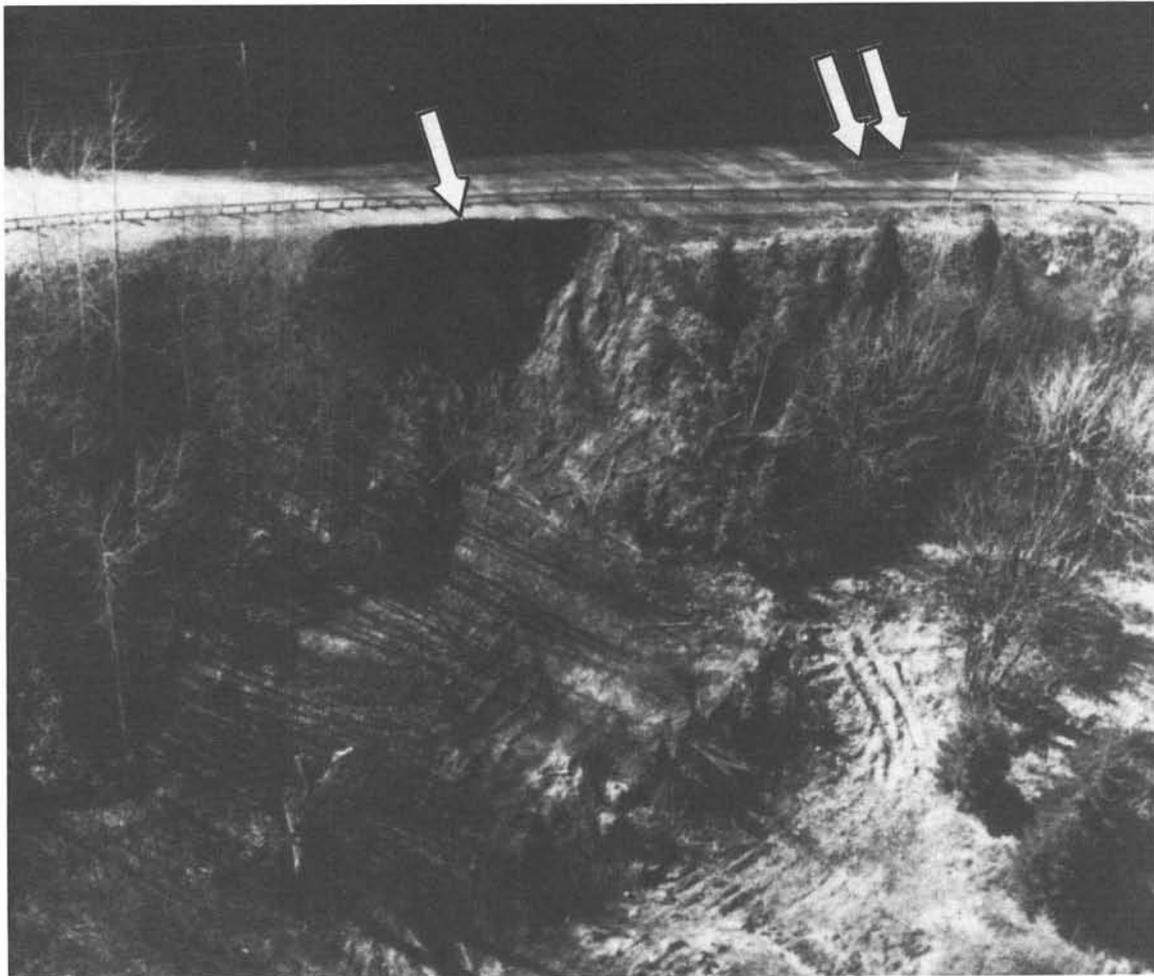
Figure 3. Aerial view of the East Whitney Hill site showing the debris flow (single arrow) and pavement cracking at the rotational slide (double arrow). Debris pile has been partially regraded to facilitate drainage. (Photograph by King County, March 1985.)

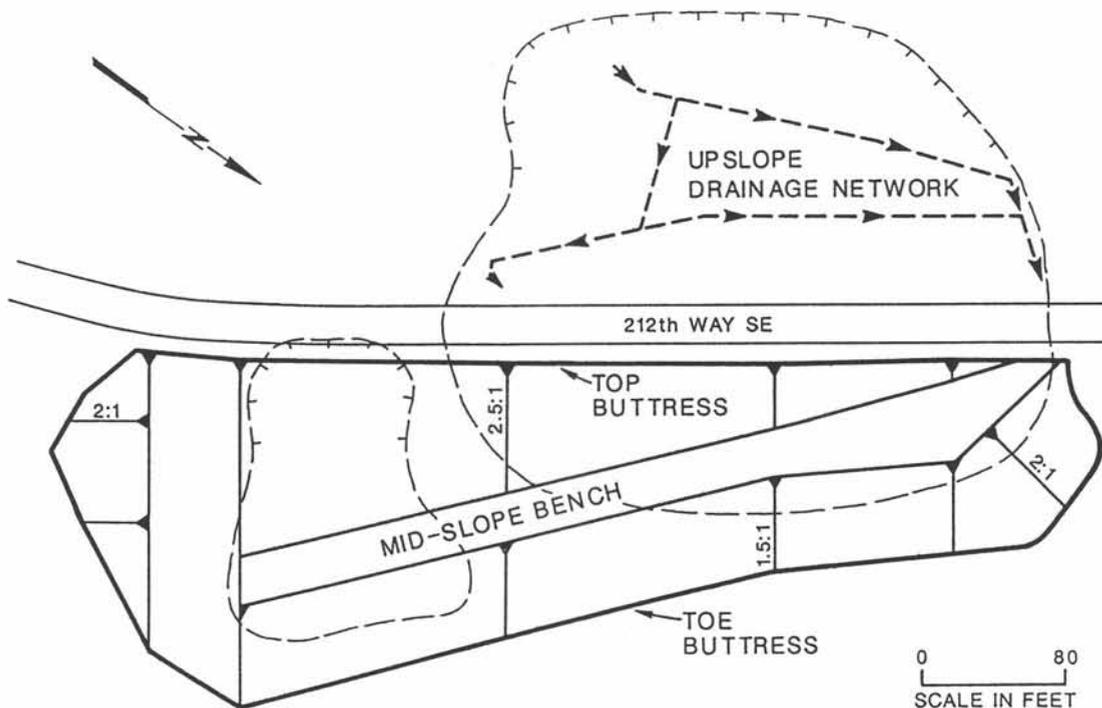
Figure 5. Buttress and drainage network configuration for remediation of the East Whitney Hill landslides.

The buttress built from the final design was approximately 580 ft long, 200 ft in maximum width, and varied from 35 to 80 ft high. A 5-ft-thick (minimum) layer of select granular borrow and two longitudinal underdrains provided drainage beneath the buttress. Approximately 61,000 cy of select and general borrow materials were used for buttress construction.

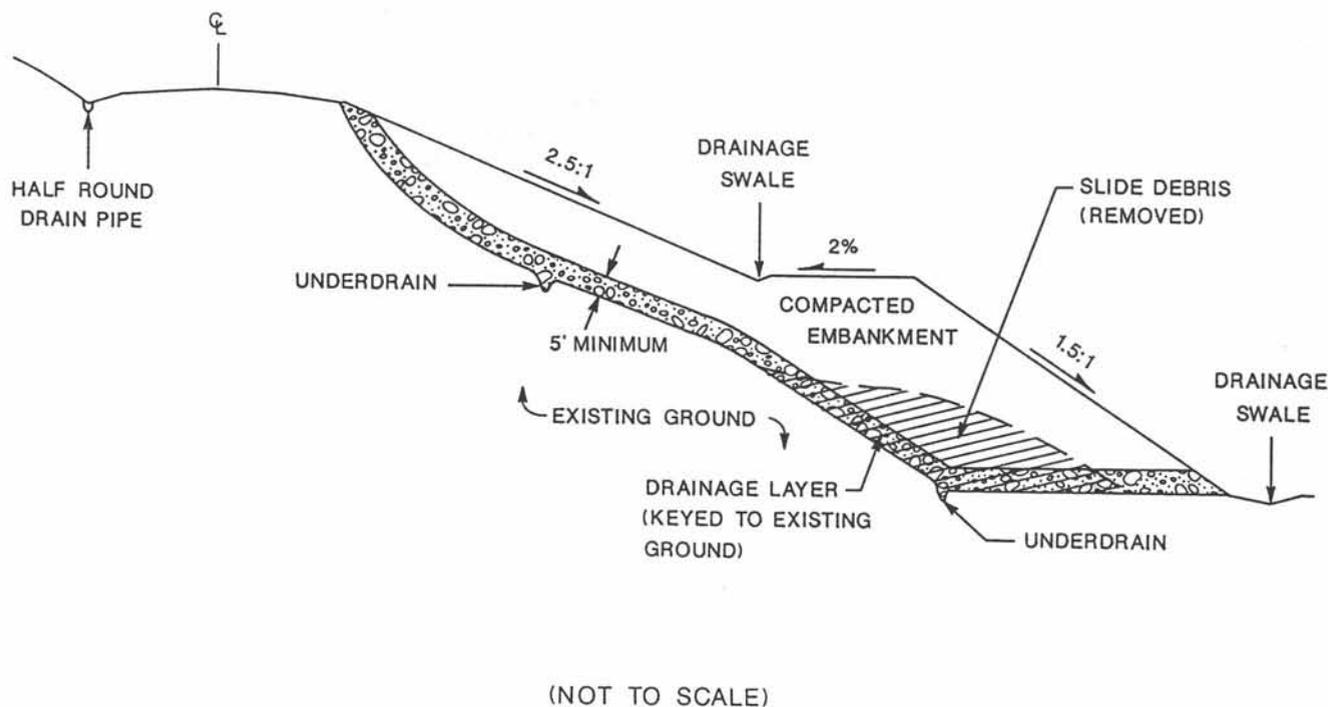
Figure 6. Typical cross-section through buttress at the East Whitney Hill site.

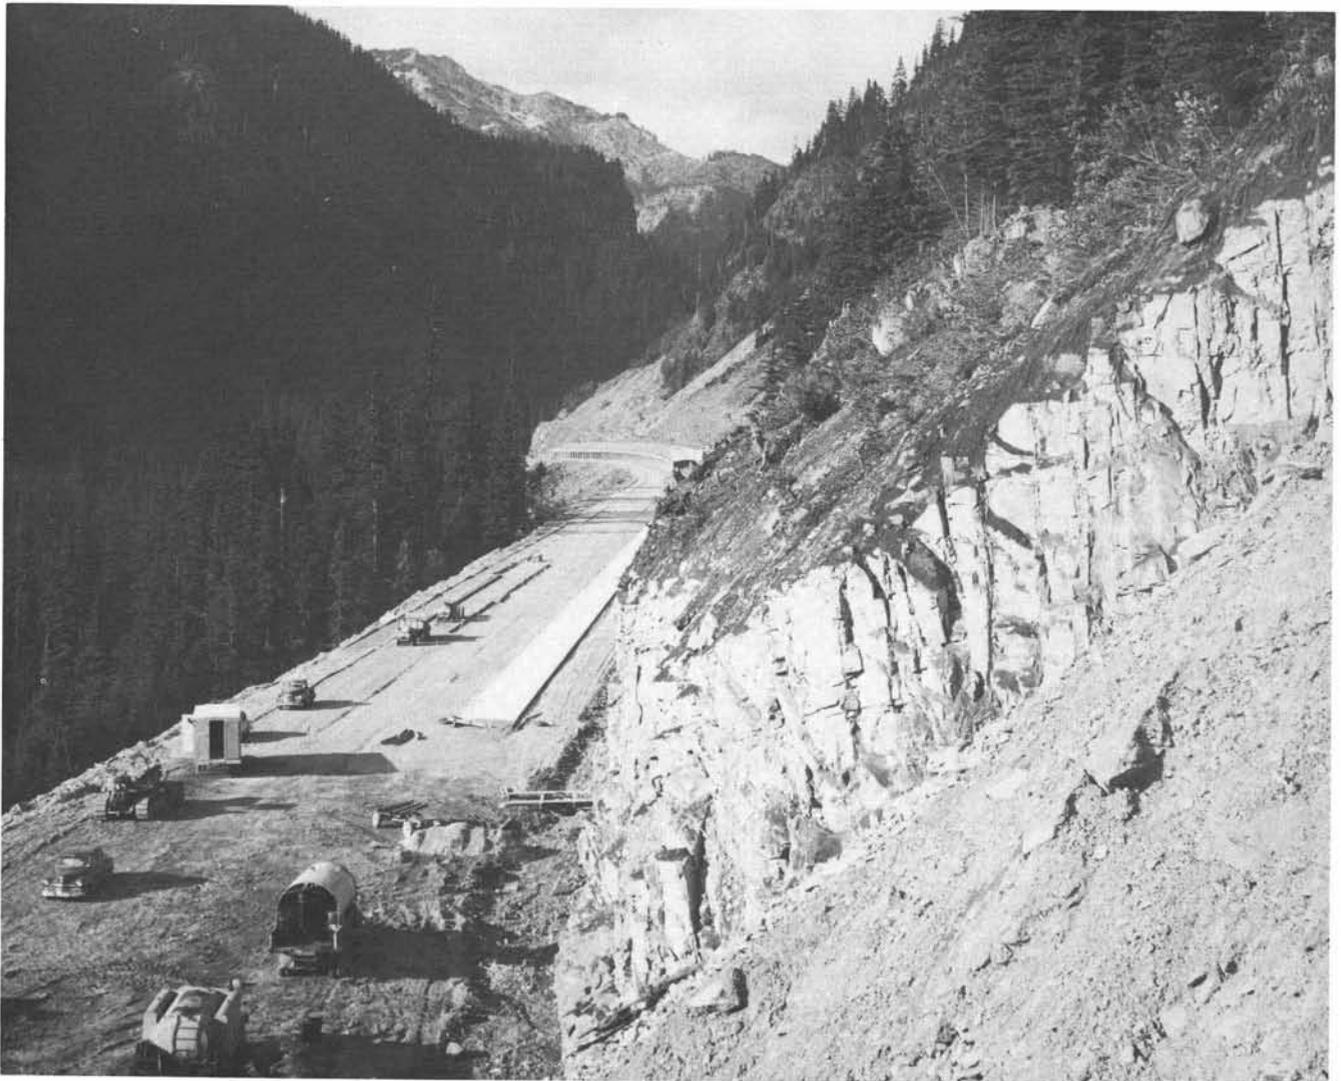
Interstate Highway 90, eastbound lanes construction west of the summit showing the north end of the Snoqualmie Pass rock slide after the road was cleared. Snowsheds (center) have subsequently been removed. Photograph by H. A. Coombs.

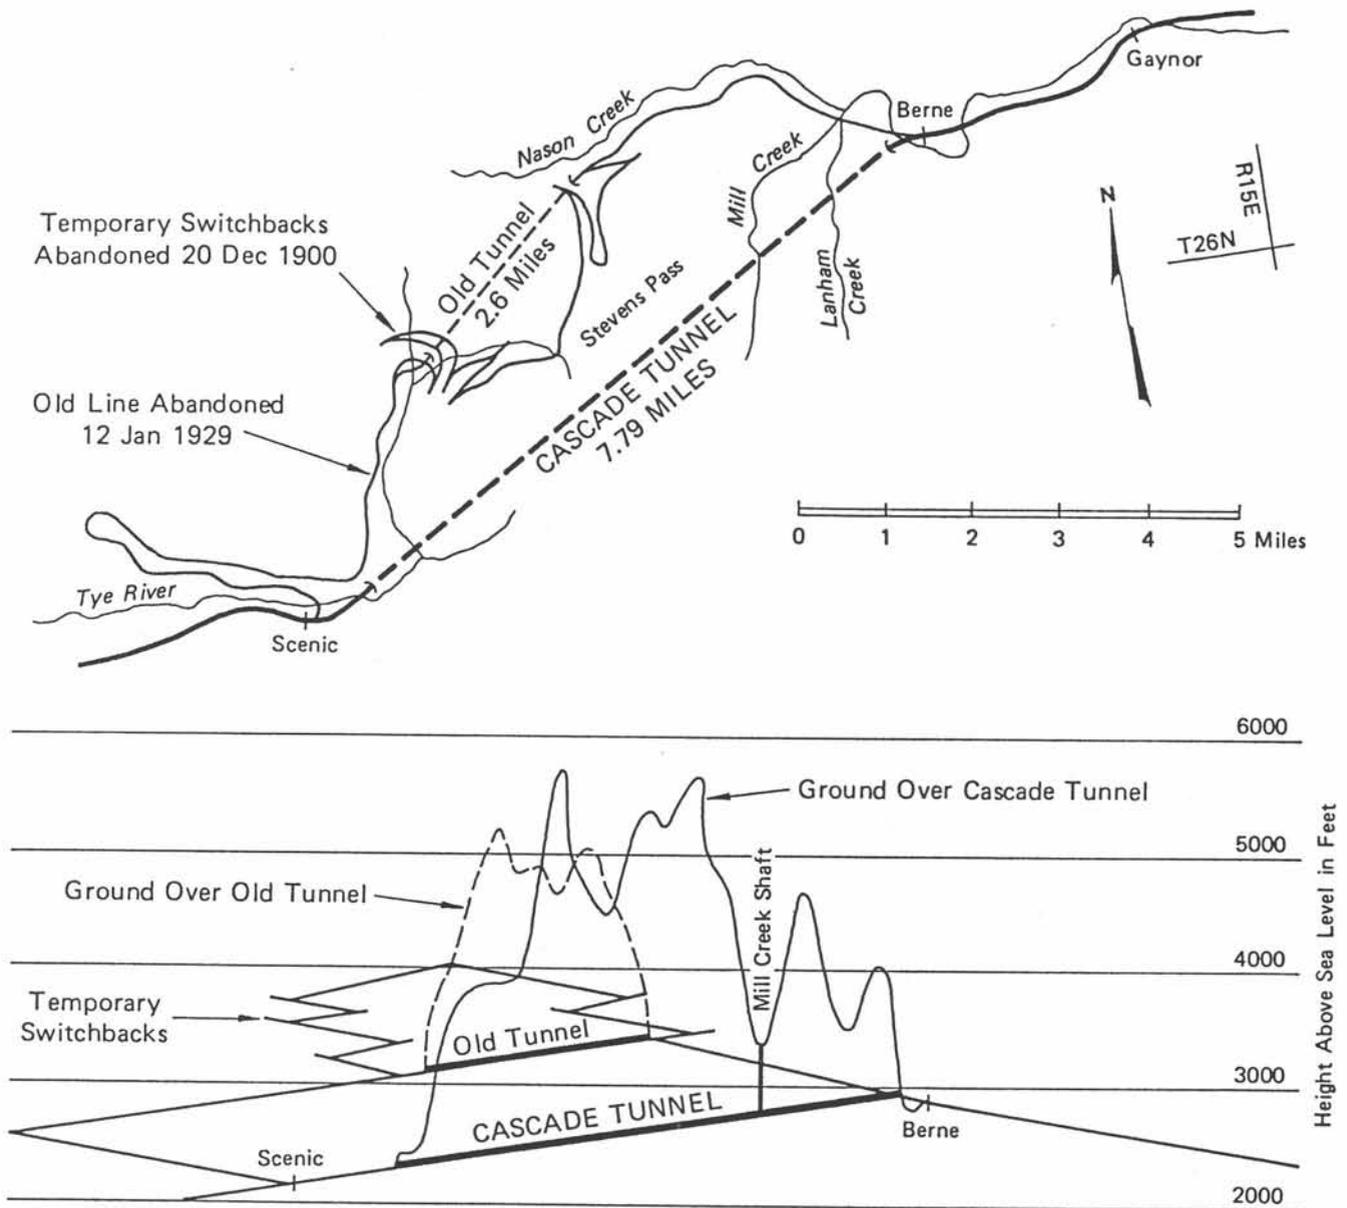
Figure 1. Plan and profile of Cascade Range crossing.

The Cascade Tunnel is a 41,152-ft-long, single-track, tangent tunnel and is on a 1.56 percent grade descending from east to west (Figure 1). The tunnel substantially lowered the summit elevation, reduced distances and curvature, and eliminated snowslide hazards, expensive maintenance on about 6 mi of snowsheds, and costs for snow removal along the Cascade crossing. Table 1 compares the old and new lines between Berne and Scenic (Kerr, 1932).

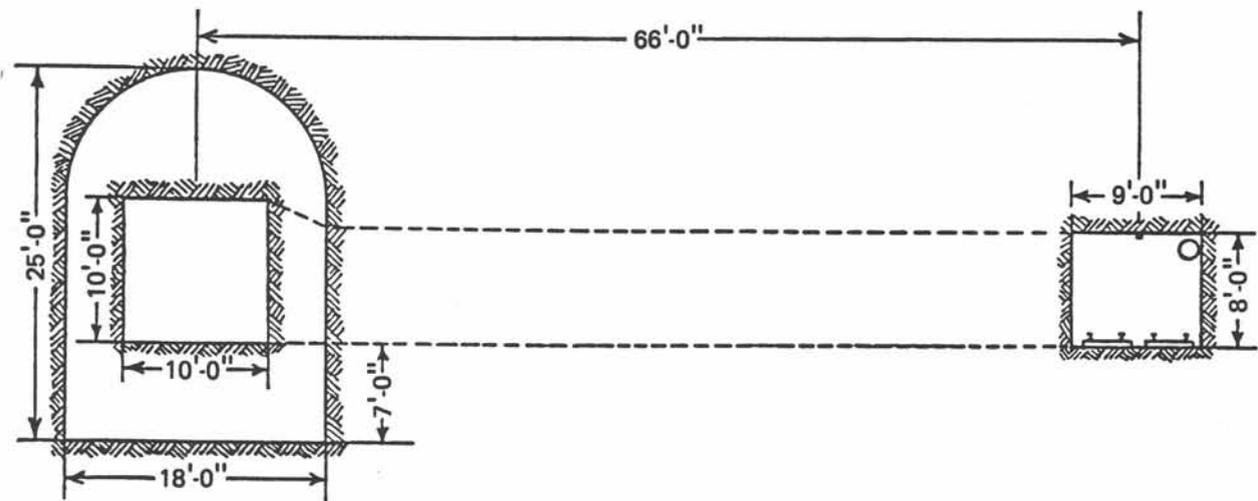
Figure 2. Cross section of center heading, main tunnel, and pioneer tunnel. From Baxter (1932) by permission, American Society of Civil Engineers.

The method chosen to provide the additional work faces in the tunnel west of the shaft was a small pioneer tunnel, parallel to the main tunnel and with crosscuts to the main tunnel alignment. The pioneer tunnel method had been used successfully to achieve high excavation rates in the Simplon Tunnel in the Swiss Alps and the Connaught Tunnel in the Selkirk Mountains of British Columbia (Baxter, 1932). This method also provided flexibility in dealing with different ground and water conditions. The pioneer tunnel was driven eastward from the west portal and westward from the Mill Creek shaft.

The pioneer tunnel also served as the primary access for supplies and for muck removal from faces opened up from the cross cuts, all of which improved the efficiency of the enlargement drilling, blasting, and mucking operations in the main tunnel. Also, compressed air, water, electrical power lines, and forced air for ventilation were supplied through the pioneer tunnel. The pioneer tunnel also provided drainage for water encountered during construction and operation of the main tunnel. Additionally, if future business warranted, a pioneer tunnel could be enlarged to a single-track tunnel at a significant cost saving.

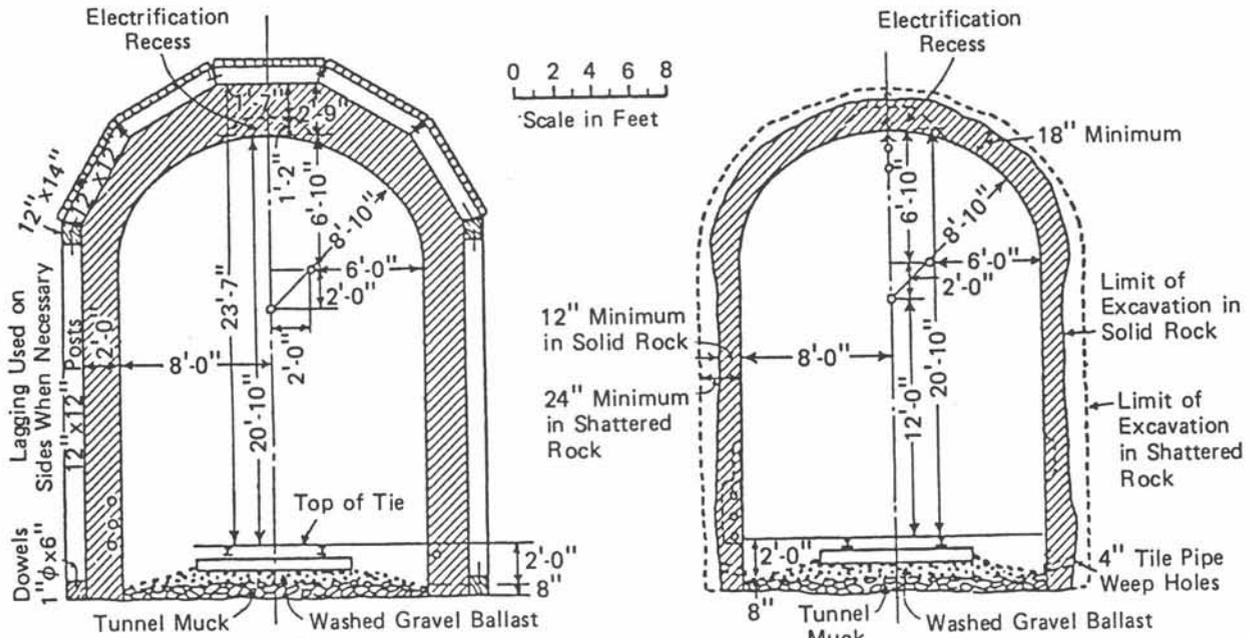
Figure 3. Typical timbered and self-supporting tunnel sections. From Mears (1932) by permission, American Society of Civil Engineers.

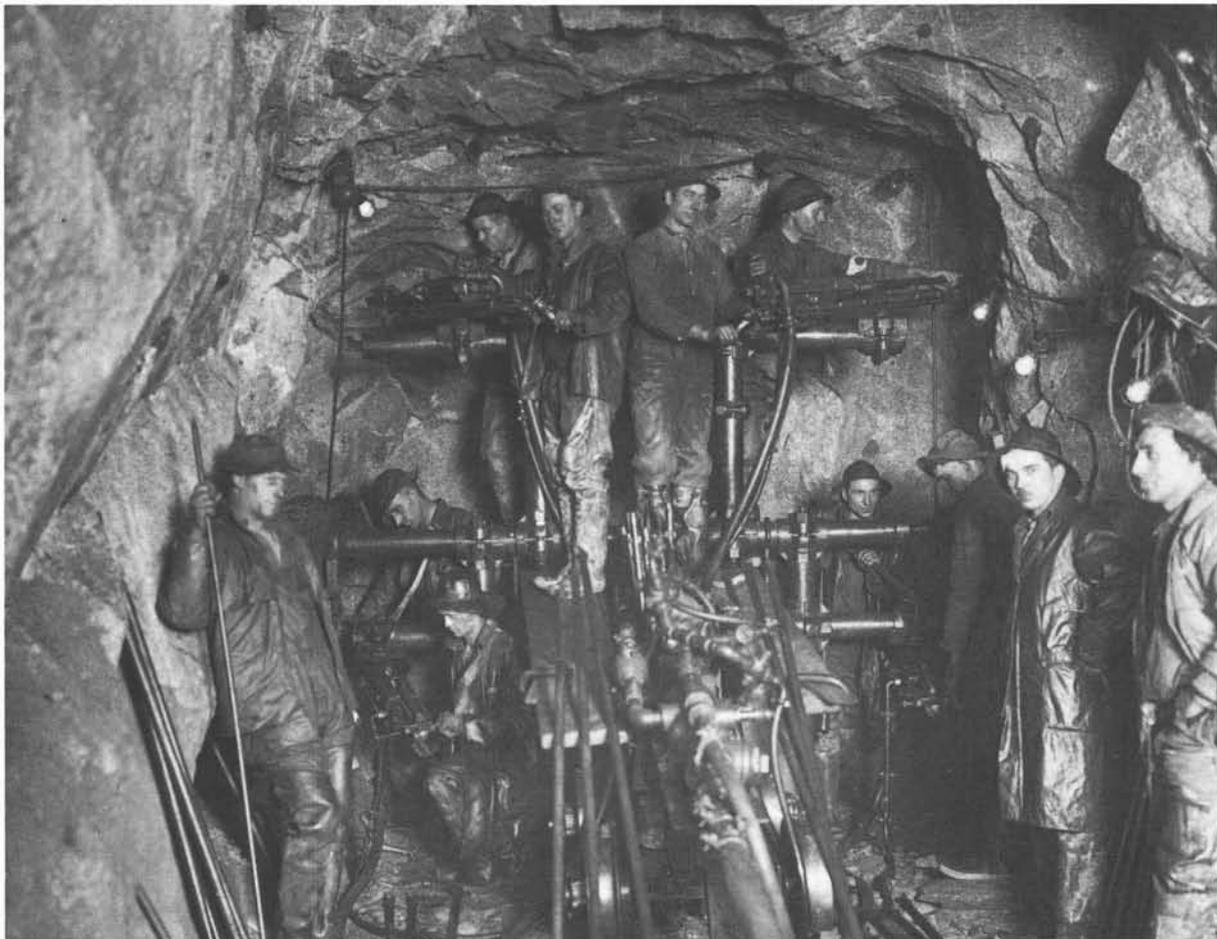
Figure 4. Sullivan drill carriage in center heading. Courtesy of Special Collections Division, University of Washington Libraries; photo by L. Pickett, negative 3762.
