ENGINEERING GEOLOGY IN WASHINGTON

Volume II

BULLETIN 78

Runoff and Stream-Channel Changes Following Urbanization in King County, Washington

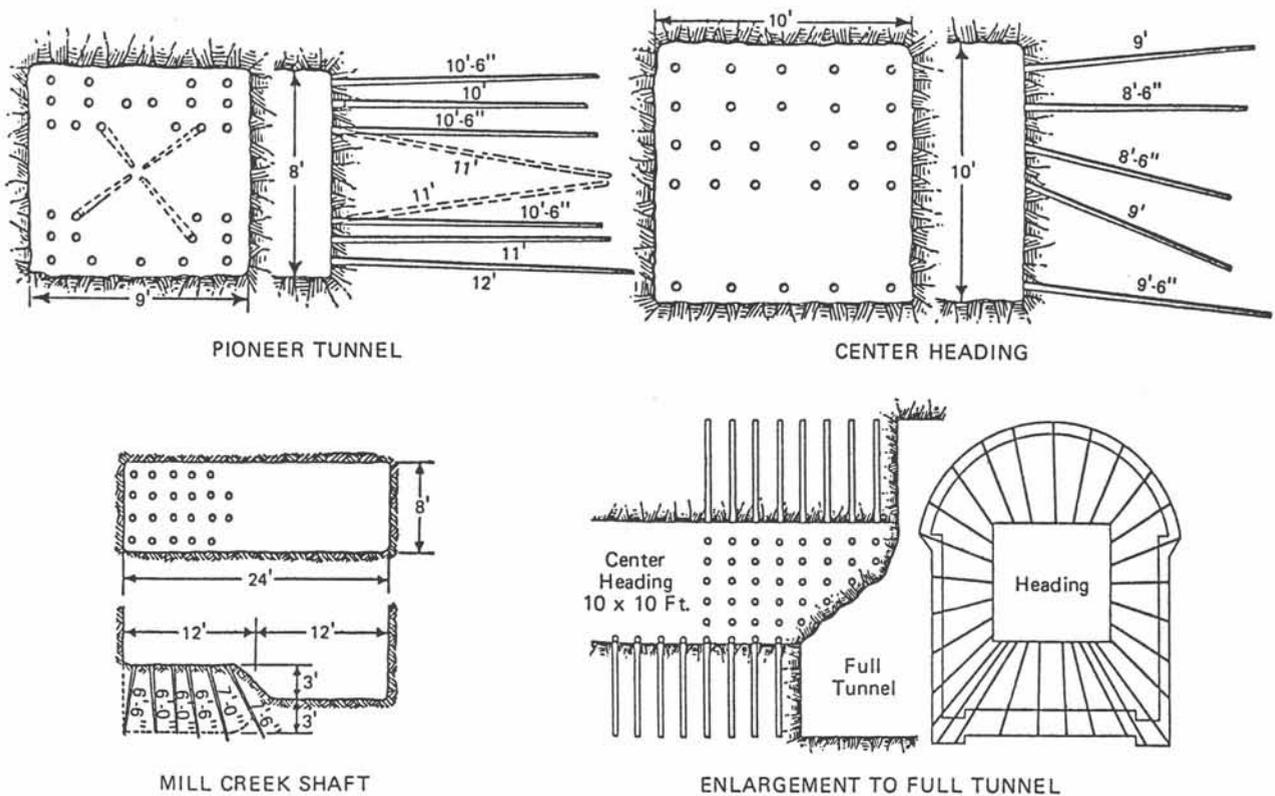
Figure 5. Typical blast hole patterns. From Baxter (1932) by permission, American Society of Civil Engineers.

About 8 to 10 lb of 60 percent dynamite per cubic yard of rock was used for each round in the pioneer tunnel and center heading. The rounds used as many as six different delays and were fired with electric blasting caps.

The shaft was sunk with a stepped bench method that permitted simultaneous drilling and mucking operations in different halves of the shaft, as shown in Figure 5. Drilling of the blast holes was done on the bench while the other side was being mucked out. The shaft round was also charged with 60 percent dynamite and fired with electric blasting caps.

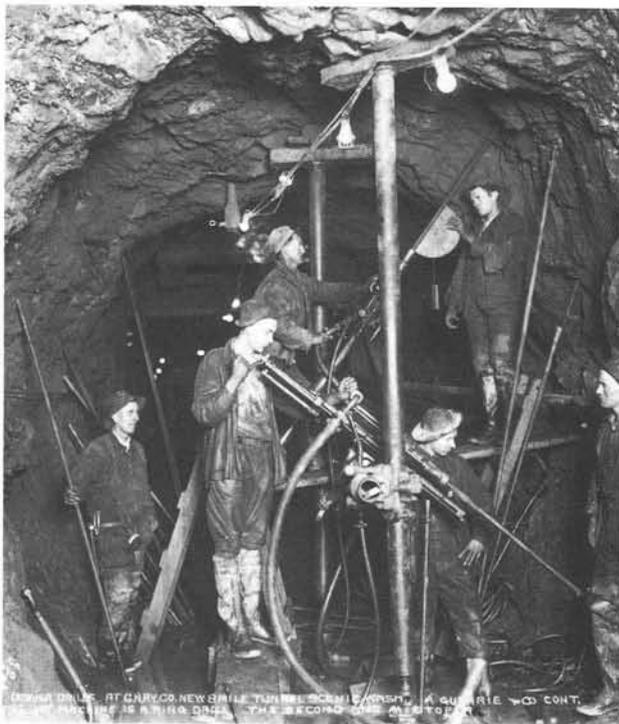
Figure 6. Ring drilling in center heading for enlargement to full tunnel. Courtesy of Special Collections Division, University of Washington Libraries. Photo by L. Pickett, negative 3534

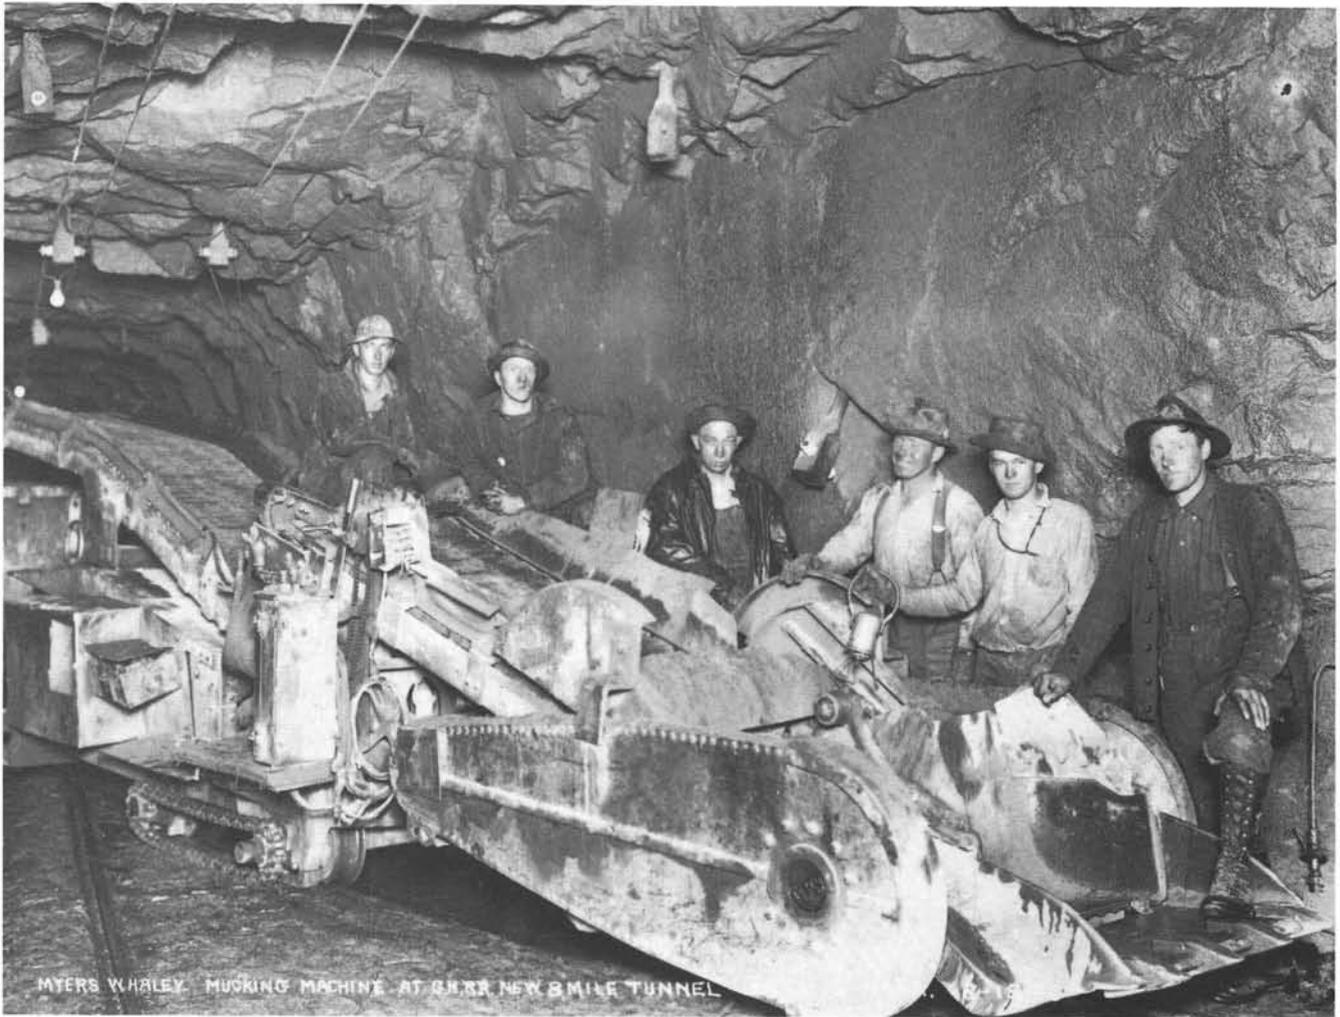
Figure 7. Myers-Whaley mucking machine. Courtesy of Special Collections Division, University of Washington Libraries. Photo by L. Pickett, negative 3257.

Mucking in all the smaller headings was generally accomplished with track-mounted Myers-Whaley mucking machines that loaded side dump cars (Figure 7). Two 24-in. gauge tracks were used in the smaller drifts from the heading to the last cross cut and spaced so that the two inner rails were at 24-in. gauge also. The mucker and drill carriage used this inner track. The 50-cu-ft dump cars were transported in and out of the tunnel, as shown in Figure 8, with 6-ton trolley electrical locomotives.

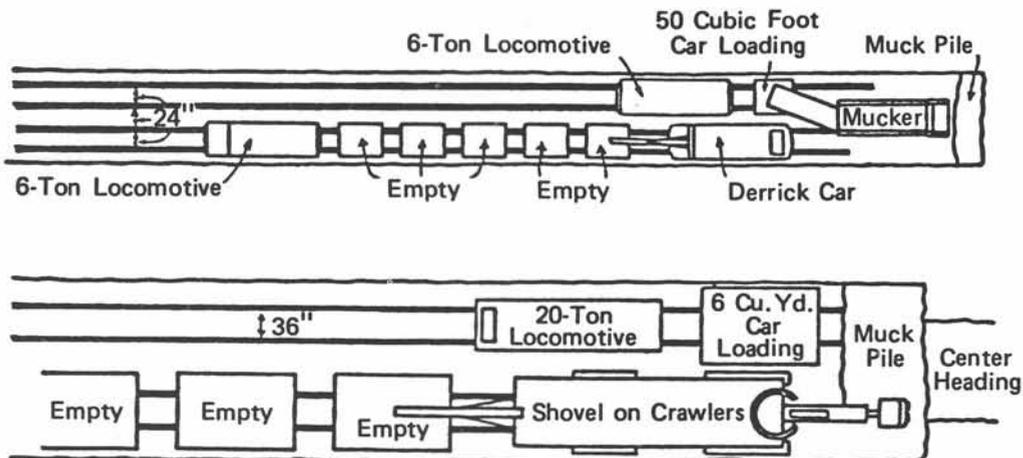
Figure 8. Dump car switching in drifts and main tunnel. From Baxter (1932) by permission, American Society of Civil Engineers.

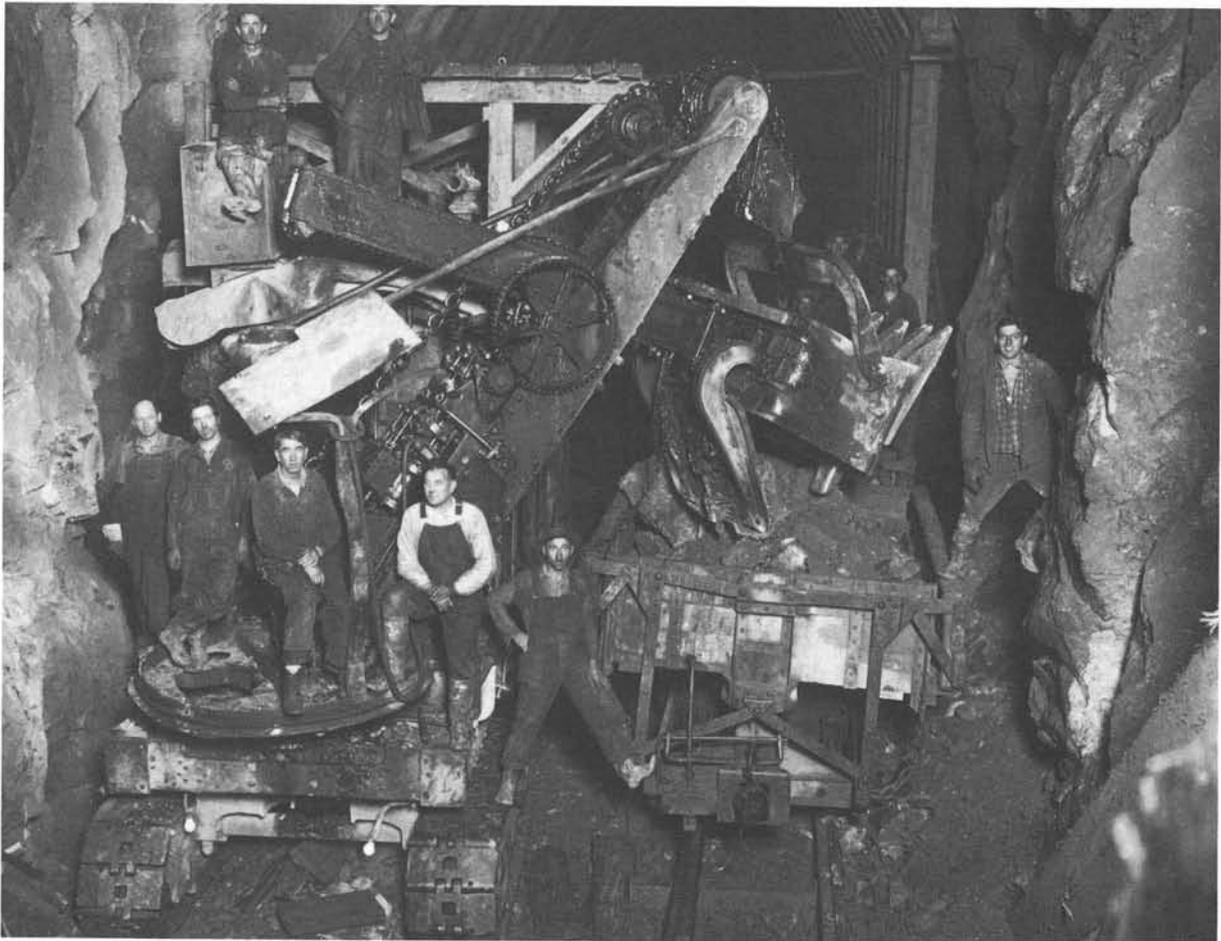
Figure 9. Marion power shovel and dump car in main tunnel. Courtesy of Special Collections Division, University of Washington Libraries. Photo by L. Pickett, negative 3535.

The two full tunnel faces at the portals and the westward face from the shaft were mucked out with Marion air-driven power shovels, modified from steam power and sized to work within the tunnel (Figure 9). The 6-cy dump cars were transported by 20-ton, 3-ft-gauge electric locomotives operated on a trolley (Baxter, 1932).

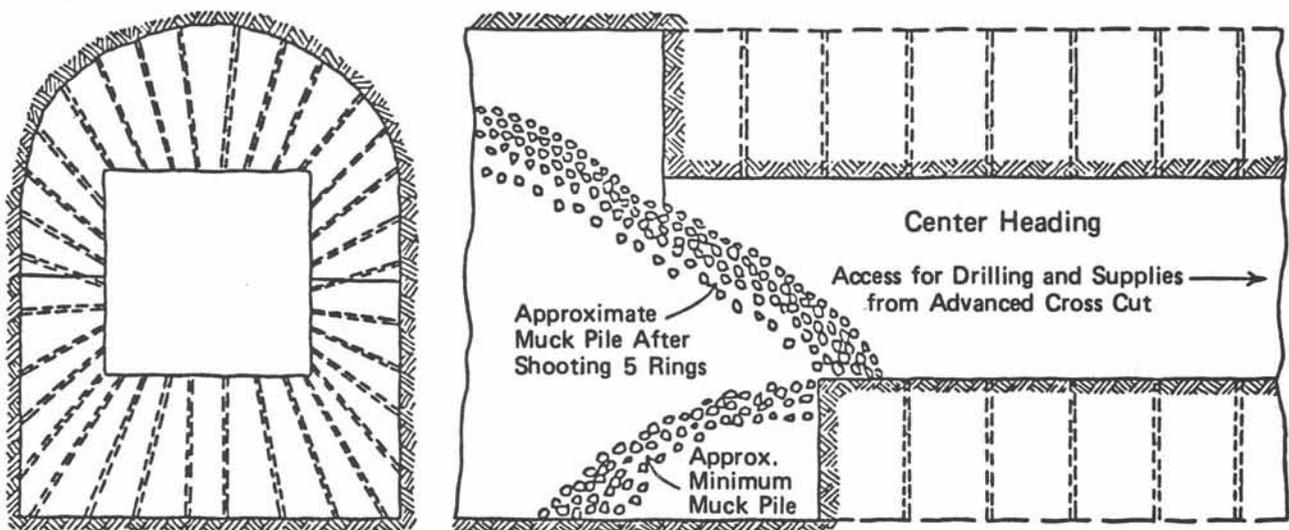
Figure 10. Excavation by ring drilling from center heading. From Baxter (1932) by permission, American Society of Civil Engineers.

Five different excavation and support methods were generally used to construct the main tunnel, depending on the ground conditions encountered (Baxter, 1932). The first method was the center heading, which was later enlarged by ring drilling as shown in Figure 10. This was the basic method used in the main tunnel, where the ground in the full section was able to stand without timber supports.

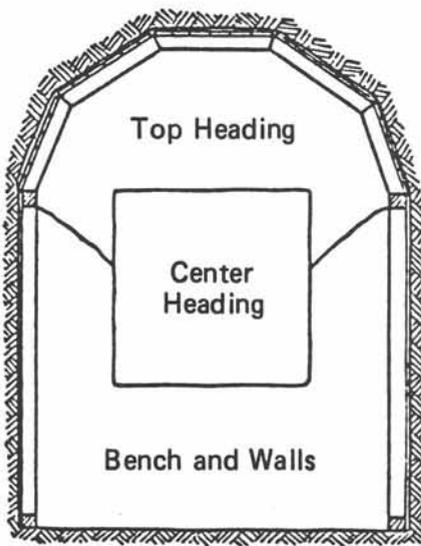
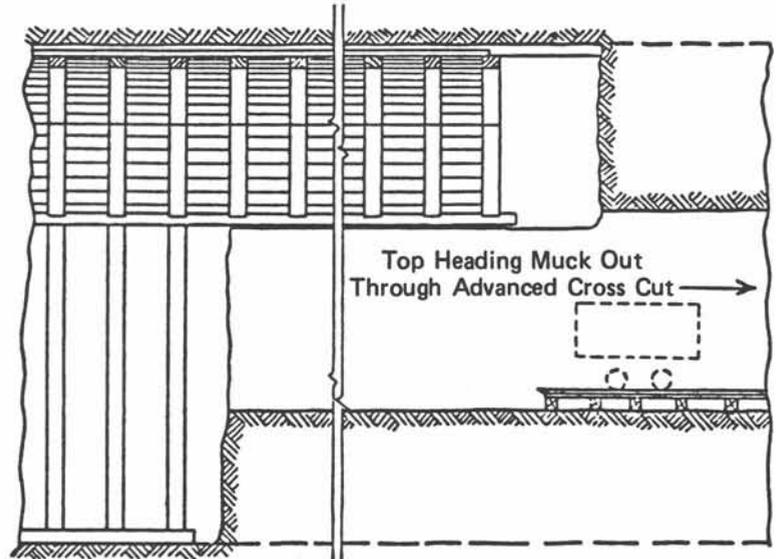
Figure 11. Excavation by center heading followed by top heading and bench. From Baxter (1932) by permission, American Society of Civil Engineers..

The second method was the center heading followed by a top heading and bench, as shown in Figure 11. This approach was used in ground that could not stand without timbering the full section. Following the top heading excavation, five wooden arch segments, 12 in. by 12 in., were placed on a wooden wall plate or beam located at the springline. Later, excavation of the bench allowed the placement of wooden posts to support the wall beam and arch. The timber supports were spaced according to the ground conditions, but they were generally on 2- to 4-ft centers.

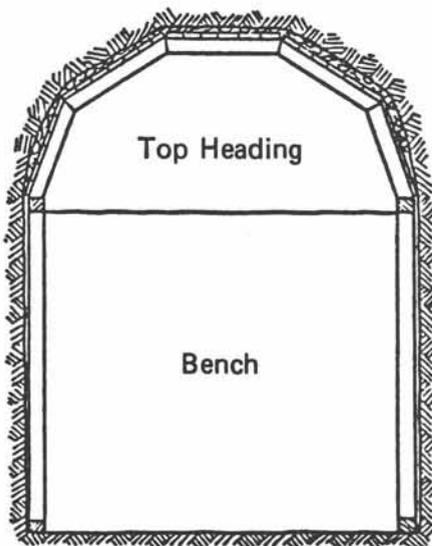
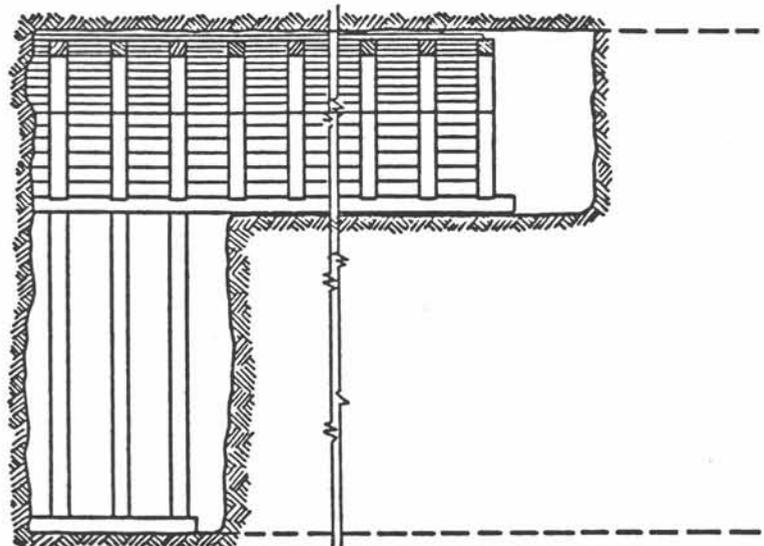
Figure 12. Excavation by top heading and bench. From Baxter (1932) by permission, American Society of Civil Engineers.

The third method involved a top heading and bench, as shown in Figure 12. This was used in advance of the center heading where the ground conditions in the pioneer shaft indicated the full tunnel section could not stand without timber supports. Timbering of the top heading is shown in Figure 13.

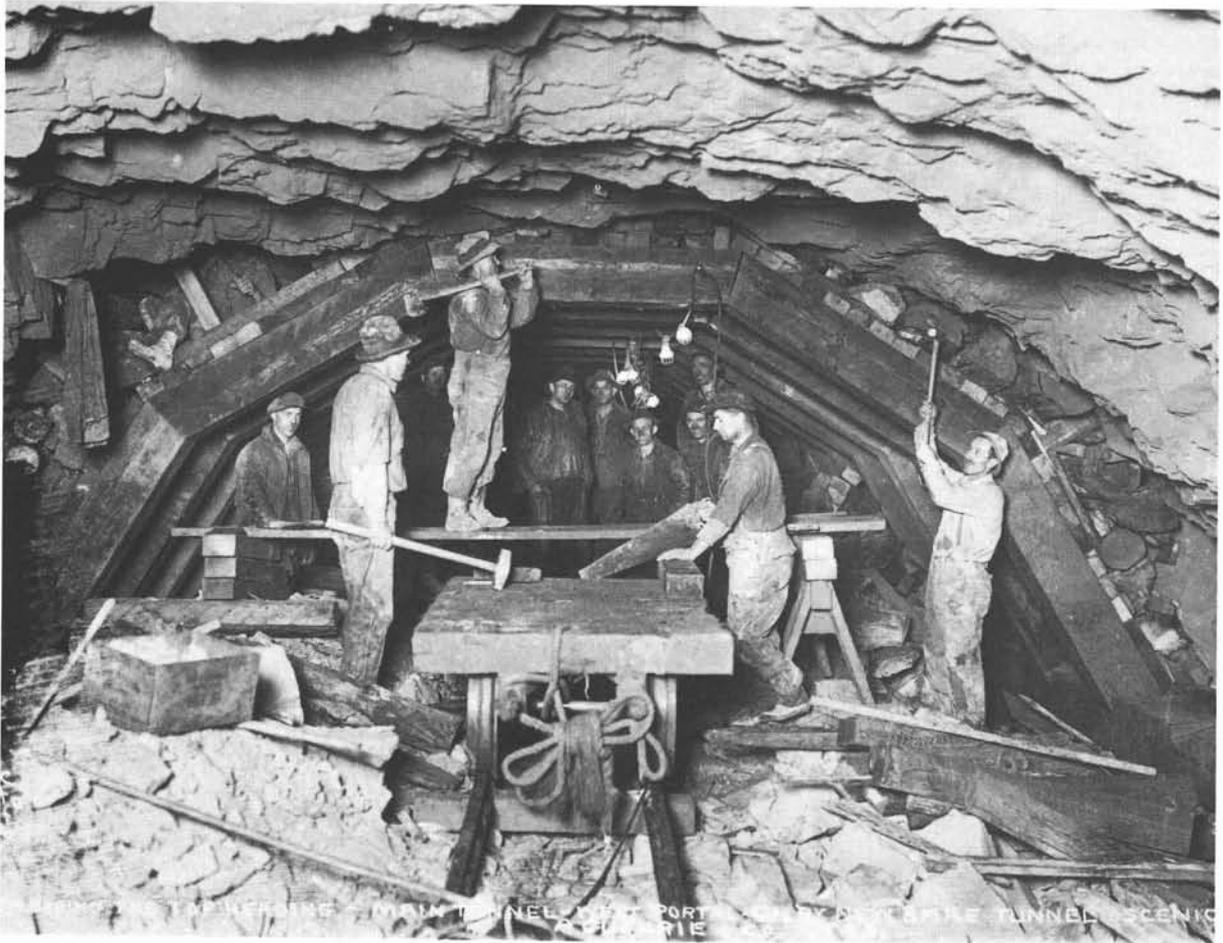
Figure 13. Placement of timber arch supports in top heading. Courtesy of Special Collections Division, University of Washington Libraries. Photo by L. Pickett, negative 3306.

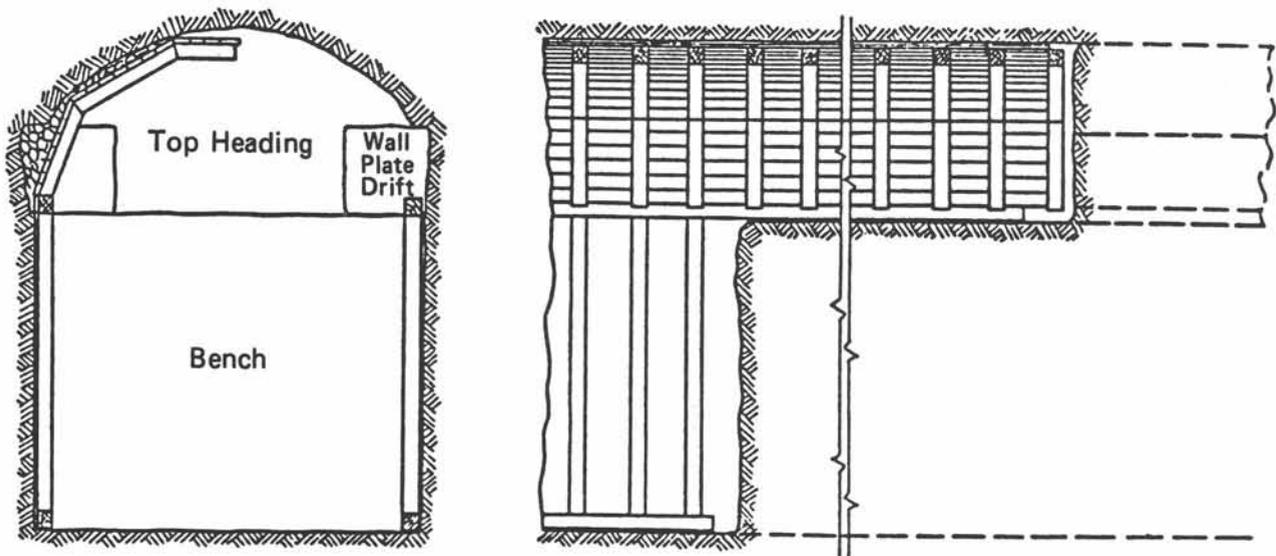
Figure 14. Excavation of wall plate drifts followed by top heading and bench. From Baxter (1932) by permission, American Society of Civil Engineers.

The fourth method, wall plate drifts followed by top heading and bench, was also used in advance of the center heading, as shown in Figure 14. This was used in ground that could not stand unsupported in a full top heading.

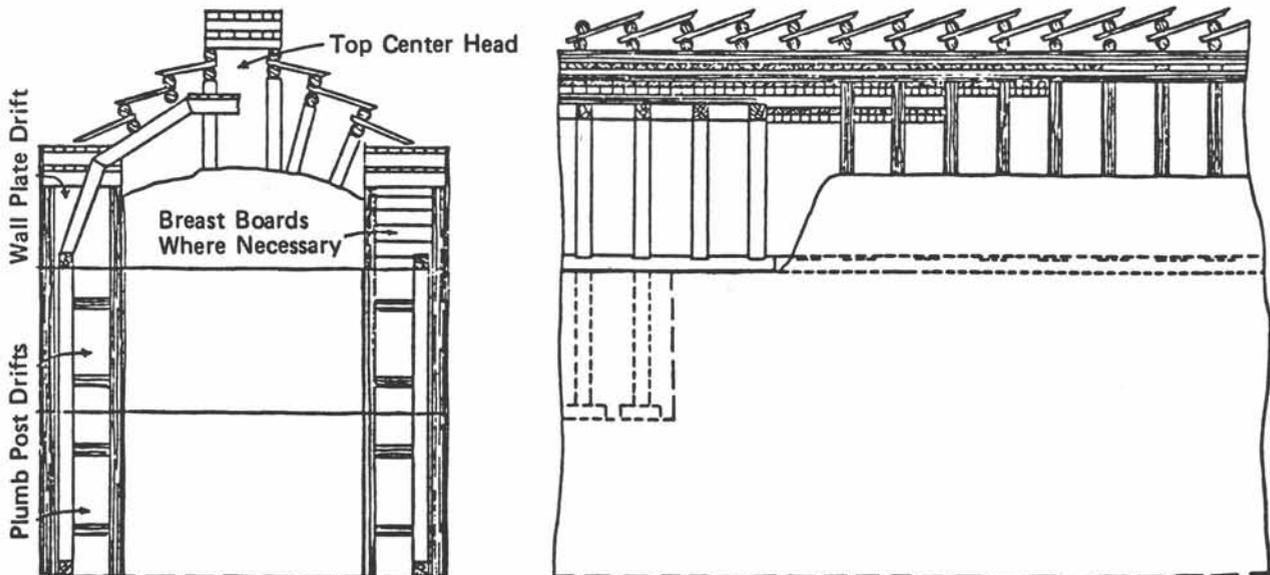
Figure 15. Excavation by top center heading and wall plate drifts using driven crown bars. From Baxter (1932) by permission, American Society of Civil Engineers.

The fifth method used both a top center heading and wall plate drifts to support very poor ground, as shown in Figure 15. These drifts were advanced with crown bars driven ahead of the excavation to provide complete ground support. Once the top was supported, small drifts were used to place the timber posts. Breast boards, which supported the excavation face, were used where the unsupported ground would run or flow into the drift. This method was used to excavate the poor ground at the west end of the tunnel.

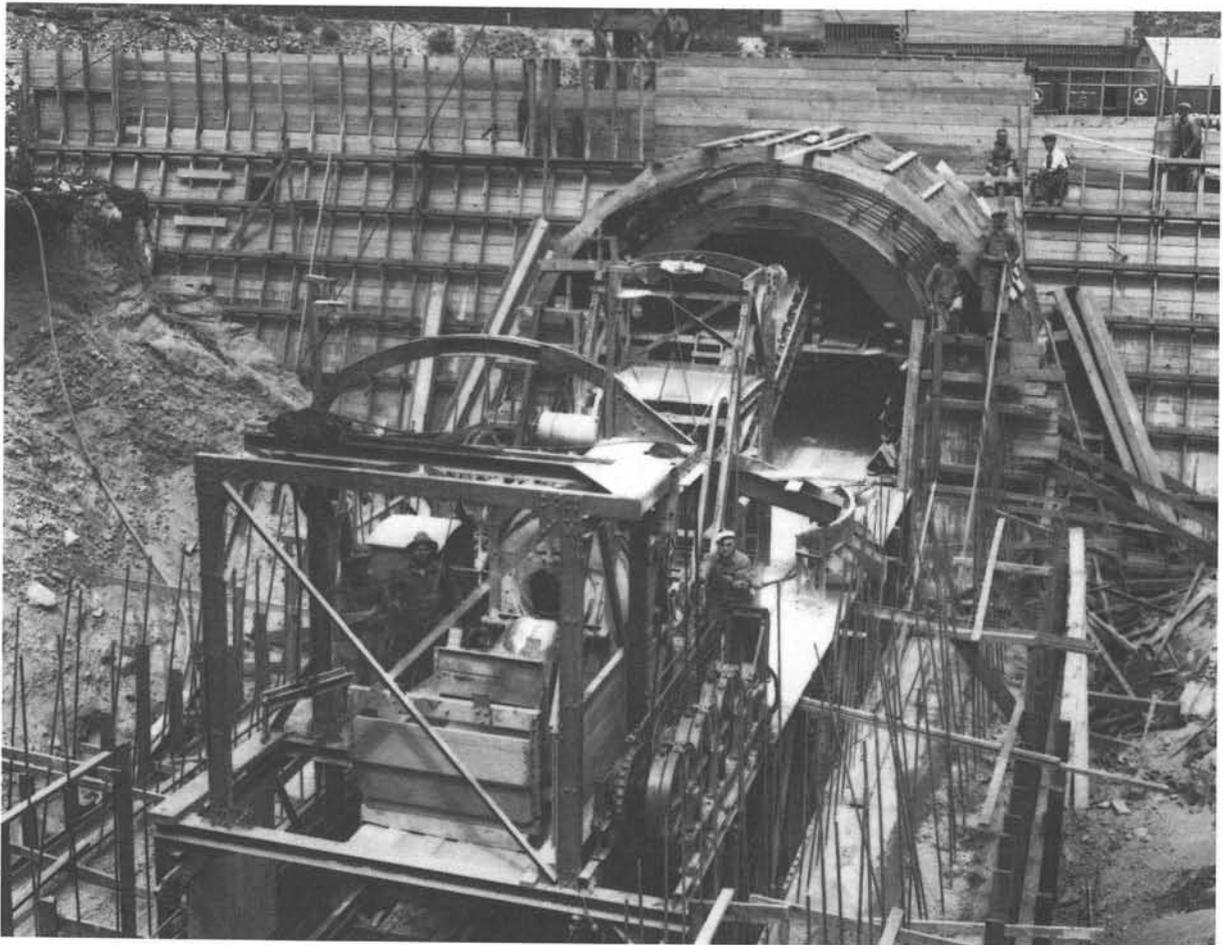
Figure 16. Concrete jumbo at east portal. Courtesy of Special Collections Division, University of Washington Libraries. Photo by L. Pickett, negative 3550.

At the jumbo, the box was lifted and the contents dumped into a mixing drum (Figure 16). After mixing, the concrete was placed in a skip that discharged into the main hopper. From the hopper, the concrete was

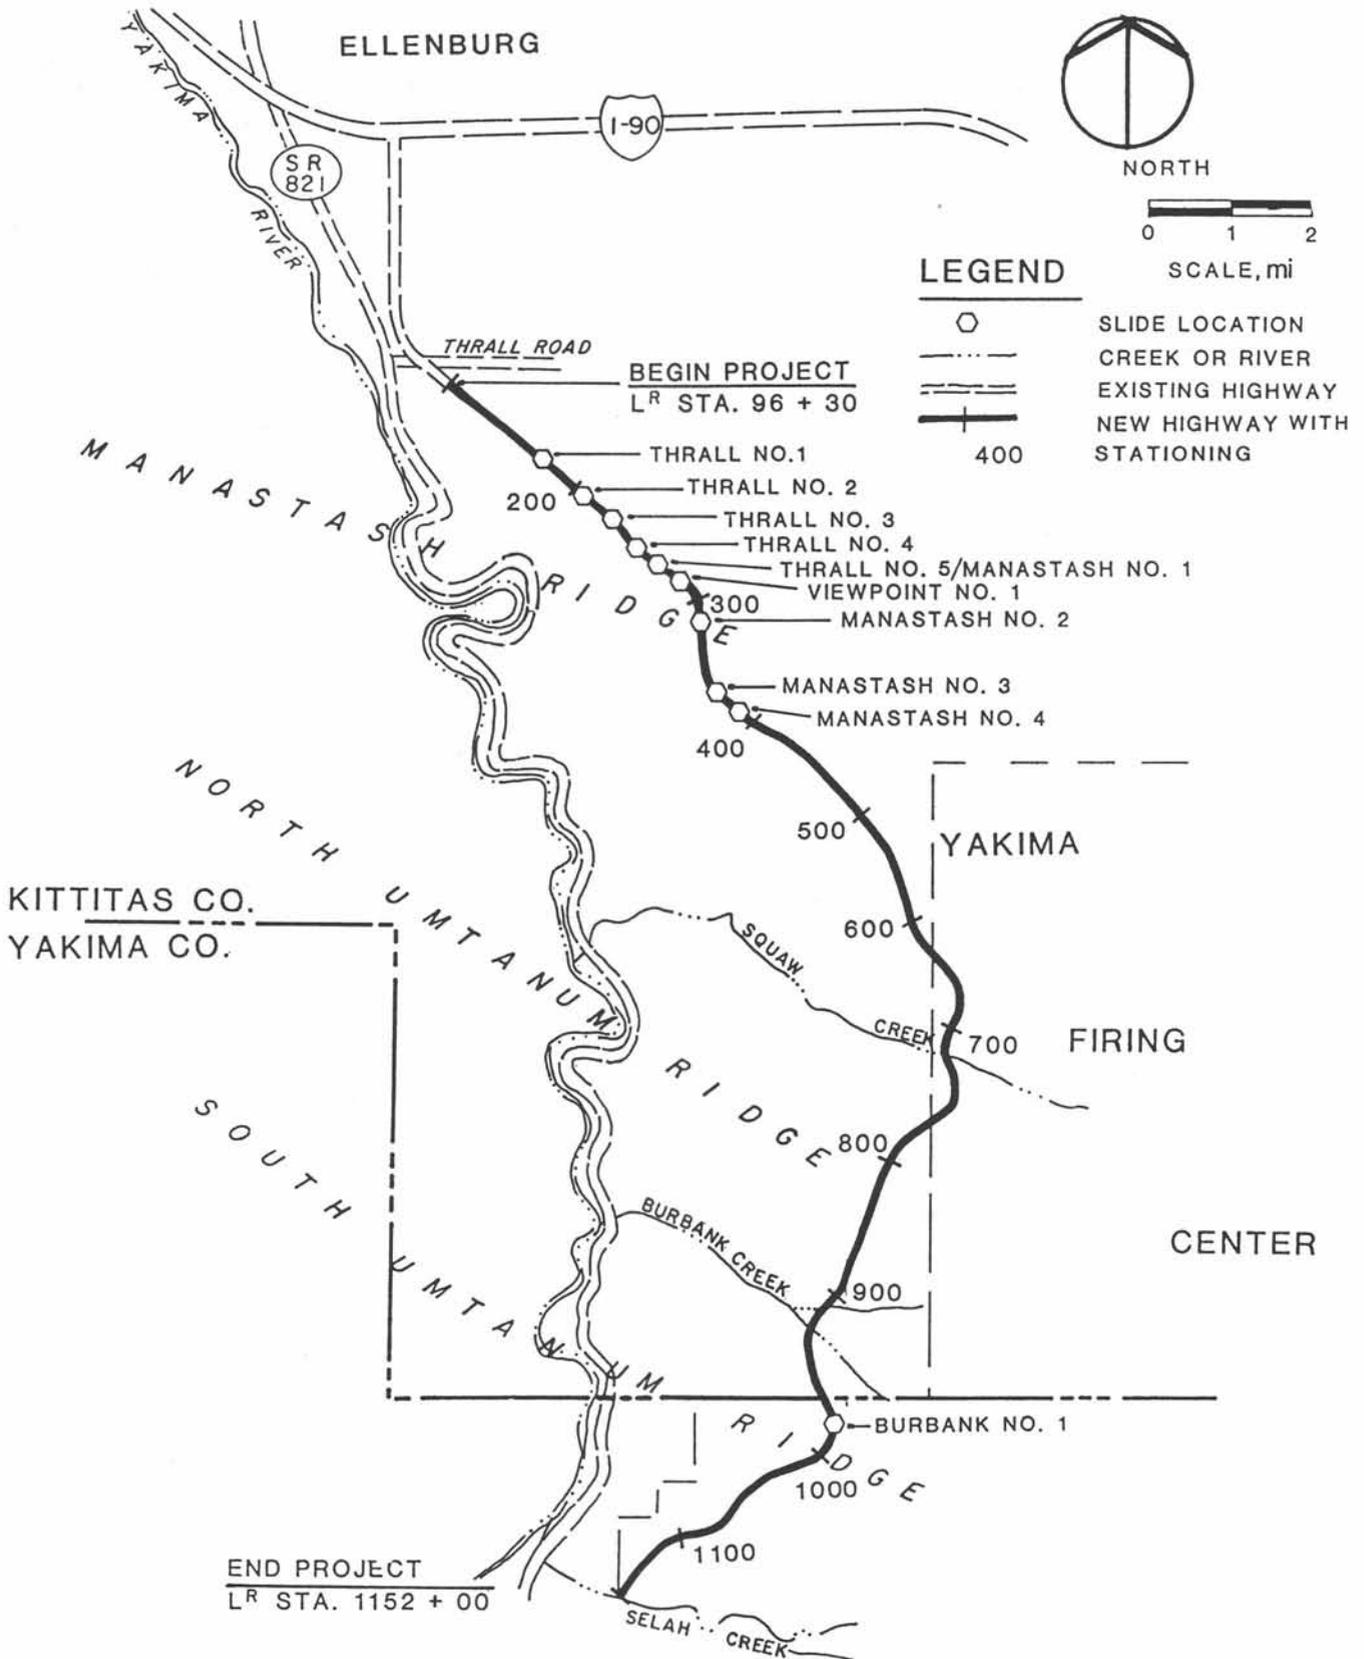
Figure 2. Slide locations along the project area.

Several ancient landslides were noted in and near the project environs. Most were along the steeper flanks of the anticlines, with the north limb of Manastash Ridge exhibiting the greatest concentration of slides. In some instances two or three slide blocks were situated one above the other. The steep dips coupled with a silt or clay stratum underlying individual basalt layers seem to be the primary cause of a majority of the landslides. Prior to construction all slides within or close to the project appeared to be stable.

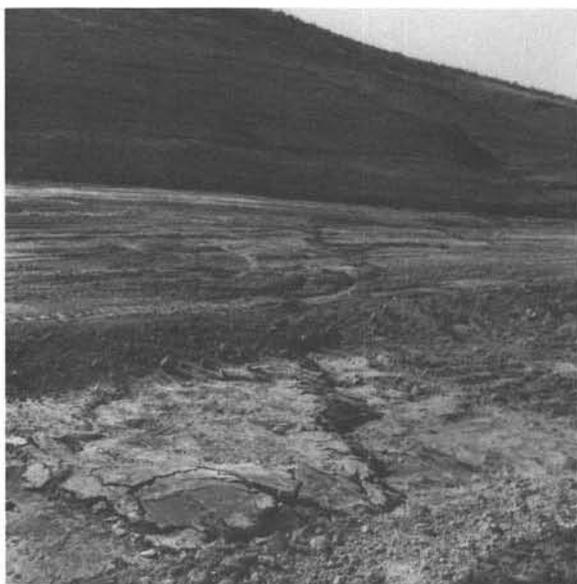
Figure 3. Thrall #1 Slide, L^R Line Station 180+ to 181. Shows slip plane down cut slope and across grade, along west edge of slide. Toe of slide in center foreground. Highway cut is 5 ft above final grade.

Thrall #1 Landslide is located on the middle part of the north slope of Manastash Ridge between Stations L^R 173 and 183. This 2H to 1V cut is 40 to 45 ft deep on centerline and 75 to 80 ft deep on the uphill, or right side. It traverses an ancient landslide block composed of slightly indurated clay, silt, and sand together with highly fractured basalt. Failure occurred on or about March 21, 1970, when the cut was still 5 to 10 ft above finished grade (Figure 3). Grading had been previously halted here when the contractor shifted his operations to another area. At that time, the cut was still 20 to 25 ft above final grade level. It was left in this state for a few weeks before excavation resumed. During this period no instability was observed. Upon resumption of grading, 10 to 15 ft of additional excavation was accomplished in a few days, and it was then that the failure occurred. This major slide was rotational in nature; the back scarp was 150 to 160 ft above and 480 ft upslope of highway centerline. Numerous small cracks were noted another 70 to 75 ft farther upslope. The toe, located near the centerline of the two L^R lanes, heaved 5 to 6 ft above the cut floor. Subsequent drilling and excavation revealed the slip surface to be a 1/8- to 1/4-in. seam of highly plastic, gray-brown clay. A ravine not far behind the slide separated it from a second old slide lying above it.

Several inclinometers were installed to ascertain the location of the slip plane and monitor ongoing movement. Data thus obtained, together with continued field observations, were used to determine the corrective ac-

tion (Noble, 1971). The need to maintain adequate support for the second old slide above was also critical. First, the new slide was unloaded by removing an estimated 150,000 to 200,000 cy of material from the head of the slide. When ongoing monitoring indicated the area to be relatively stable, a second step was initiated. A 30-ft-thick rock buttress was constructed. This was accomplished by excavating into the 2H to 1V cut in 50-ft-long segments, each segment being immediately backfilled with buttress rock. This prevented excessive removal of the toe support. The buttress extended 6 or 7 ft below the slip plane to provide a shear key. The slip plane was revealed in the shear key trench. Slow movement into the open trench was observed just ahead of the buttress backfilling. Movement continued, though at a considerably reduced rate, and a few cracks appeared a short distance behind the top of the removal area. Additional unloading of the upper part of the slide arrested slide movement.

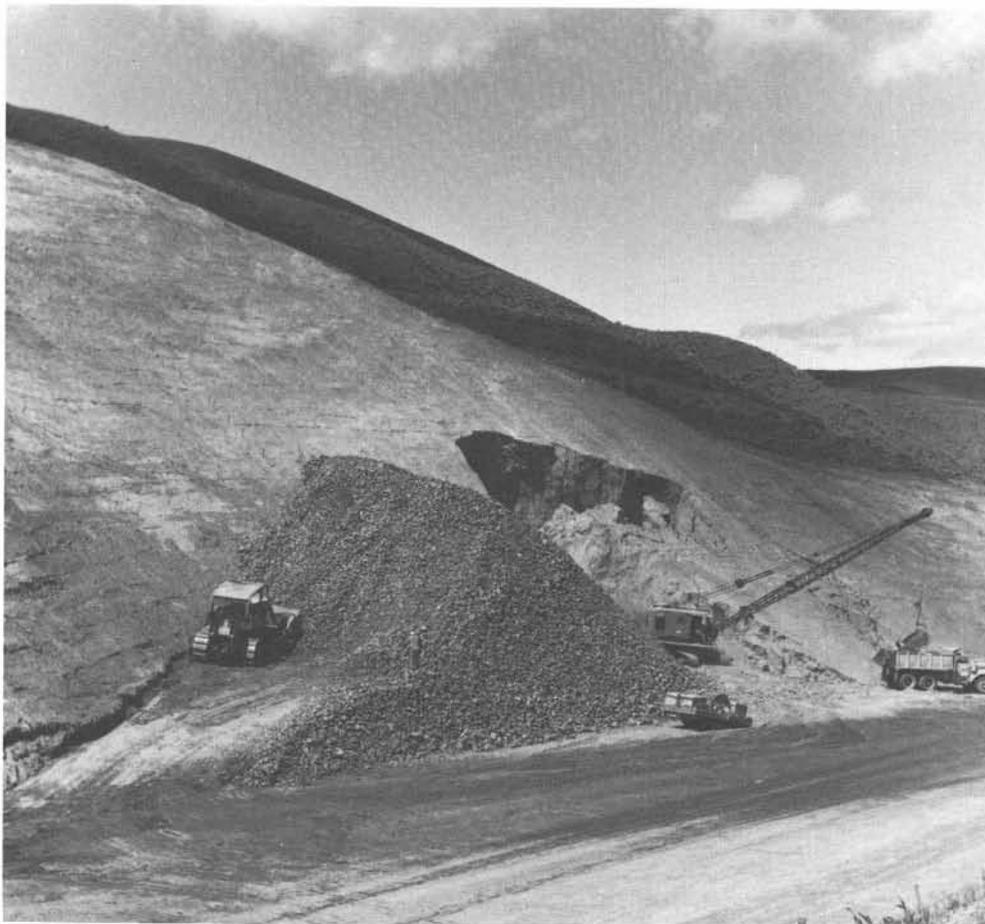
Figure 4. Thrall #4 Slide, near L^R Line Station 250. Note slide debris removal and rock buttress construction proceeding simultaneously.

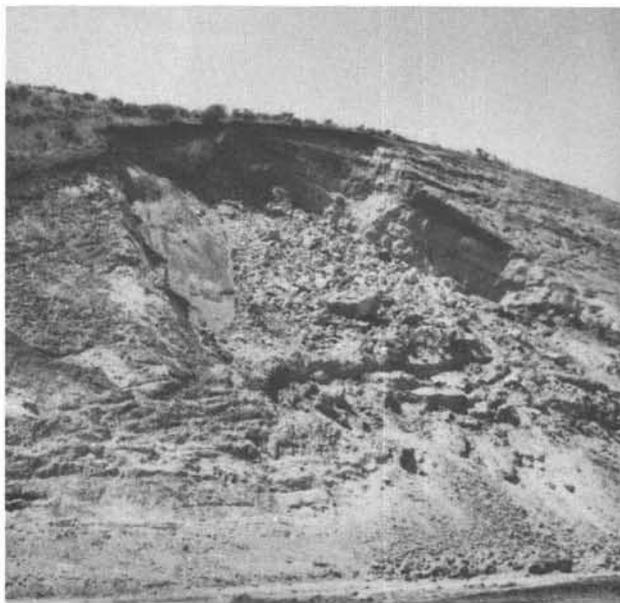
Figure 5. Manastash Slide #1, L^R Line Station 276 to 278. Note dipping sedimentary rocks at right center. Slip surface in clay strata is exposed as the smooth lobate area at the left edge of the slide.

This shallow block glide failure was located on the L^R Line between Stations 276 and 278, which is the upper end of the cut described in the Thrall #5 slide. Moderately dipping sandstone, siltstone, and claystone beds were undercut by the 1H to 1V cut slope, thereby

removing the toe support (Figure 5). The result was a landslide of several thousand cubic yards. The slip plane was the upper surface of a claystone layer, the strike of which diverged from the alignment to the west, thus limiting the slide potential in that direction. Because both Thrall #5 and Manastash #1 slides basically resulted from overly steep back slopes and were in opposite ends of the same cut, the recommended treatment called for flattening the entire cut face to a 1.5H to 1V slope. This required some 35,000 cy of additional excavation. Since neither area presented an immediate or particularly hazardous stability problem, correction was deferred and completed in July 1972, under a separate contract.

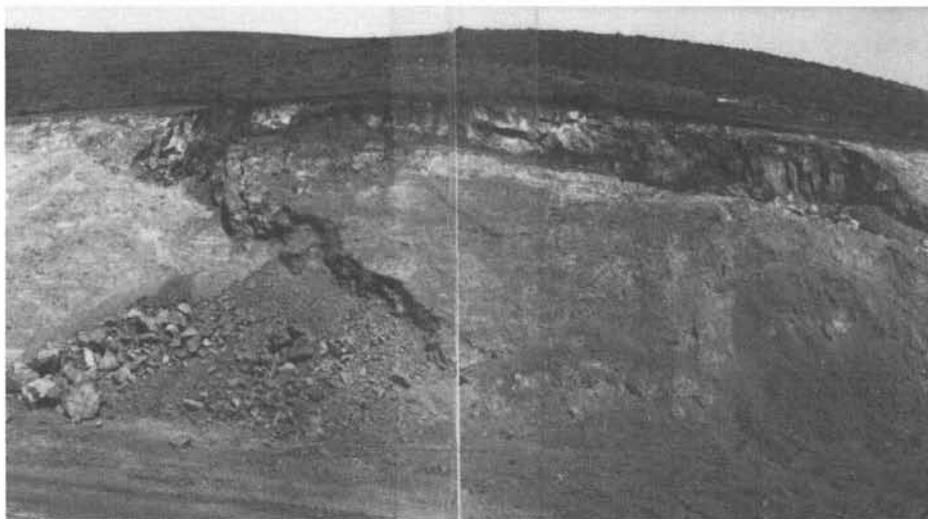
Figure 6. Manastash #3 Slide, L^L Line Station 380 to 382. Most of the cut was on a 1H to 1V slope in weathered and highly fractured basalt.

This rock slide occurred on the gently dipping south slope of Manastash Ridge on the L^L Line from Station 380 to 382, where the cut was 75 to 80 ft deep (Figure 6). The material was predominantly weathered, highly fractured basalt, none of which required drilling and shooting. Some thin sedimentary interbeds were also encountered. The 1H to 1V slope failed while under construction along what appeared to be an old fault plane. Approximately 20,000 cy of finely jointed basalt was involved, and it partially buried a piece of earth-moving equipment at the toe of the cut. The problem was cor-

rected successfully by flattening the cut to a 1.75H to 1V slope, which required about 75,000 cy of additional excavation.

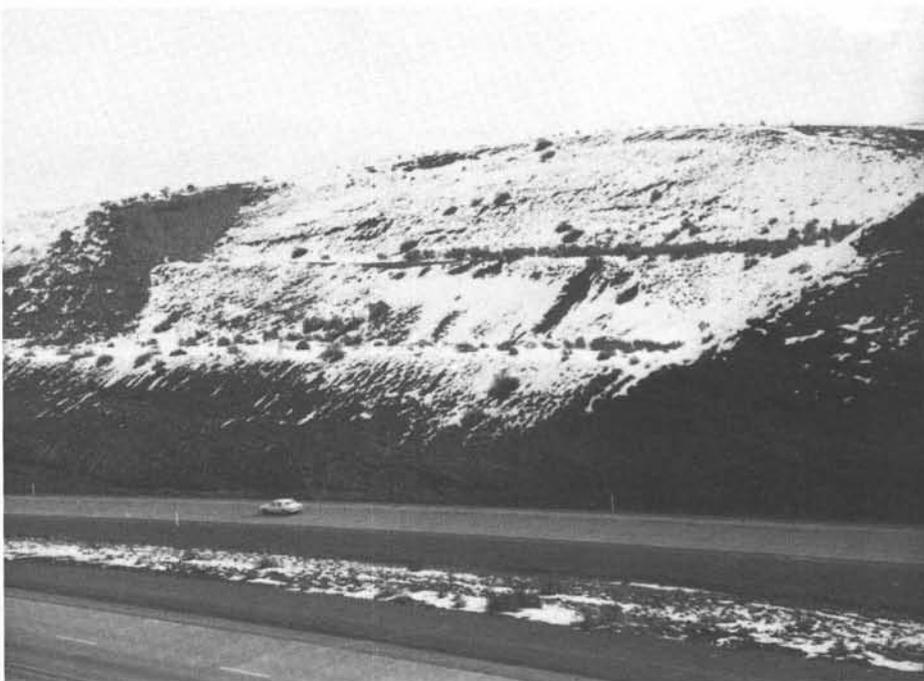
Figure 7. March 1987 photo of Burbank #1 slide area, L^L Line Station 968+50 to Station 972+50. Note dipping sedimentary rock, also rock buttress across the center of the photo.

was feared the slide area was becoming active. However, no movement had been reflected by the inclinometers. A closer examination revealed a 1- to 2-ft-wide, untreated band of swelling clay to be the culprit. In the Burbank area, a somewhat thicker deposit of untreated clay caused two or three of the concrete paving panels to buckle and break.

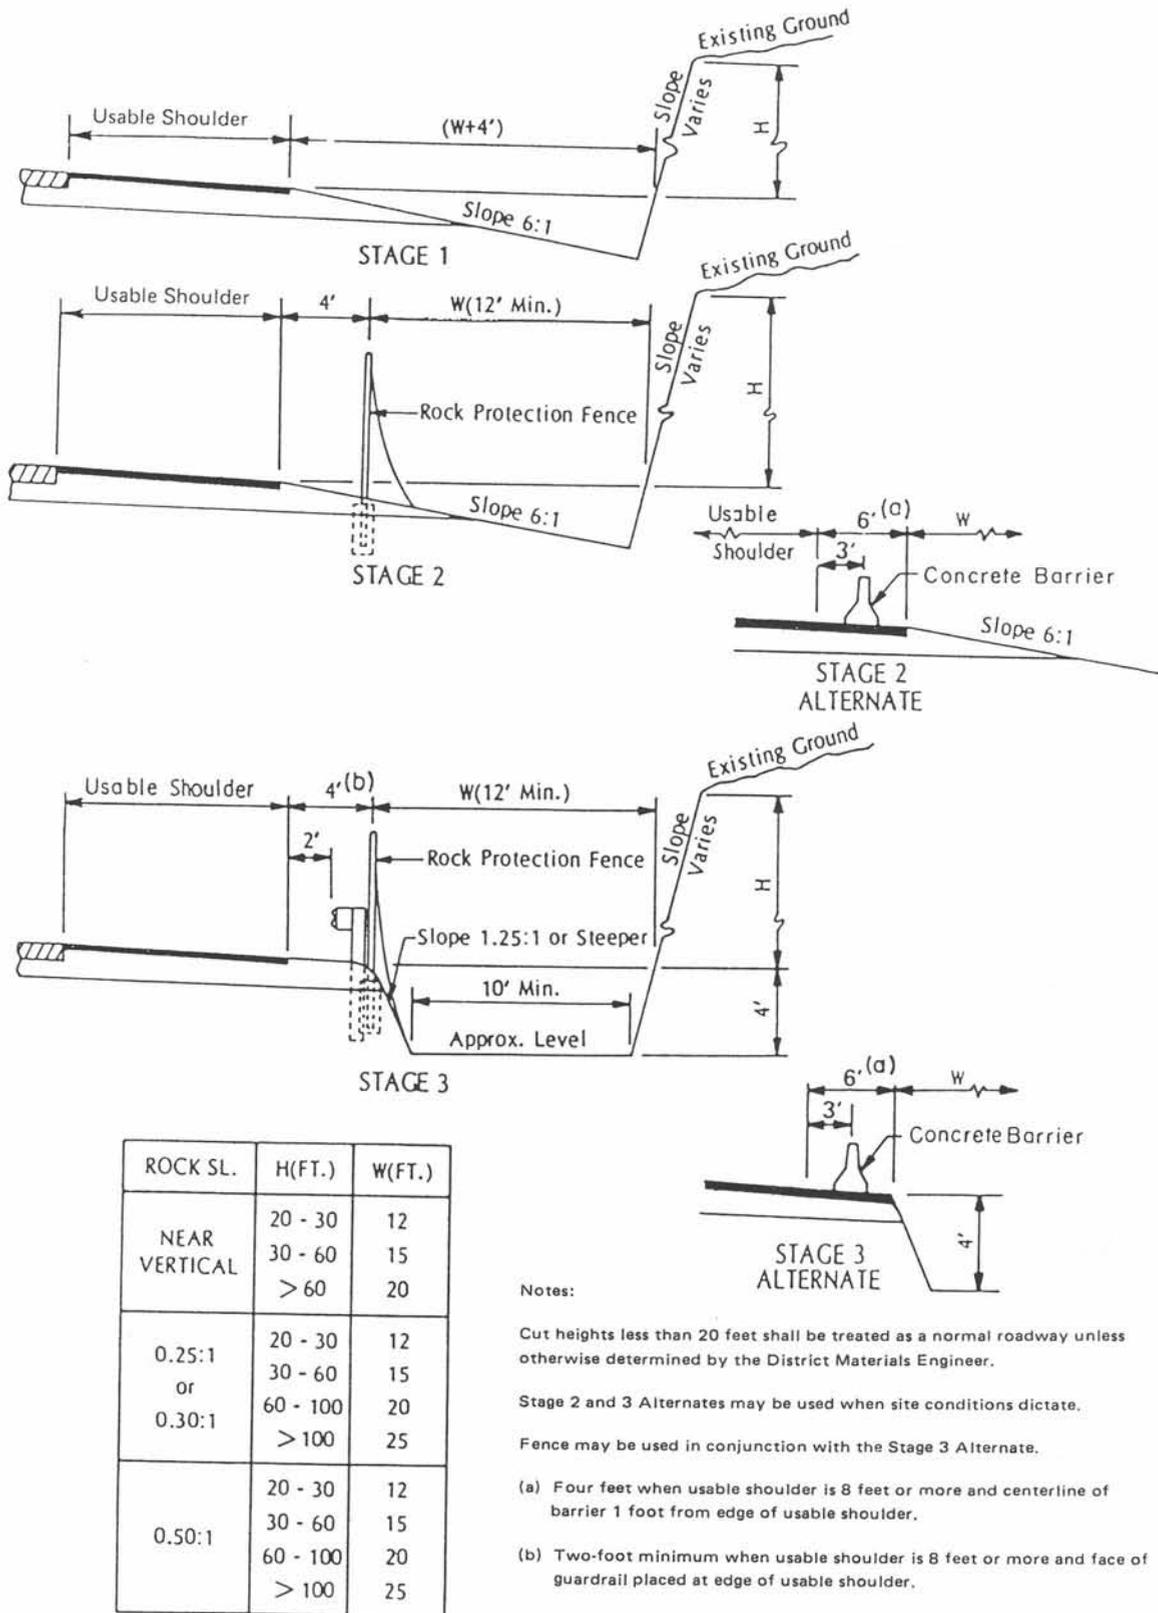
Figure 8. Roadway sections in rock cuts, Design A from Washington State Department of Highways (1968).

A less serious slope stability problem was severe raveling in some of the cuts in highly fractured and weathered basalt. At most locations such conditions were anticipated, and standard rockfall ditches were constructed in accordance with the WSDOH Design Manual (1968). In a few places this problem became apparent only after it was too late to build an appropriate rockfall catchment area. At such locations rock protection fences were placed near the toe of slope (Figure 8). These proved to be quite effective; few of the fallen rocks are large, and rockslides of any appreciable volume are uncommon. The amount of accumulated rock in many ditches and behind the fences attests to their effectiveness.

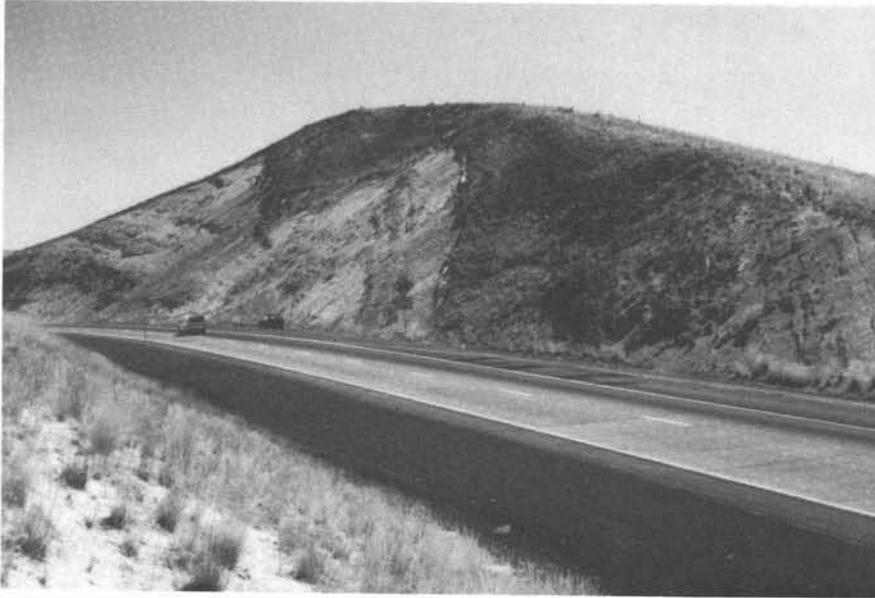
View northwest to Kittitas Basin from Vanderbilt Gap where Interstate Highway 82 crosses Manastash Ridge in a deep rock cut at the crest of the Manastash anticline. Photograph by R. W. Galster, August 1987

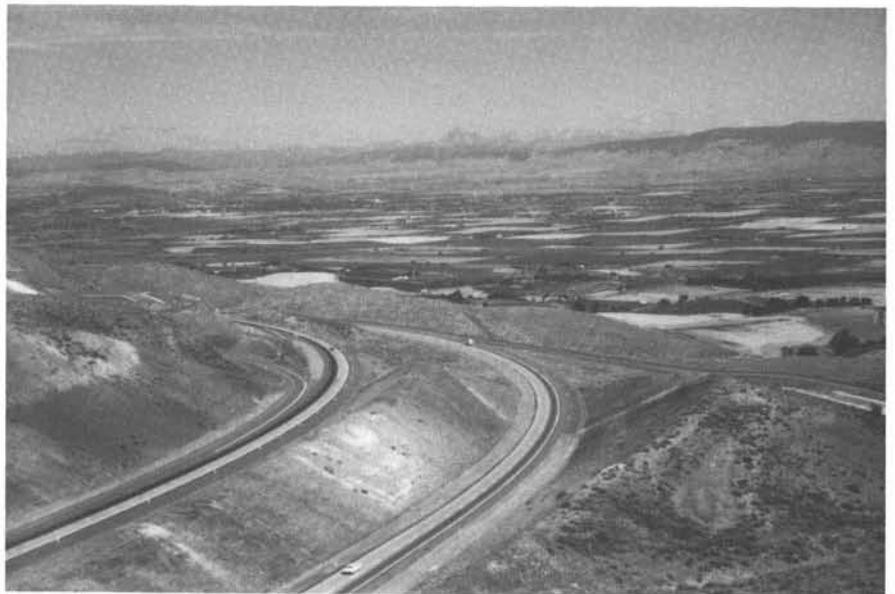
View of a highway cut along Interstate Highway 82; west-bound lanes at Selah Ridge crossing through (left to right) the Selah Member of the Ellensburg Formation, the Pomona Member of the Saddle Mountains Basalt, and tilted post-Pomona sediments. Photograph by R. W. Galster, August 1987

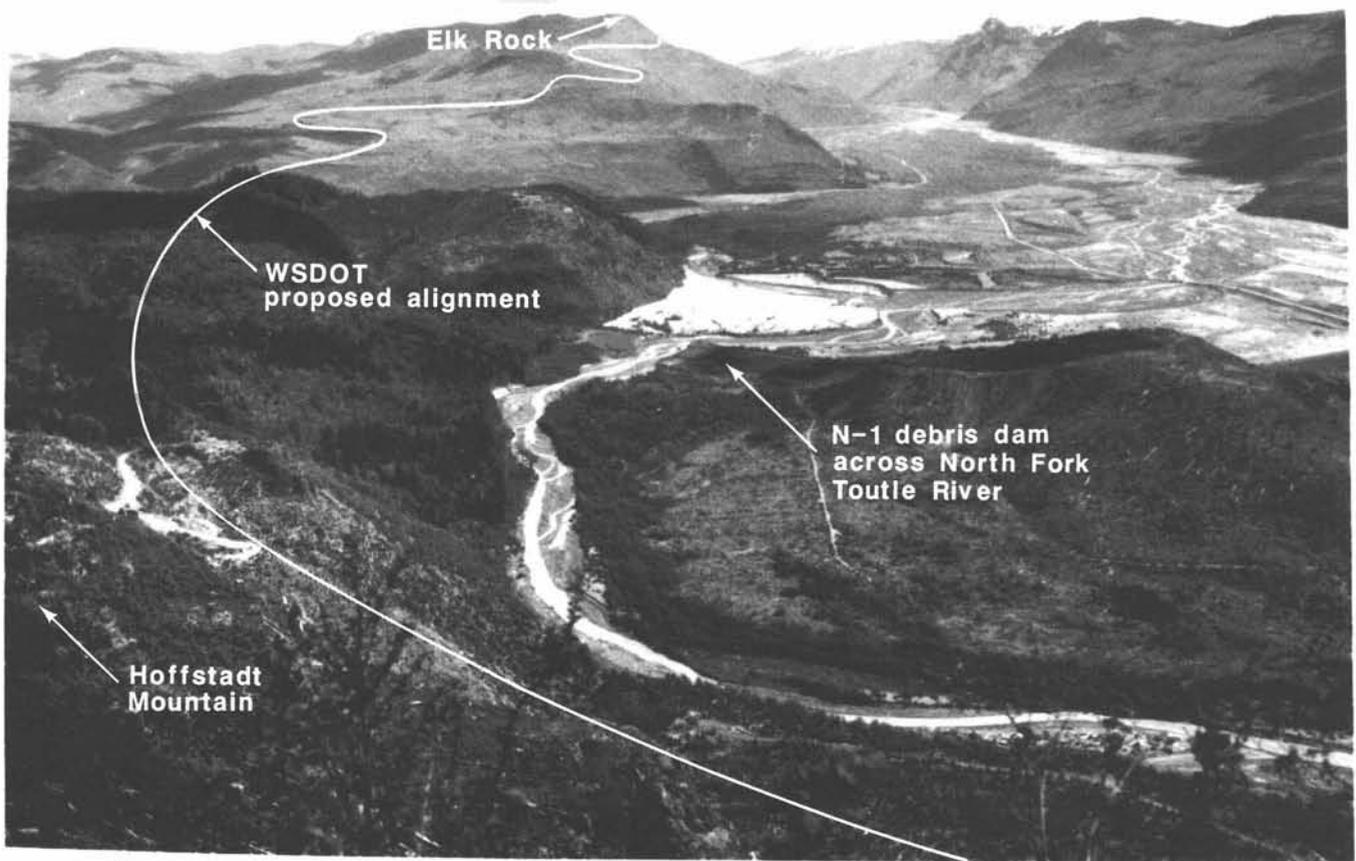
Figure 1. Portion of the Spirit Lake Memorial Highway alignment along the north side of the North Fork Toutle River valley. The original State Route 504 was located in the valley bottom and is now buried beneath the 1980 mudflow and debris avalanche deposits from Mount St. Helens.
