ENGINEERING GEOLOGY IN WASHINGTON

Volume II

BULLETIN 78

Runoff and Stream-Channel Changes Following Urbanization in King County, Washington

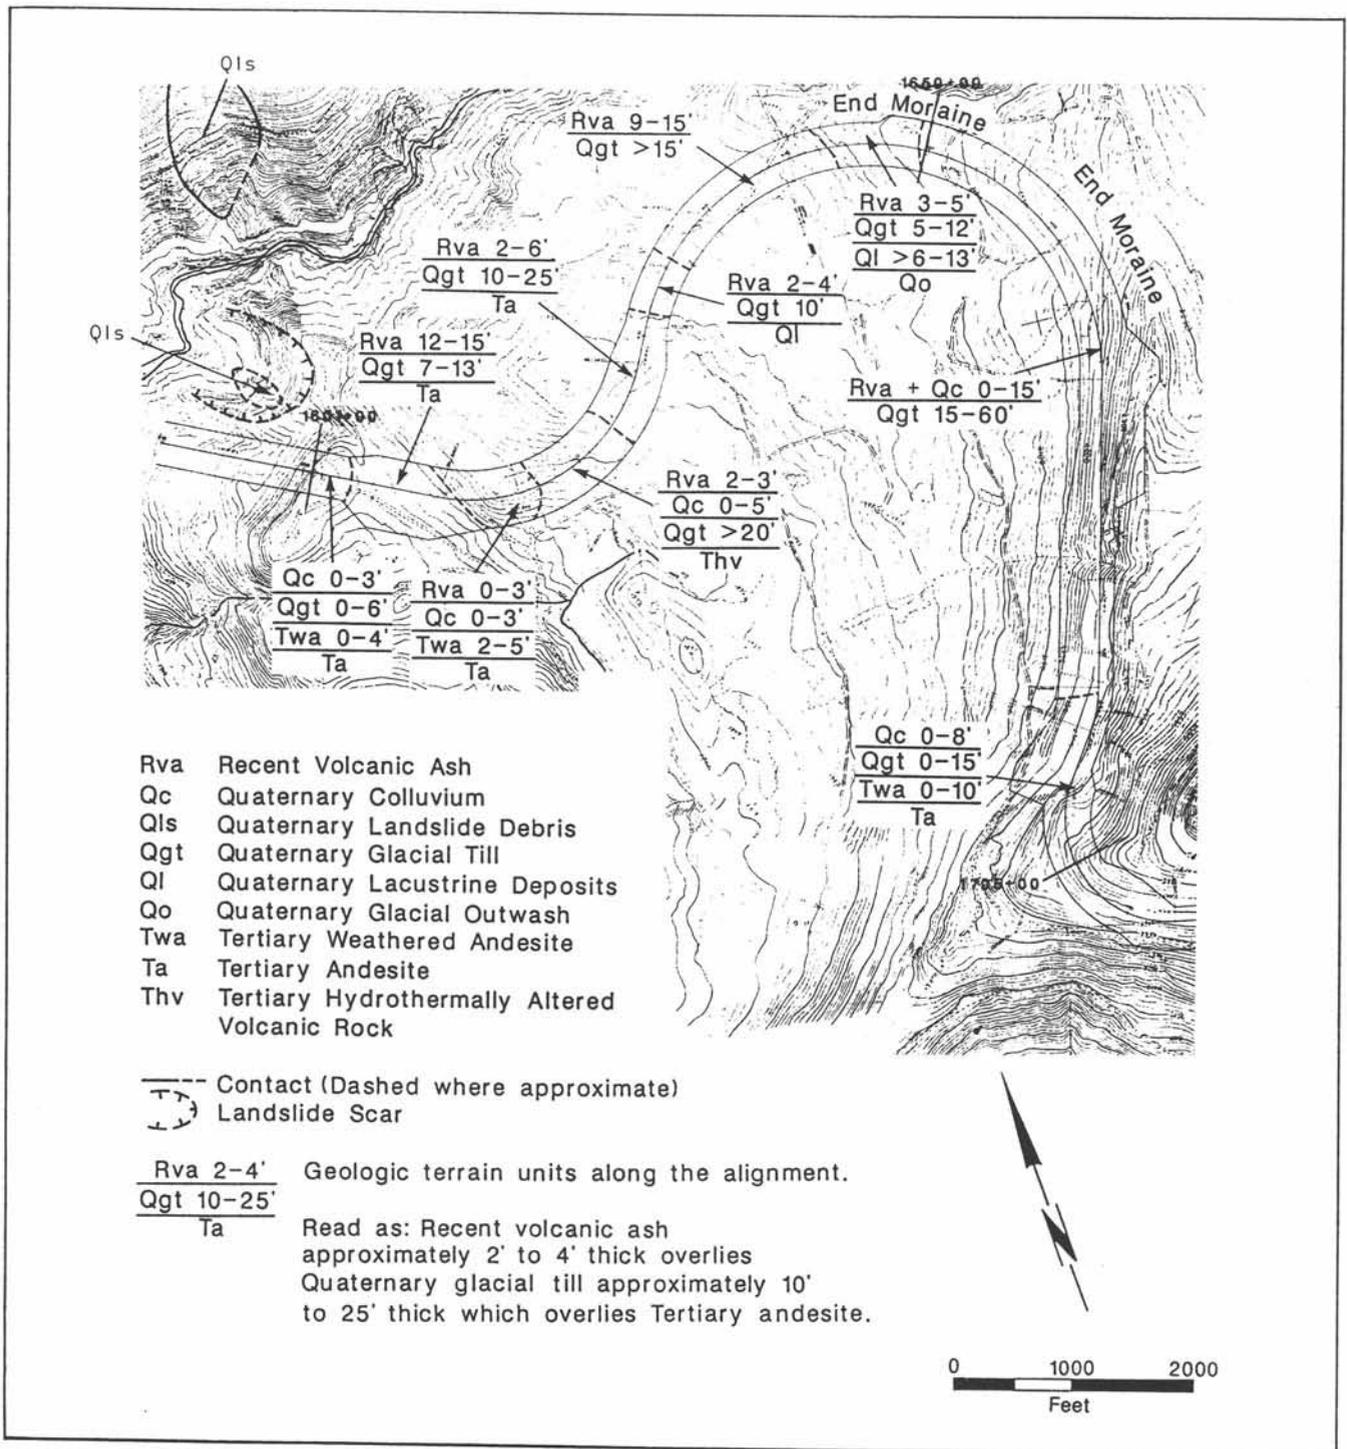
Figure 3. Typical geologic terrain-unit map prepared for each of the six segments of the highway alignment.

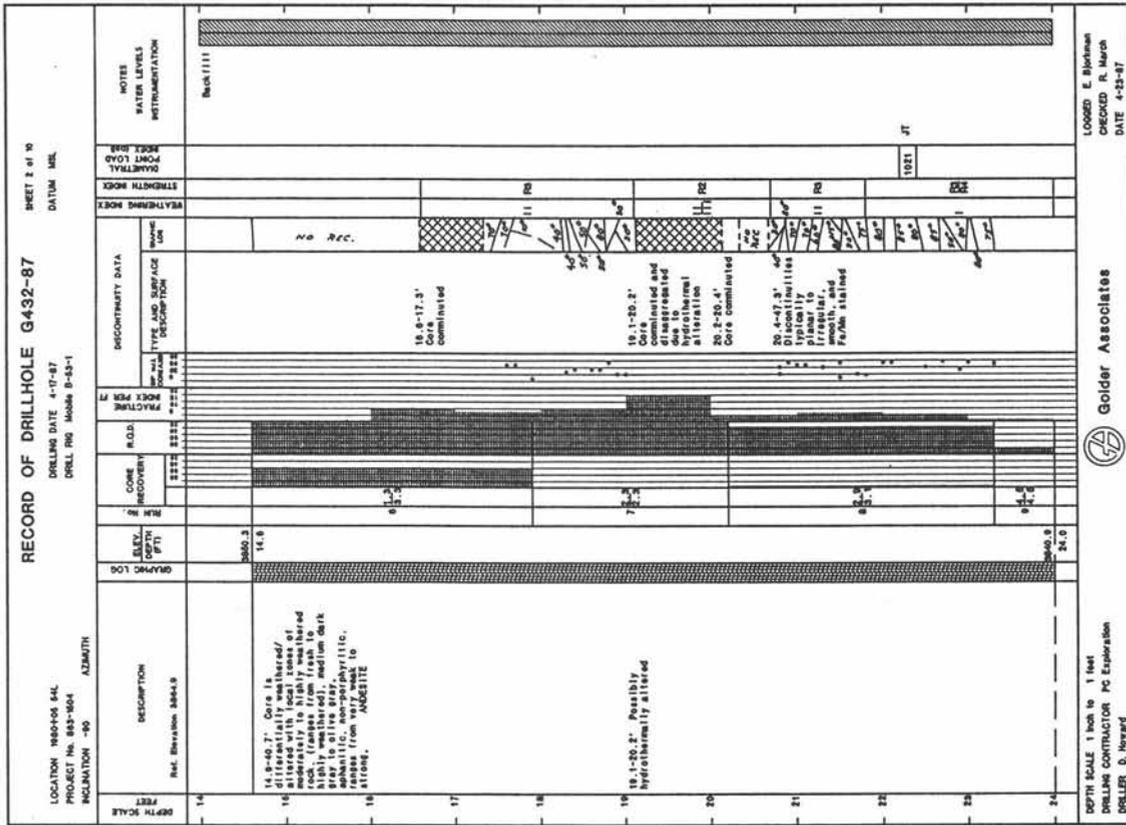
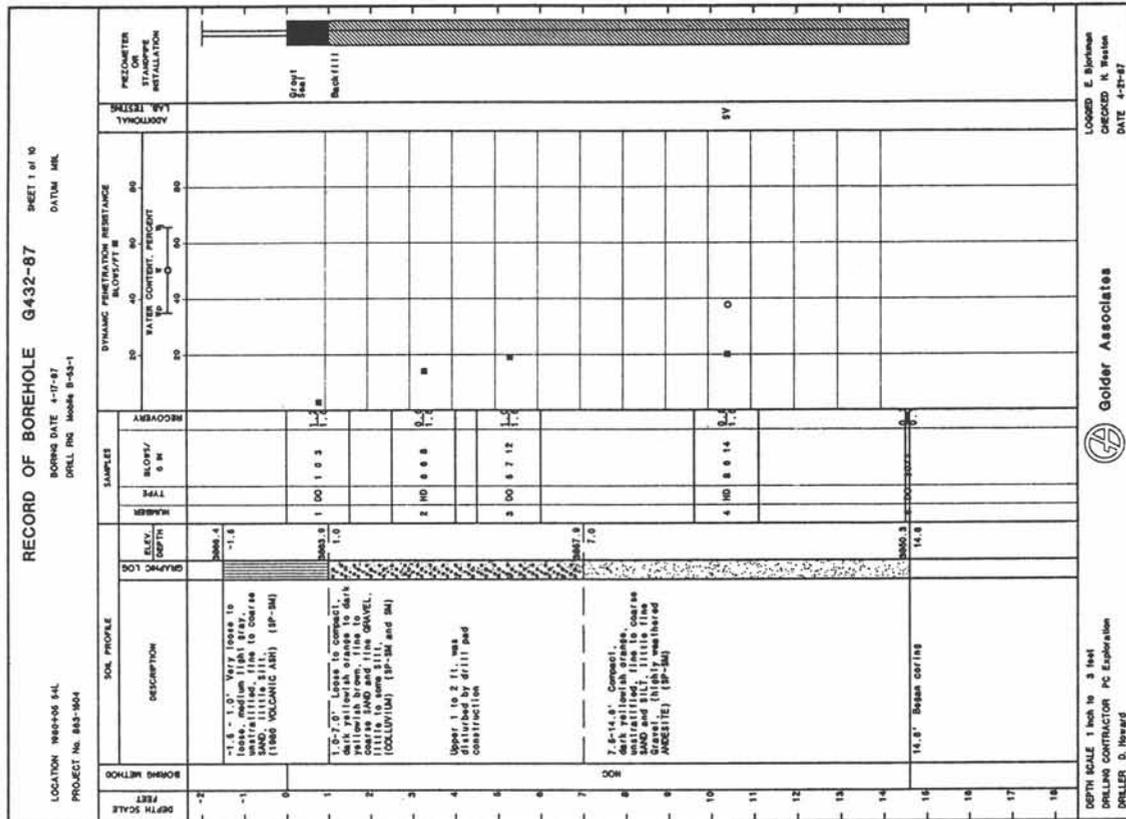
Figure 4. Example of the final borehole logs that were produced at the project site using Golder Associates Inc.'s SEATLOG computer program. The discontinuity graphic log is the only portion that is hand-drafted. An associated database management system allows the retrieval of the log data.

1985). Sampling in the unconsolidated deposits was accomplished by drilling casing, washing, and then driving either standard split-spoon samplers or larger diameter California samplers using both standard penetration test (SPT) methods and modified heavy hammer methods alternately. In rock and indurated deposits, diamond core drilling using a double-tube system with a split inner barrel was used to obtain core samples. Test pits were dug with a track-mounted excavator. Rig geologists or engineers were present to log all boreholes and test pits. Logging was accomplished using Golder Associates Inc. standard procedures for soil descriptions (Golder Associates Inc., 1987) and a standard method for rock descriptions, which is based on the International Society for Rock Mechanics (ISRM) Suggested Methods (Brown, 1981). All soil samples and core were independently reviewed in a field laboratory for consistency of description prior to production of final borehole logs. Because of the large number of boreholes and the necessity of on-site engineering analysis concurrent with the investigation program, final borehole logs were produced at the project site using Golder Associates microcomputer

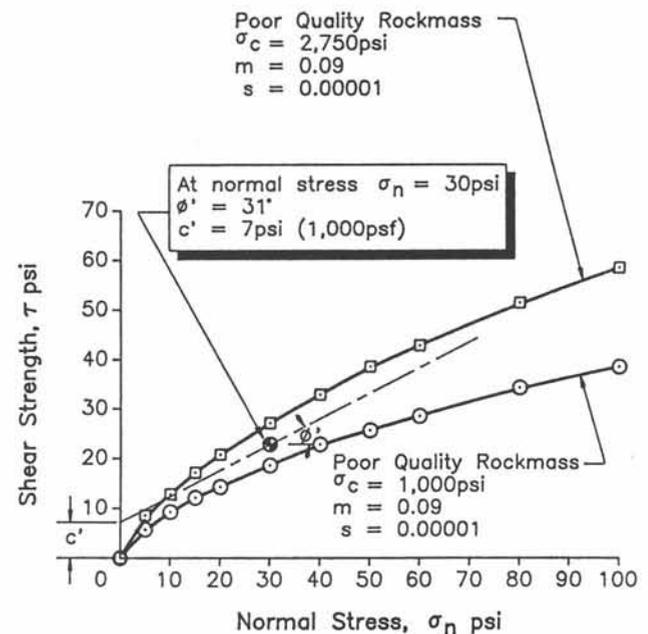
Envelope based on Hoek-Brown failure criteria:

$$\sigma_1 = \sigma_3 + \sqrt{m\sigma_c\sigma_3 + s\sigma_c^2}$$

Poor-quality rock is moderately to completely weathered (the ISRM designation does not distinguish between weathering and alteration [Brown, 1981]) and broken by closely to very closely spaced fractures which cause the rock mass to behave in a manner that is intermediate between a weak rock and a soil. The relict structure of the rock will cause the material to dilate during shear at low normal stresses, although this behavior will cease at higher normal stresses as shear failure will pass through the material regardless of the relict structure. As shown in Figure 5, this behavior gives rise to a curvilinear shear strength envelope. Shear strength parameters selected for engineering purposes, in this example, are an effective angle of friction of 31° and an effective cohesion of 1,000 psf. Curves similar to those shown in Figure 5 were constructed for fair and good quality rock masses for each of the alignment segments.

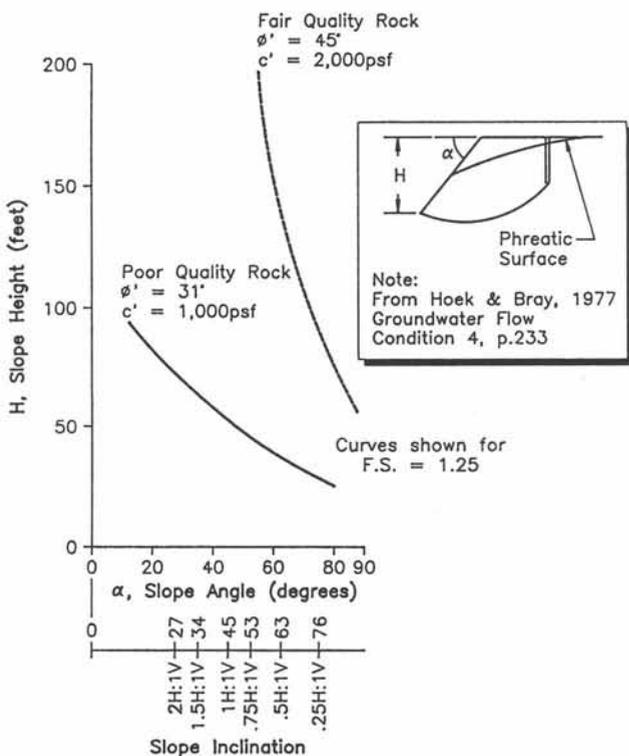
Figure 6. Rock slope stability for circular failure in poor- and fair-quality rock masses.

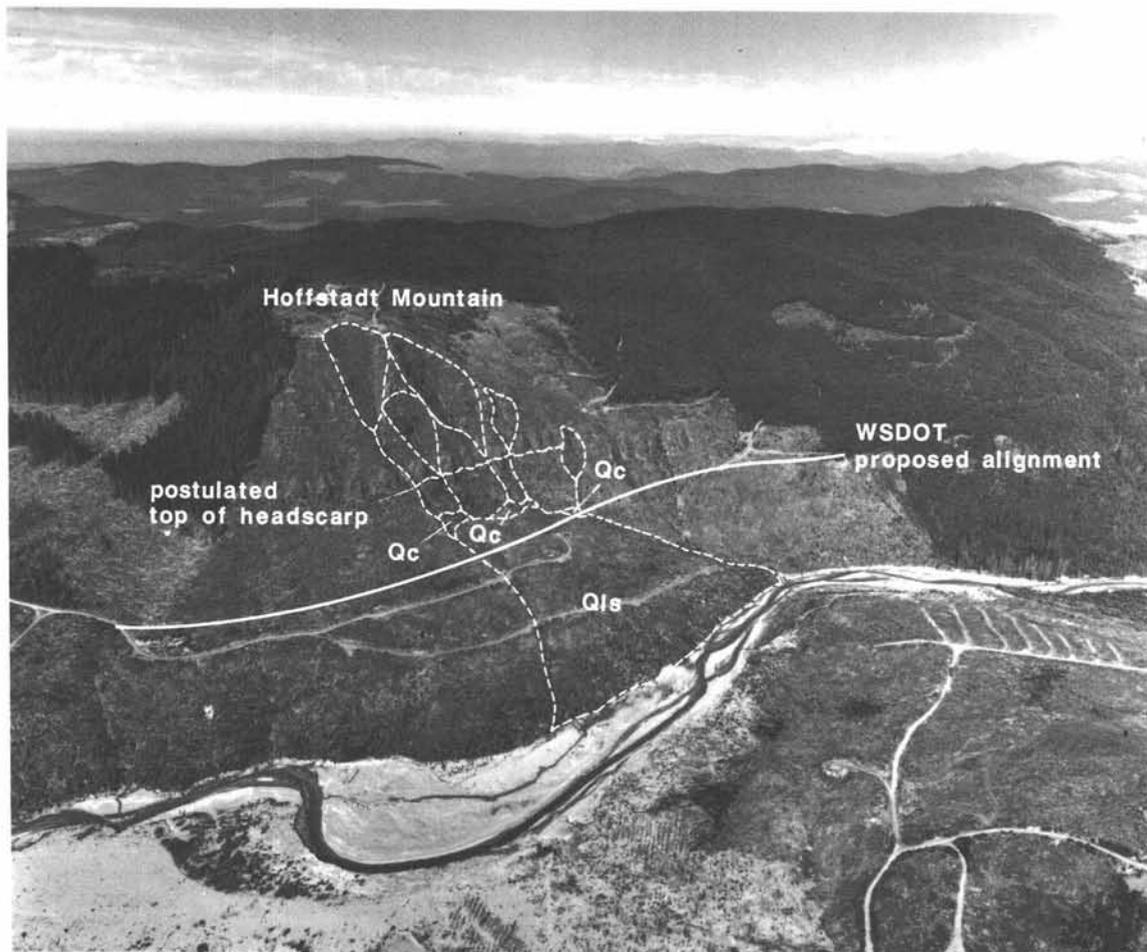
Figure 7. The highway alignment crosses a large Quaternary landslide deposit (Qls) that is overlain by colluvium and talus (Qc) derived from Hoffstadt Mountain.

On the basis of the results of these analyses and the lack of any geomorphic evidence of recent slide activity, the landslide deposits are considered to be stable in terms of their effect on highway design and construction. Nevertheless, an inclinometer was placed in one of the exploration boreholes in order to confirm that no movements are occurring.
