GEOLOGIC INTERPRETIVE MAP SHOWING

AREAS OF UNSTABLE SLOPES

Kitsap County, Washington.

By Kurt Othberg - 1975

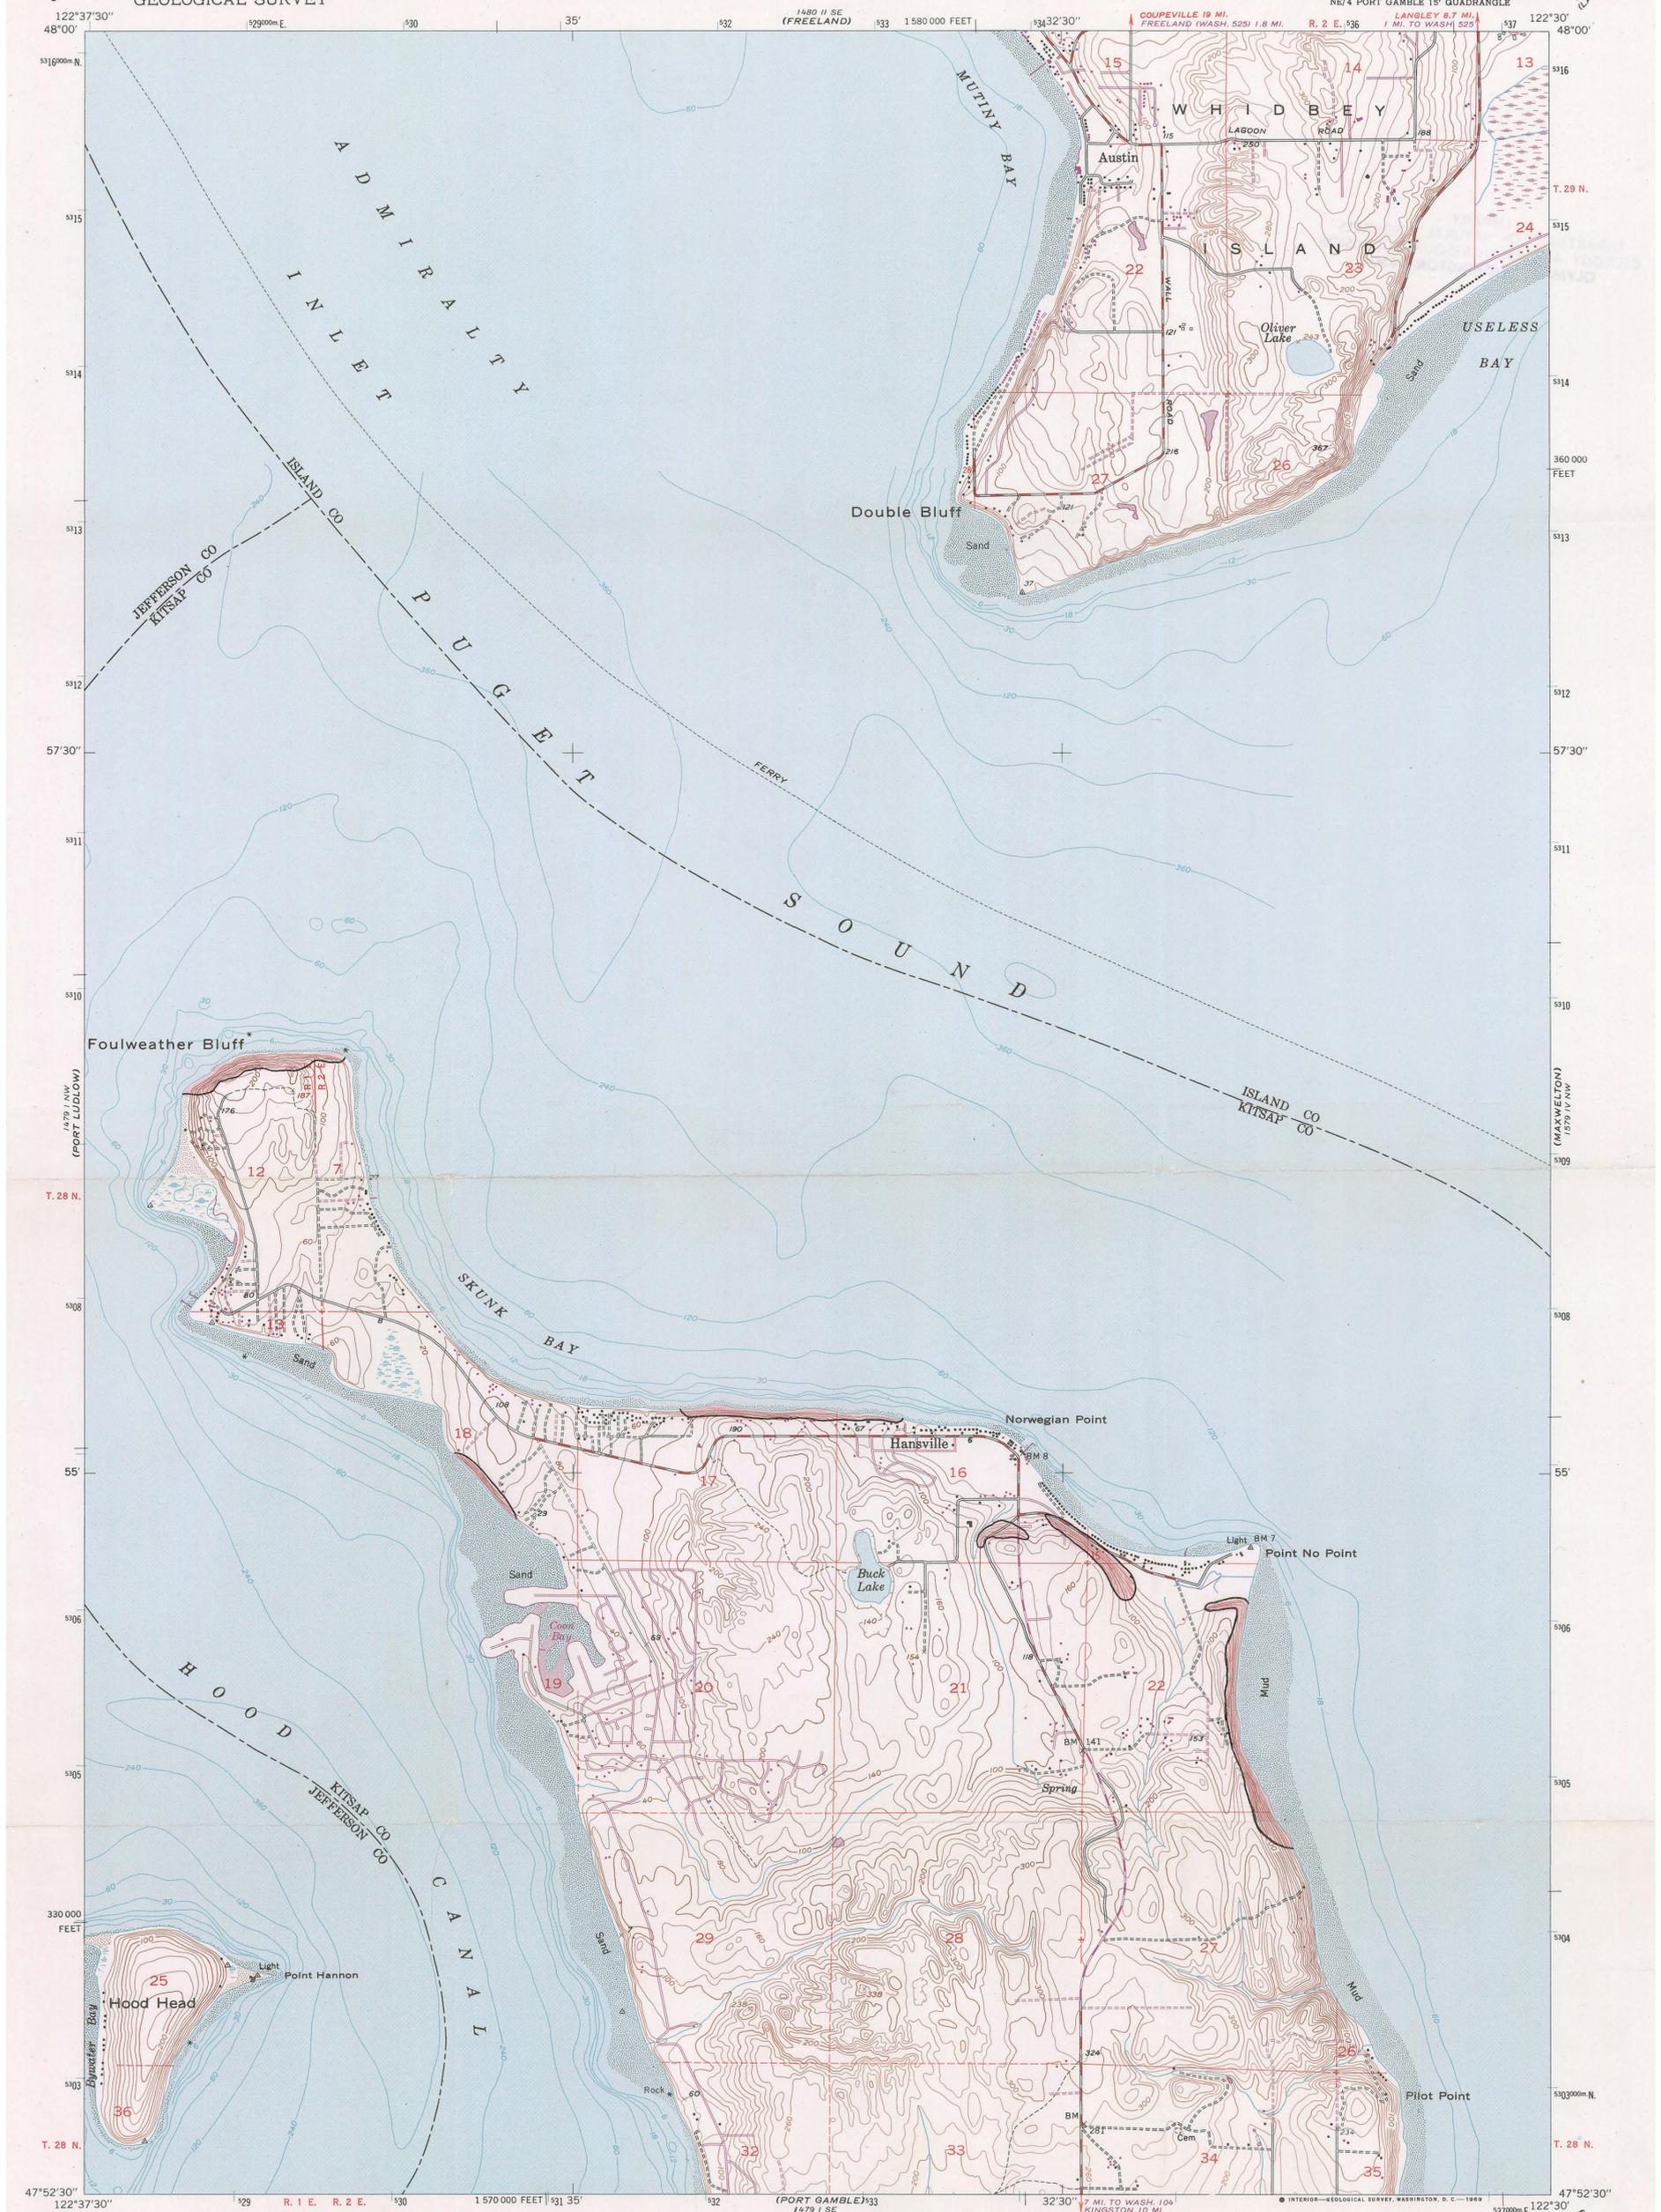
HANSVILLE QUADRANGLE

Unstable slopes as mapped show one or more of the following characteristics:

1. Evidence of active landsliding.
2. Observable land forms that are the result of past active mass movements, e.g., landslide scarps and toes.
3. Known or strongly suspected presence of geologic formations which, given enough ground water, or disturbance, can provide the conditions necessary to initiate landsliding.

Mapping of unstable slopes is based on 1973-1974 field observations with the exception of areas adjacent to Colvos Passage. Unstable areas along Colvos Passage have been mapped using data from published ground water geology maps.
